**INVESTIGATION INTO THE CAUSES OF AN ALLISION BETWEEN THE WINDFARM SUPPORT VESSEL
NJORD FORSETI AND A WINDFARM TOWER IN THE SOUTHERN NORTH SEA ON 23RD APRIL 2020.**

FINAL REPORT

Derrick A Thorrington

Jersey Maritime Administration

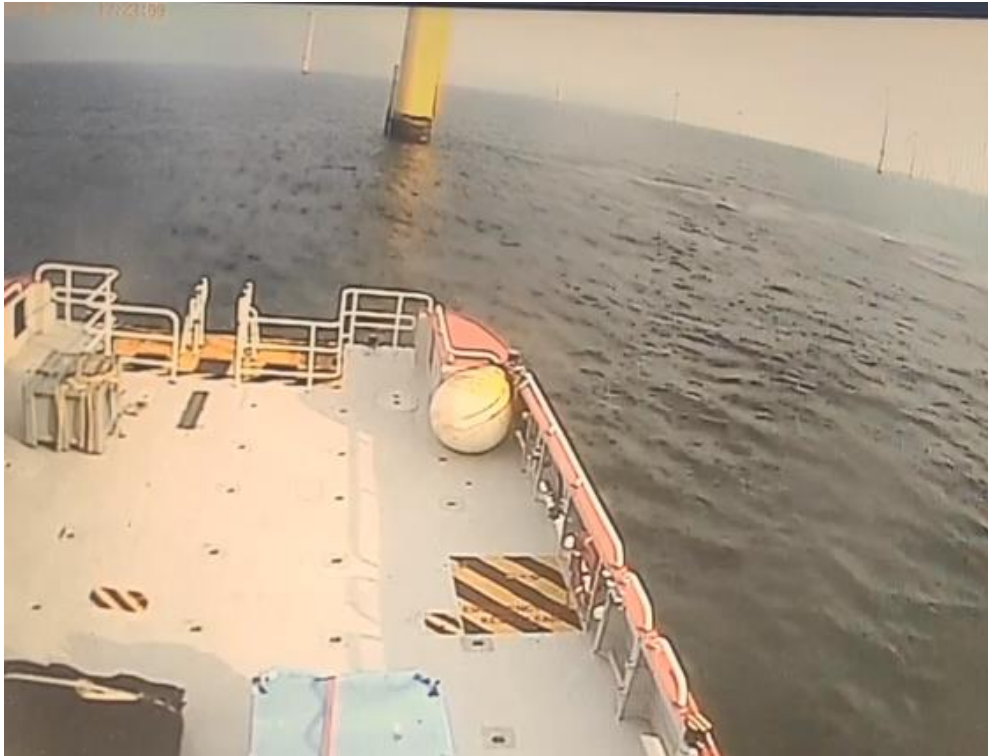
8.6 As has been acknowledged in the Njord commissioned incident report, CCTV footage of the turbine tower in the seconds before impact shows a slick orientated approximately in a WSW direction which suggests current flow in this general direction. It is therefore possible that when transiting between windfarms Borkum Riffgrund 1 and 2, insufficient allowance was made for this tidal set.

Vessel CCTV coverage showing Njord Forseti approaching turbine tower Q05 shortly before impact. A slick most probably caused by tidal flow can be seen running from the turbine tower across the direction of travel of the vessel.

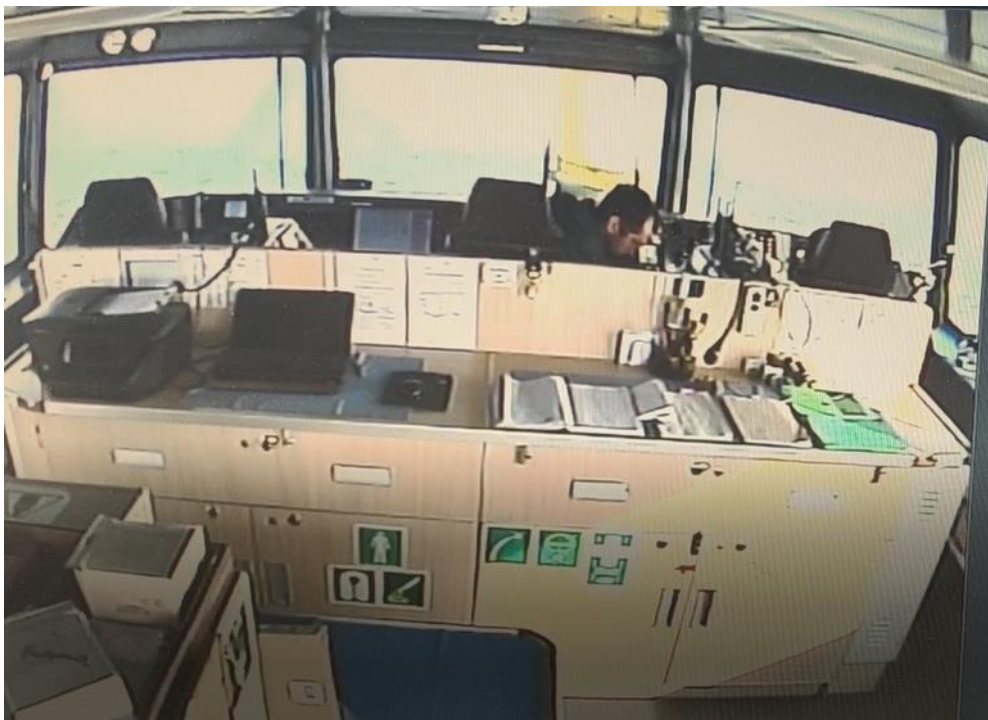
8.4 For the period of coverage sighted by the undersigned up to the point of impact (approx. 1 minute) the Master was seen to be leaning over the starboard side of his seat, with his attention being almost entirely taken by something in this area. It is not entirely clear for how long he had adopted this position. The company reports that CCTV coverage suggests that this posture was adopted for at least 2 minutes. Although he adjusts his position during the footage, it cannot be determined objectively what task the master was engaged in. In the seconds immediately before the impact the master's attention is drawn to the wheelhouse front and at the point of impact, the CCTV

8.5 The CCTV shows no other persons in the forward part of the wheelhouse immediately prior to or at the time of the incident. Therefore, it is concluded that immediately prior to the incident, the only person undertaking lookout duties is the vessels master.

Vessel CCTV coverage showing the Master in the wheelhouse distracted by something to starboard of his seat in the seconds before impact. The turbine tower can be seen through the centre wheelhouse window.

4.2 The company should identify tasks, equipment and functions that may give rise to possible distractions for the person having the conduct of the vessel whilst underway. The company should implement measures to ensure that the safe conduct of the vessel is not impaired by these or other factors.

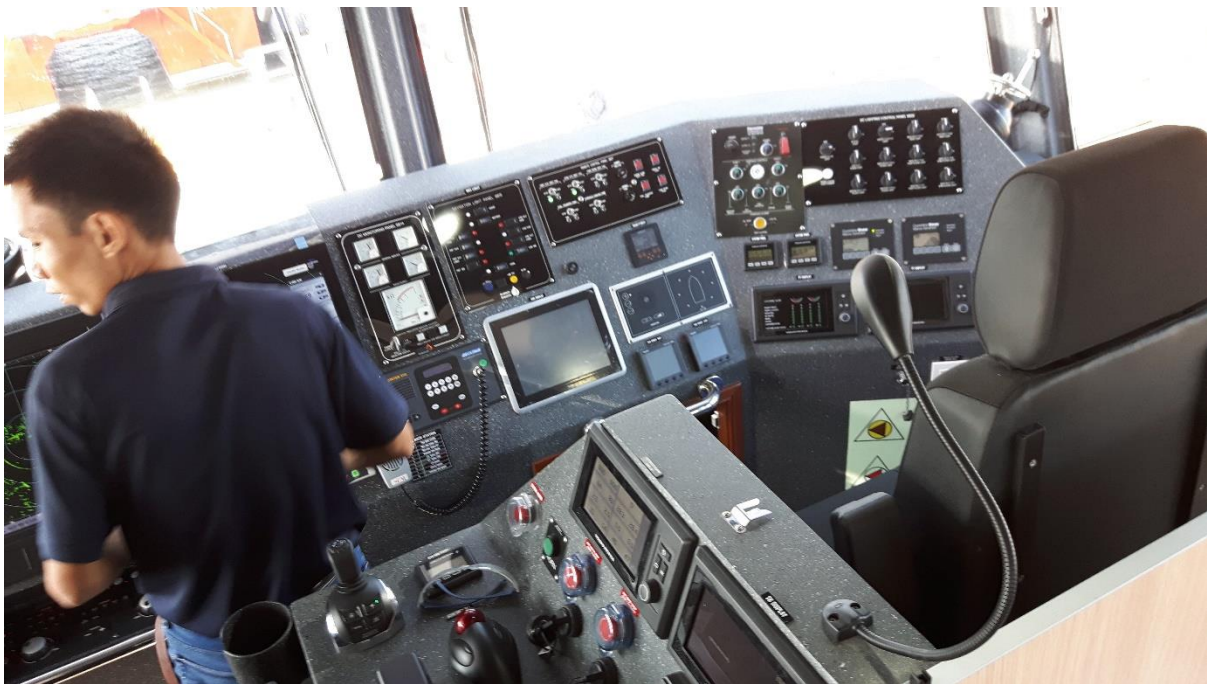
9.1 To the starboard side of the master's seat is a console to which engine and vessel controls are fitted. Engine panels are fitted at the high level on the vertical panel, and on the horizontal surface is fitted with a VHF radio. It is possible that the Master was distracted by this piece of equipment, although the CCTV coverage suggests that the Master was not using it for communication.

9.2 In the Njord commissioned incident report, the engineer reported that following the impact when he tried to use the VHF to summon assistance, the unit was not on its usual setting but was displaying a different screen. This supports the possibility that the Master may have been making adjustments to the settings of the set immediately prior to the incident.

Photograph of bridge front. The engineer's seat is to starboard, the Master's seat out of shot at the left-hand corner, the Masters console centre bottom with the VHF radio just out of shot.
