LOSS OF THE FISHING VESSEL BLUE PEARL J163

ON MONDAY 30TH JULY

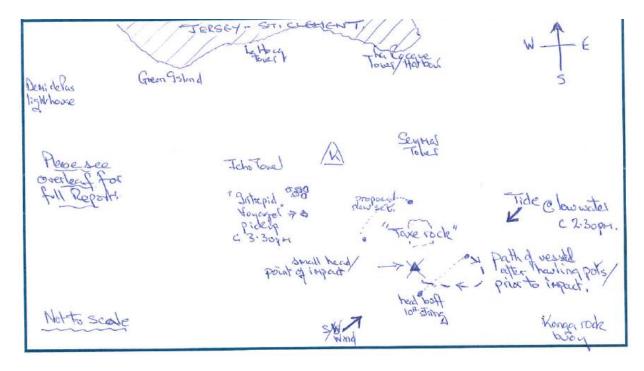
FIG 2 Drawing of area where vessel sunk provided by skipper.

- 5.3 The vessel was slowly moving SW at approximately 3 knots. The skipper was engaged in banding recently caught lobsters at the same time. Banding is the practice of placing elastic bands over the lobsters claws to prevent then injuring handlers or each other. He was located on the starboard side of the vessel at the time. Shortly after this the vessel struck and grounded on a submerged rock which he later identified as the small rock SSW of Taxe rock that dries at 2.7m. At 14:30 tide height was 2.5m and the tide would have begun to turn shortly afterwards to the east. This isolated rock would have been just on or below the surface.

- 5.4 The vessel struck the rock and grounded, immediately taking on a list to port. The tide tables show that low water actually occurred a 1450 where the tide had dropped a further 20cms. The list was further compounded by the weight of pots stored on that side. The vessel soon swamped and capsized. The skipper managed to scramble onto the upturned hull, standing up to attract attention by waving his oilskin. There were no other vessels visible in the area.

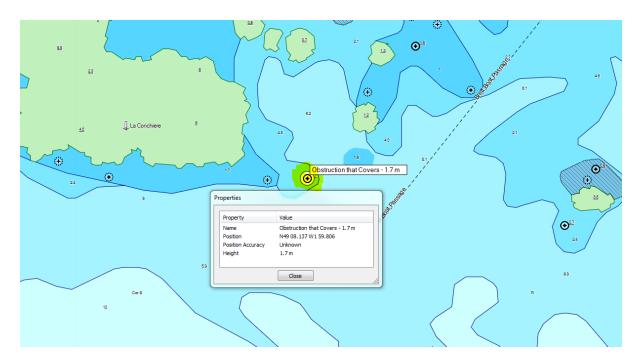
FIG 3 Print off from the chart plotter of INTREPID VOYAGER showing the position the casualty was recovered.

- 6.1 It can be seen from **Fig 3** that the distance between the point of capsize to where the casualty was recovered is approximately 800m. The casualty embarked on this swim almost naked in sea temperature of 18°C and without a life jacket. By the time he left the Taxe Rock was becoming awash the tide was flooding and his nearest drying rock, La Conchiere (2m High) was 1000m away and up tide from him. His swim against the tide covered 800m in 45 minutes and left him exhausted and hypothermic. By his own admission he lacked the strength to complete the final 20m to La Conchiere rock, which indicated the advanced state of exhaustion he was in. The position from which he was recovered would have covered at half tide. If he hadn't been picked up when he was it is very likely that he would have succumbed to hypothermia. Survival rates for an exhausted person in the water with a temperature of 18°C is approximately 1-2 hours
