REPORT ON BERTHING ALLISION BETWEEN HSC GRANVILLE AND SAILING YACHT SHAMU

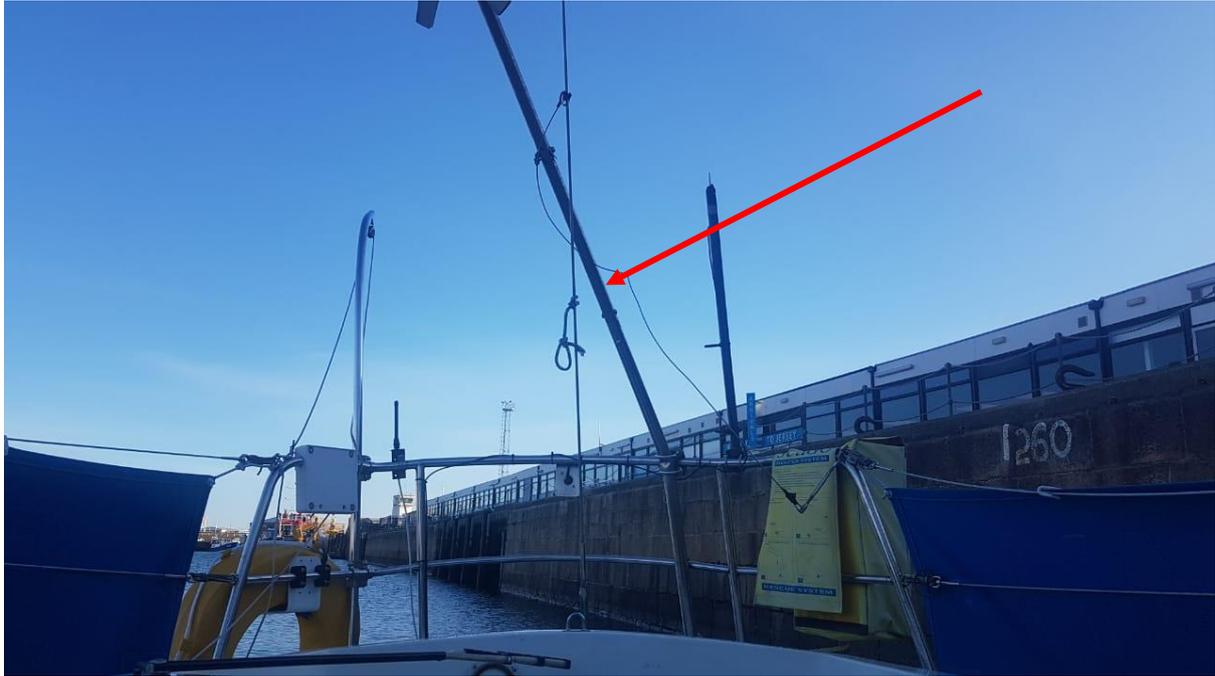
2.4 The vessel's bow made contact with the yacht pontoon and the inboard port side of the moored yacht. The pontoon suffered a small slicing of the wooden decking where the bow of **GRANVILLE** made contact. The yacht **SHAMU** suffered some gel coat and hull damage in way of the toe rail. The **SHAMU** also suffered impact damage to the wind generator mast, cracks to the deck edge and some handrail stanchion damage. The boarding ladder on the transom also sustained damage.

Fig 1 Stern of SHAMU showing damage to wind generator mast.

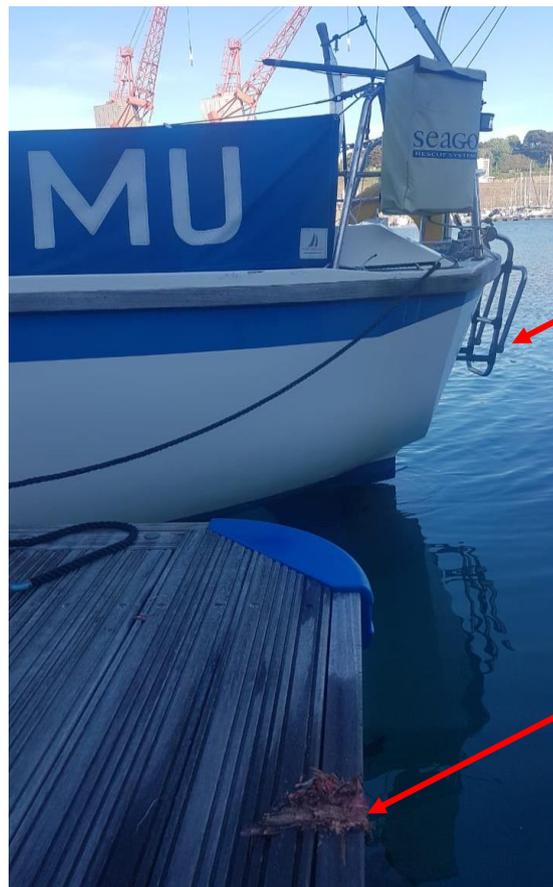
Fig 2 showing stern of SHAMU and decking damage to Albert Pontoon. Note overhang of stern which reduces the length of No.3 berth due to the change in angle

7.6 The yacht SHAMU was overhanging the end of the pontoon.

8.5 Yacht mooring on south end of Albert Pontoon should be monitored and consideration given to the desirability to restrictions in both number or position.

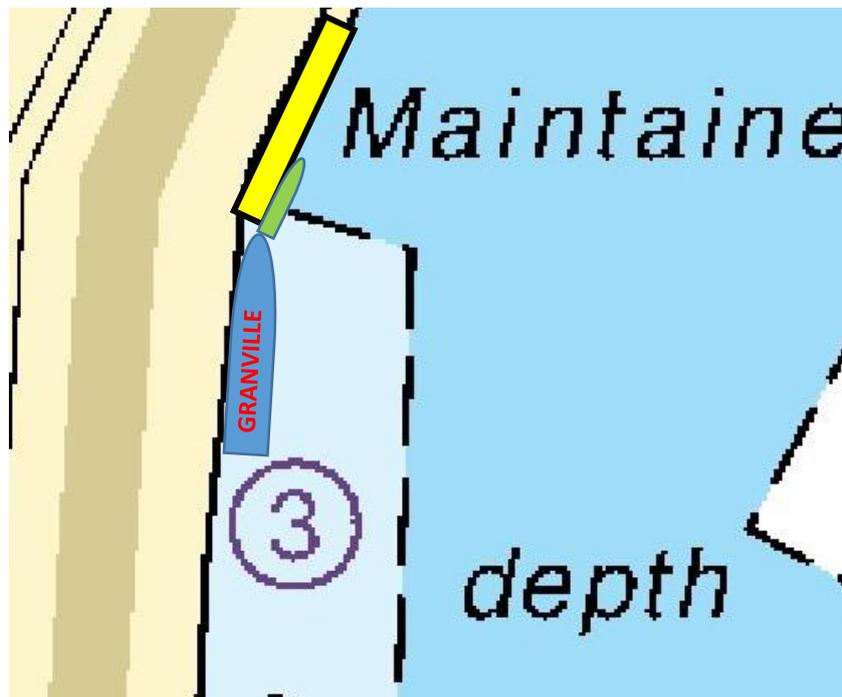
Figure 3

This diagram (**Fig 3**) illustrates the effect of a small overhang of yachts together with the impact of rafting on the pontoon, to the area of space available for the passenger ferries to manoeuvre. The passenger ferry positions are quite critical to allow both to place gangways over the stern onto the half tide landings at No.3.

7.5 The Albert Pontoon extends very close to the axis of No. 3 berth north limiting the amount of manoeuvring space available. This should be factored into any approaching manoeuvre;
