SERIOUS MARITIME INCIDENT INTERIM INVESTIGATION REPORT:

Fire and explosion aboard pleasure vessel INNER MEETING (JY 384) in Saint Helier Harbour

30th December 2021

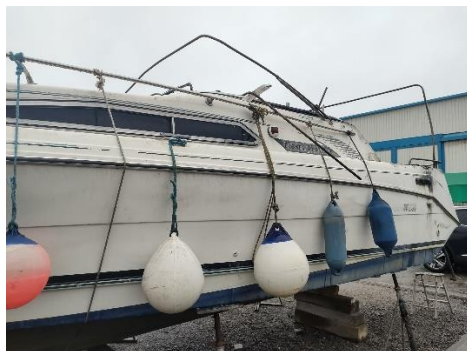
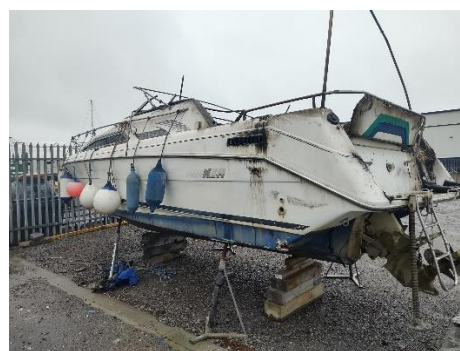
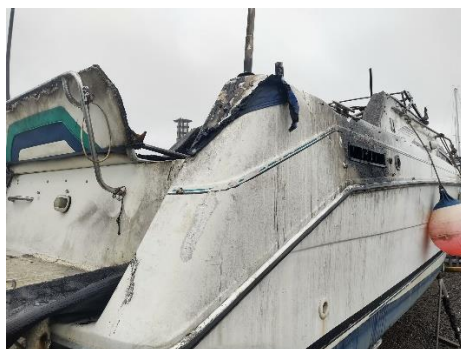
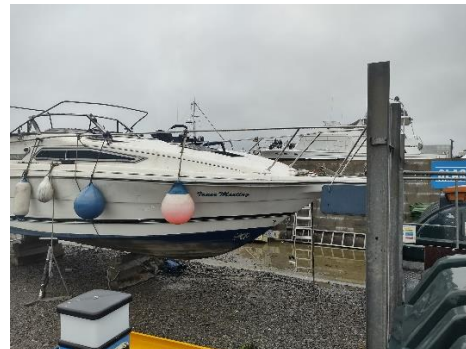
External Photographs after the accident

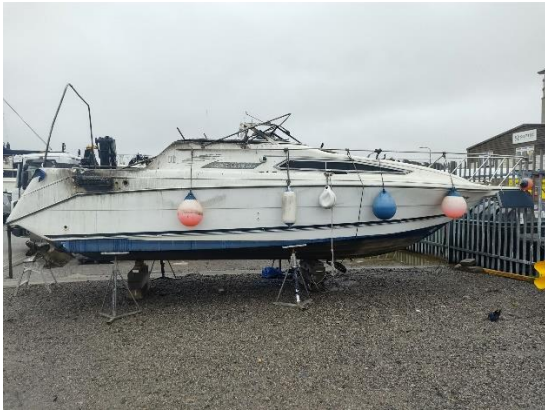
Starboard side view

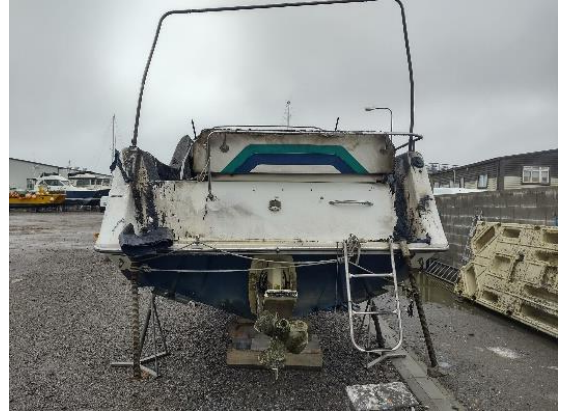
Transom view

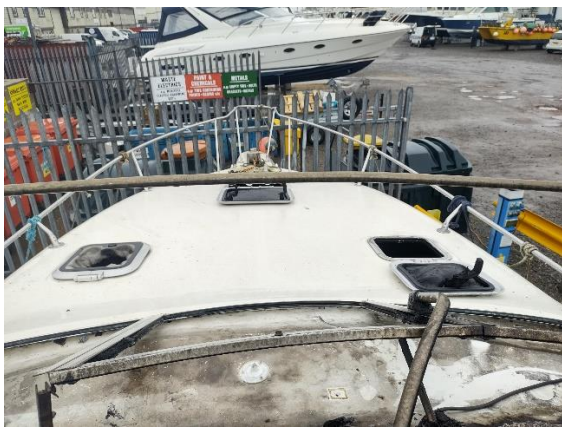
Foredeck port hatch melted starboard hatch opened

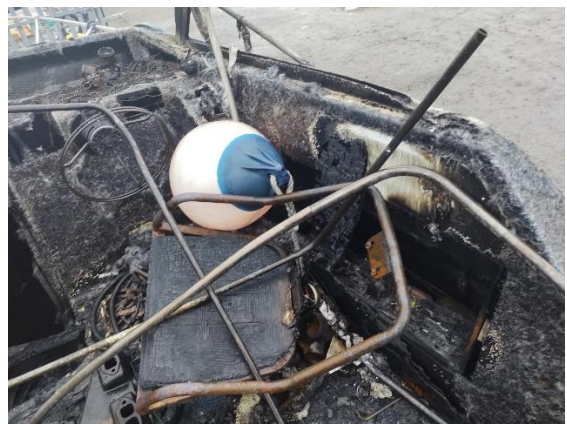
Control position (cockpit starboard side)

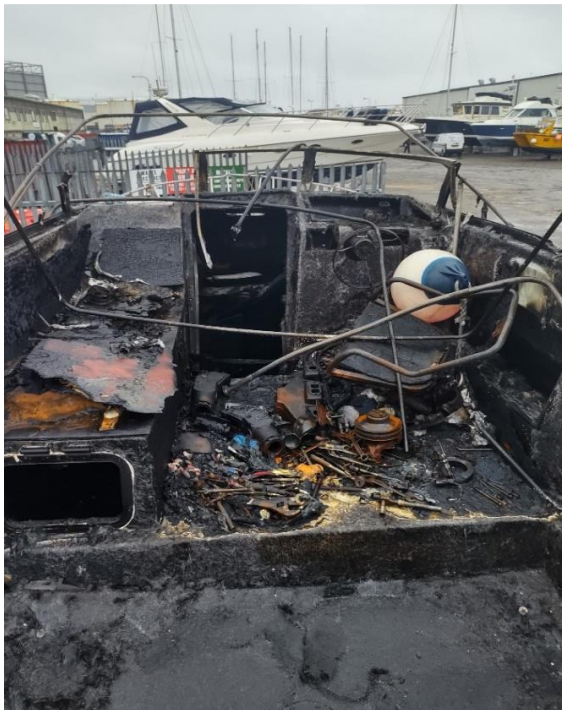
Cockpit looking forward

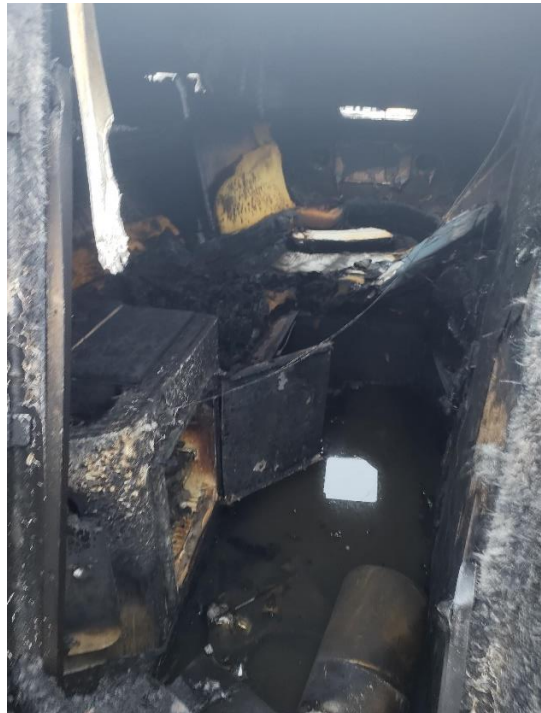
The owner had isolated the engine ignition, believing this made the whole of the vessel electrics safe, prior to working on the pump. There were however two remaining potential sources of ignition, the wires to the pump itself; and an old refrigerator at the after end of the cabin on the port side, which at the time of the explosion had the door open. A spark from either of these sources would have been sufficient to ignite the fumes.

Cabin including fridge with door open

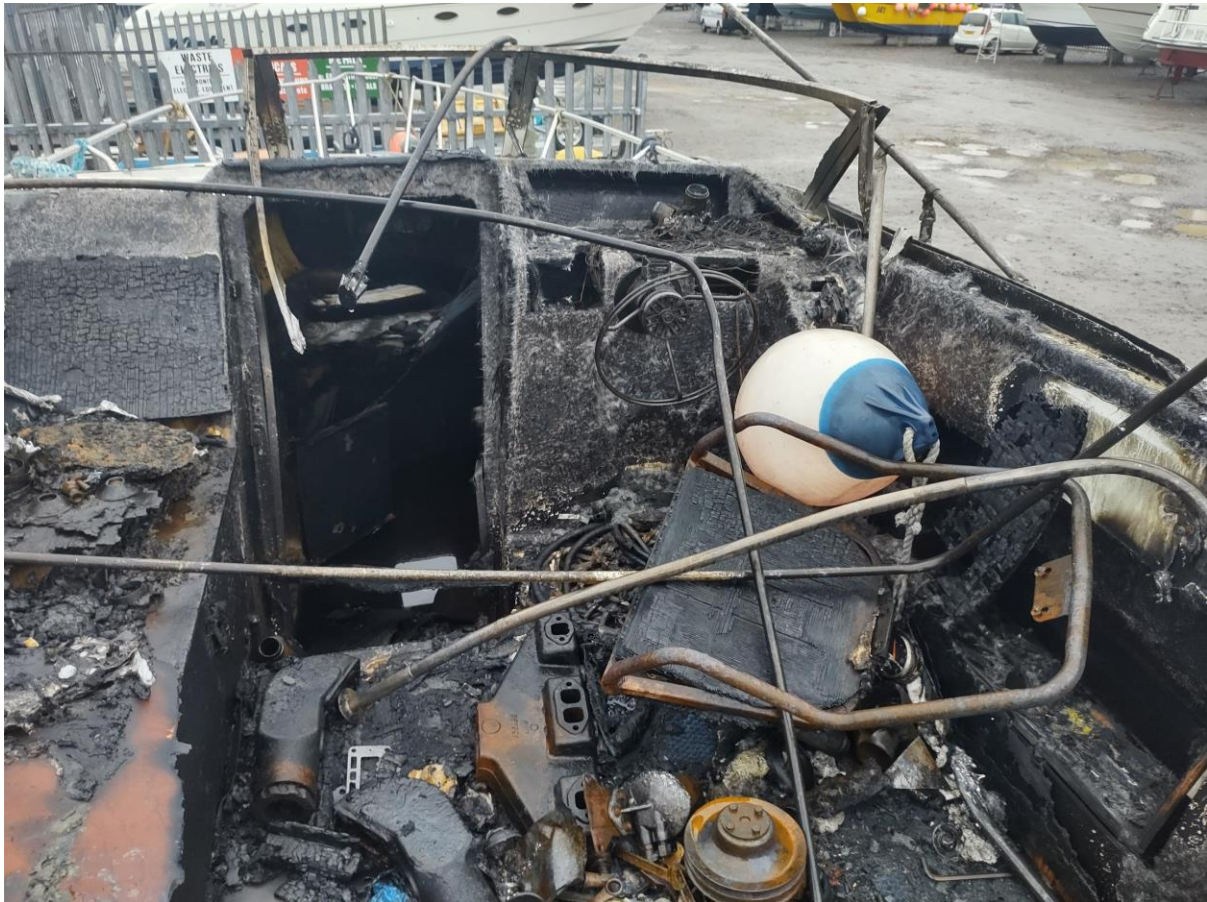
Cockpit looking forward including area where pump was being worked on

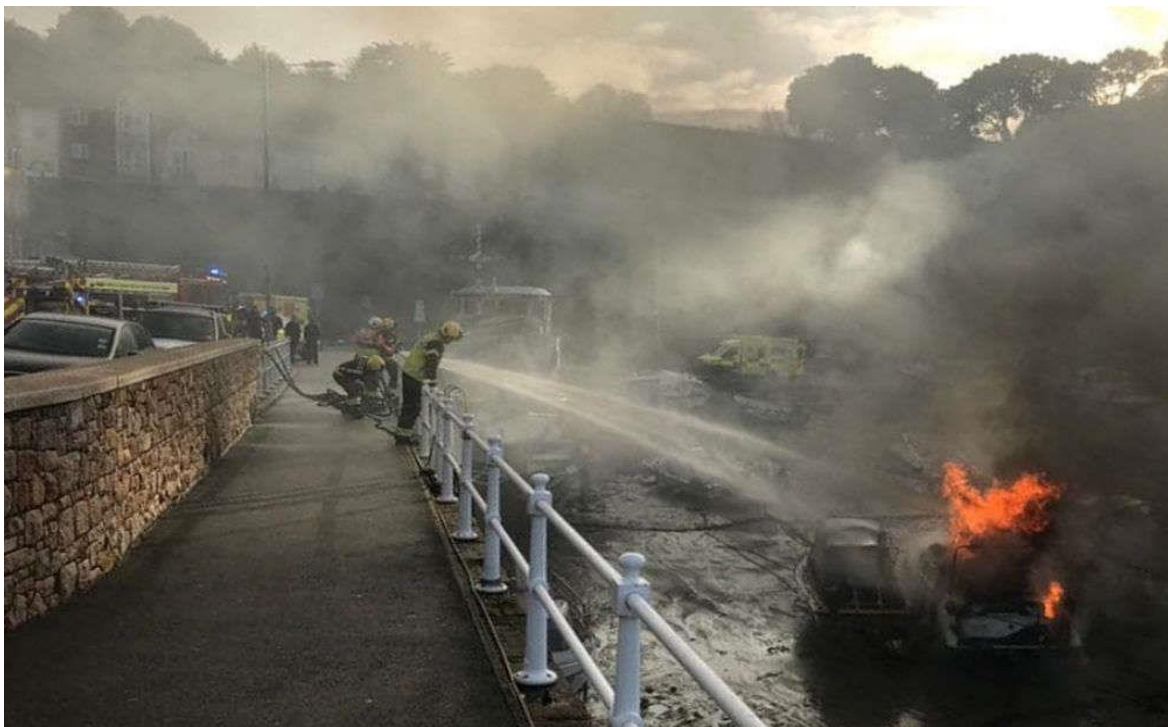
Fire Fighting from quayside walkway - showing proximity of adjacent vessels on both sides
