**MARITIME INCIDENT  
INVESTIGATION REPORT INTO THE  
ENGINE ROOM FIRE AND  
SUBSEQUENT SINKING OF  
PLEASURE VESSEL  
“JUST MINE”  
13<sup>TH</sup> NOVEMBER 2020**

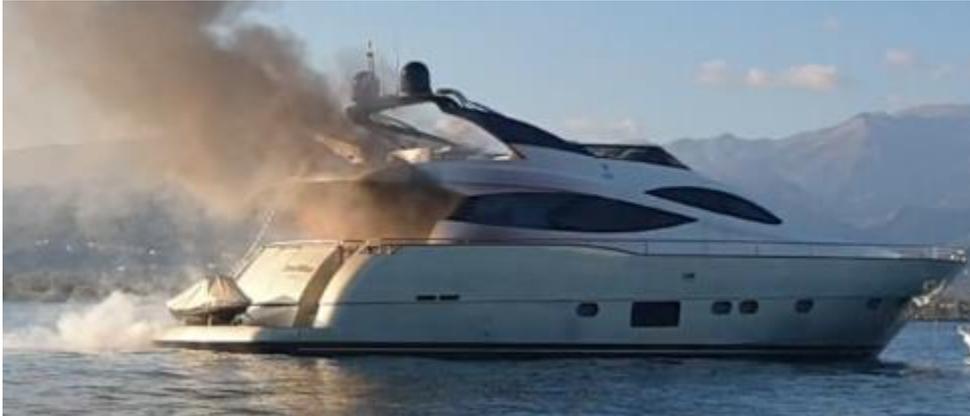
**FIG 1 - Smoke darkening and first flames visible. At anchor with small open FV approaching bow. Taken by crew from tender.**

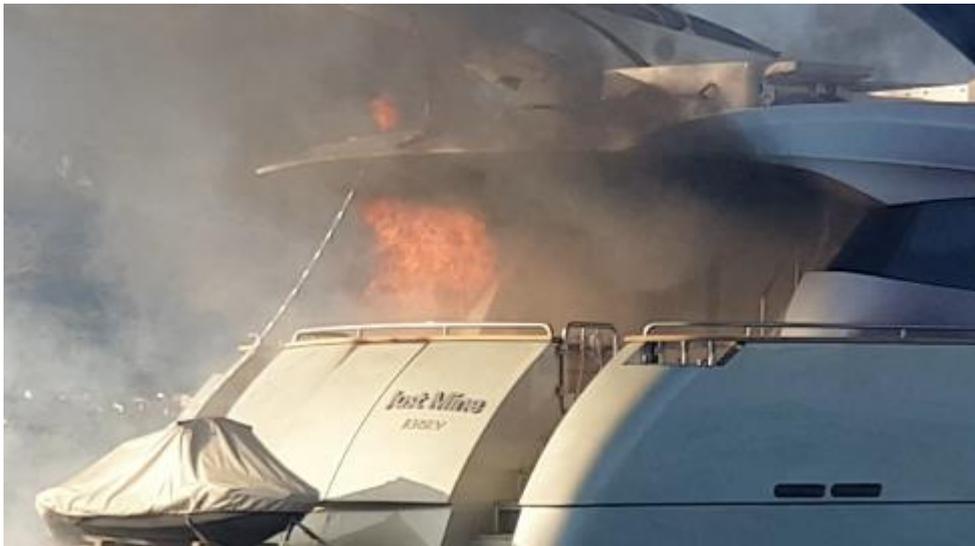
**FIG 2 - Significant fire on port side of aft main deck**

4.3 From the video footage the fire appears to have been most severe at the aft end of the Engine Room on the port side but, as there was no visual or CCTV evidence of the start of the fire and loss of the vessel has prevented any subsequent examination, the actual cause of the fire cannot be determined. The deck hand, who was experienced with the vessel, had noted nothing unusual in his inspection immediately before the fire; neither had the skipper in his rounds just before the vessel weighed anchor. The crew reported that since joining the vessel in Turkey and throughout the multi-leg voyage between 10<sup>th</sup> and 13<sup>th</sup> November JUST MINE “had not encountered any mechanical or electrical system failures and, despite the weather, the boat had run smoothly”.

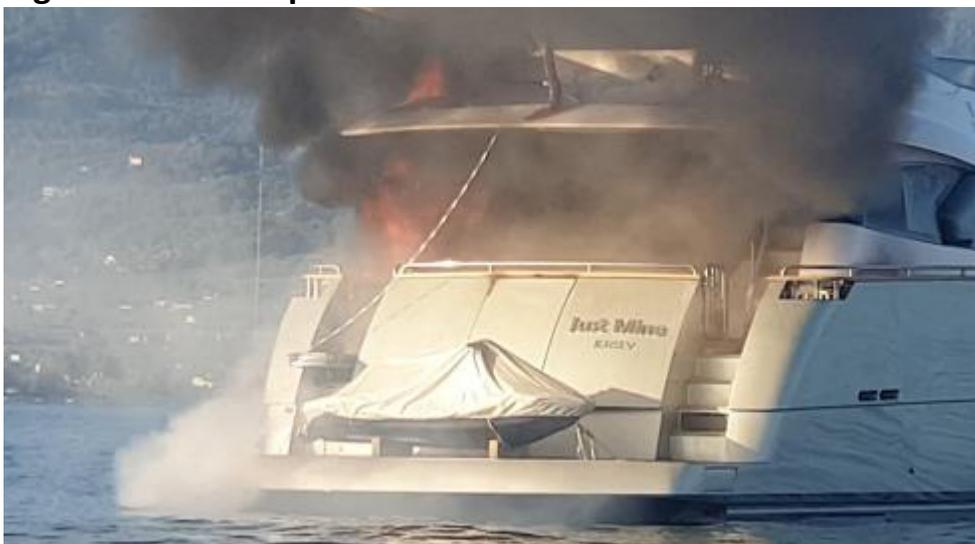
**FIG 3 - Steam on surface of water Port Qtr.**

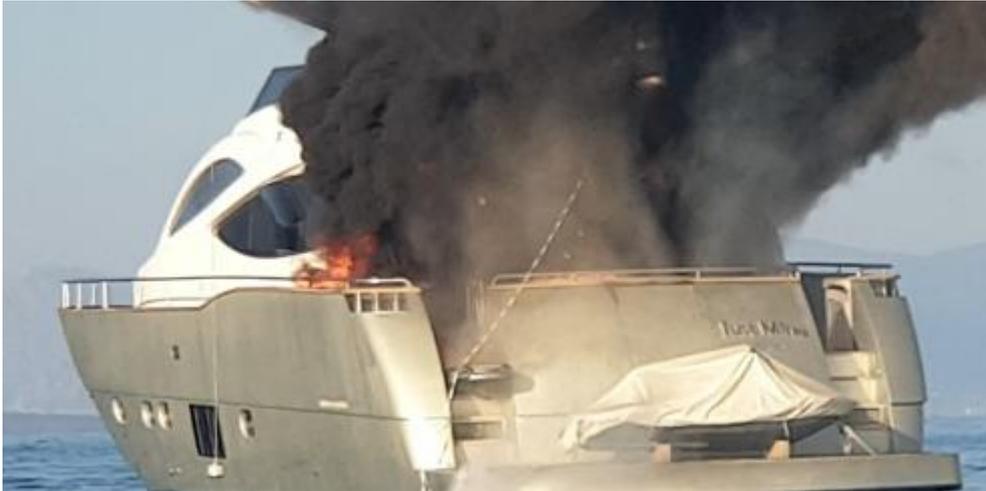
**FIG 4 – Flames now visible above height of bulwark**

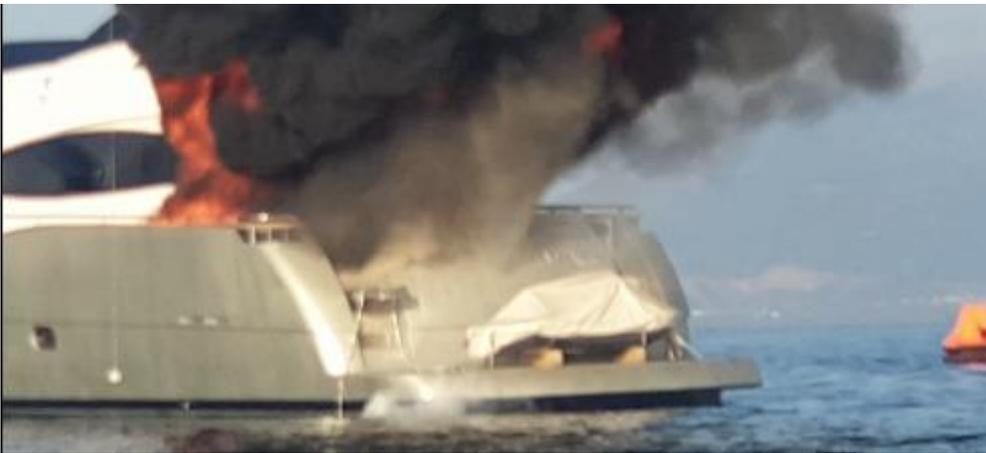
**FIG 5 – Flames increasing on Port Quarter to height of flying bridge**

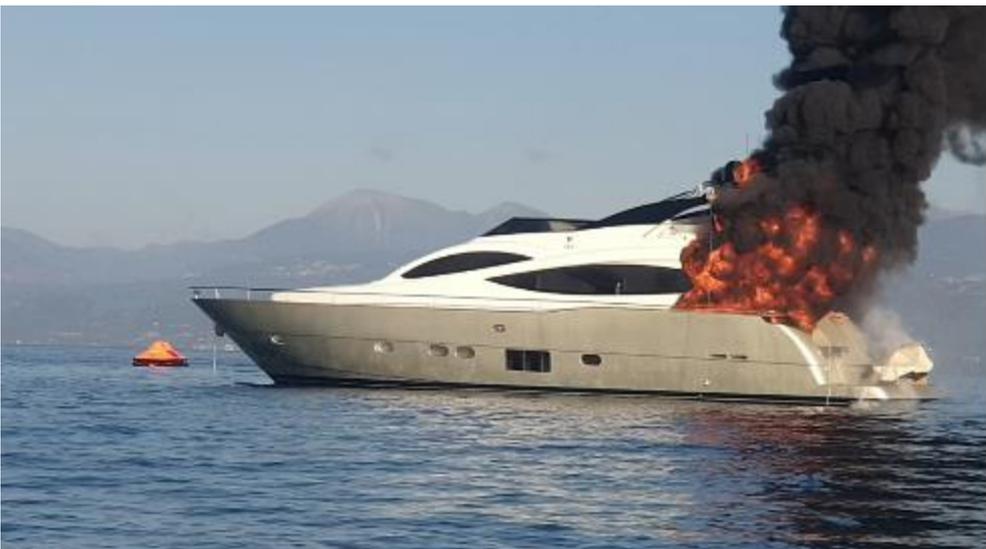
**FIG 6 – Stbd Qtr. Showing, now drifting, life raft (taken from tender)**

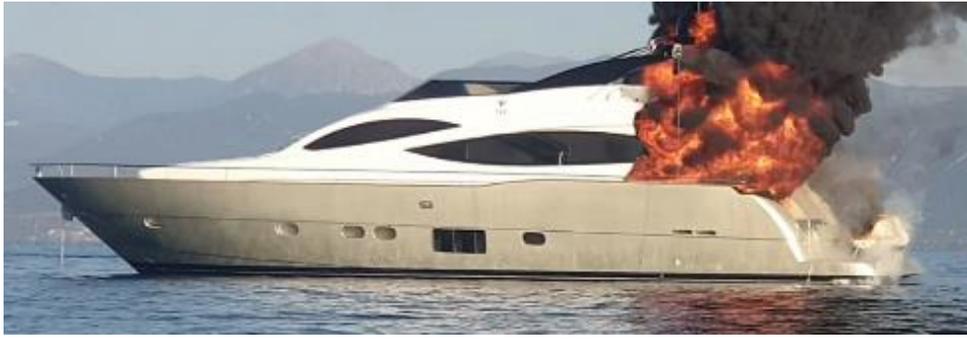
**FIG 7- Flames moving forward on Port quarter, cover of PWC catches fire**

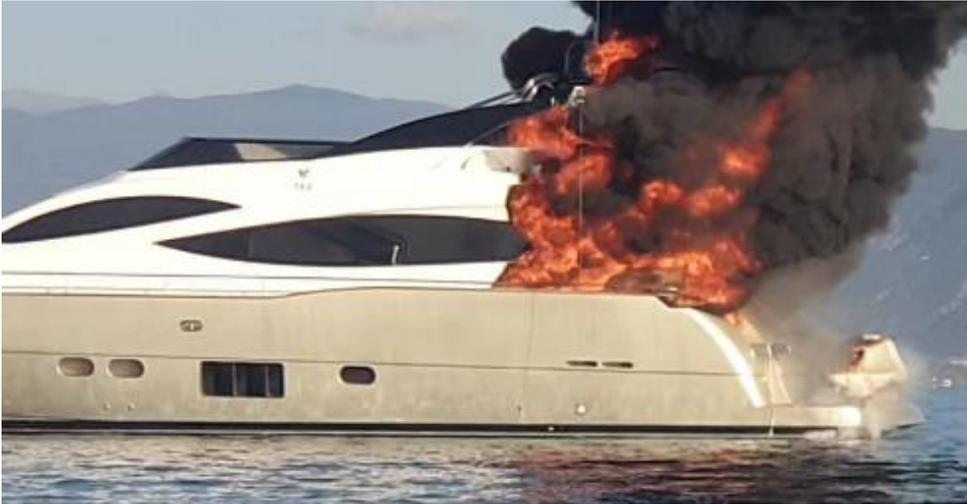
**FIG 7a – PWC itself on fire**

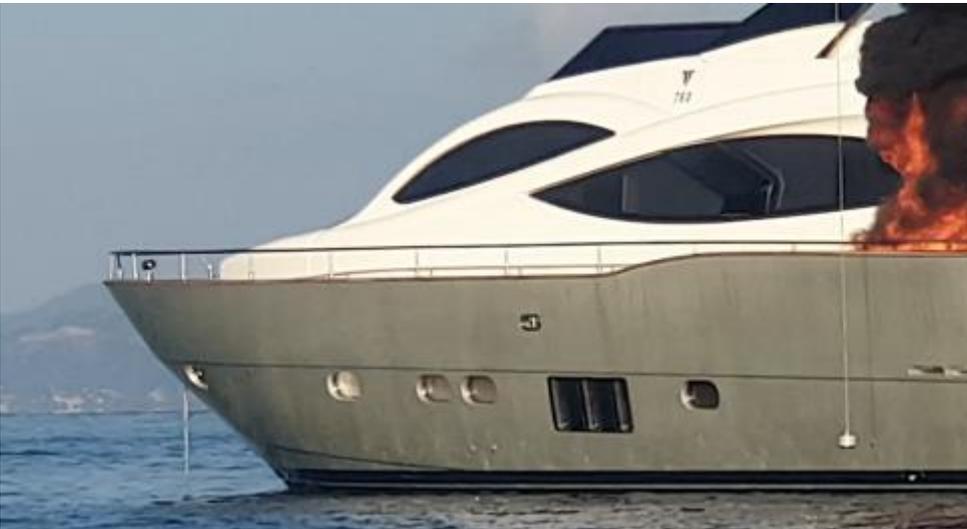
**FIG 8 – Port Qtr showing crane wire in position used to deploy tender.**

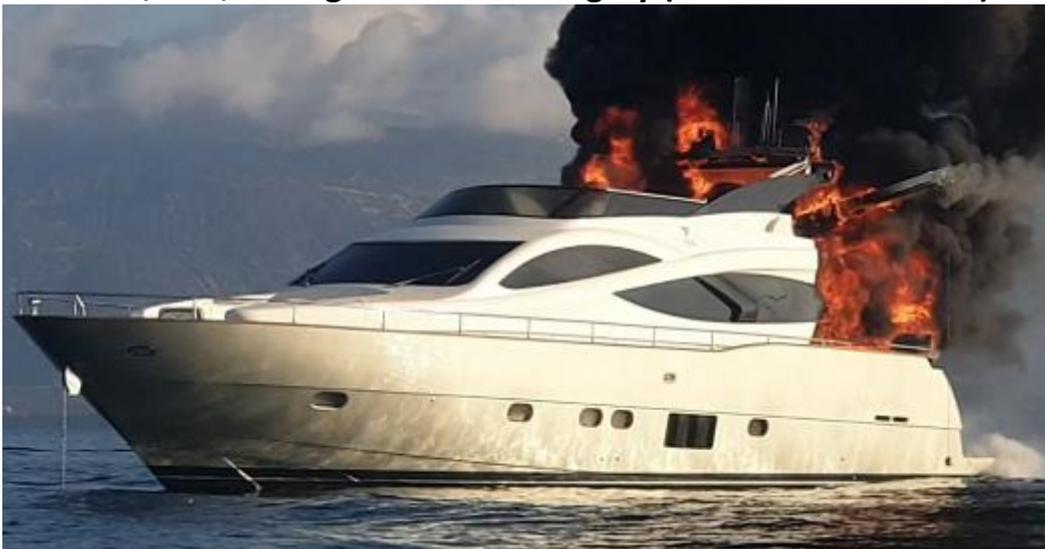
**FIG 10 – Stern of the vessel well ablaze – crane position (tender launched Port Qtr.)**

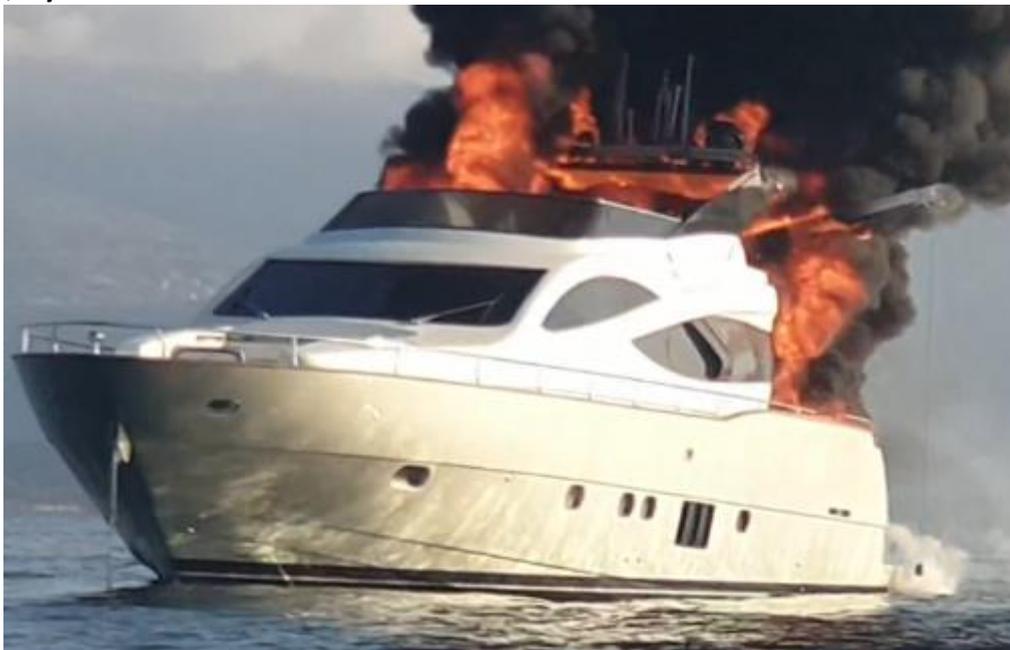
**FIG 11 – Fire engulfs the accommodation and spreads to the flying bridge**

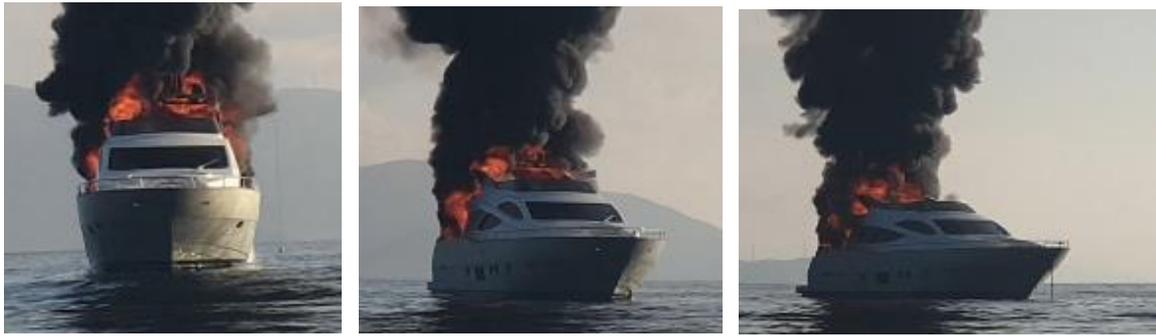
**FIG 12 a) b) & c) – Fire spreads over the accommodation to the flying bridge and across full breadth of vessel**

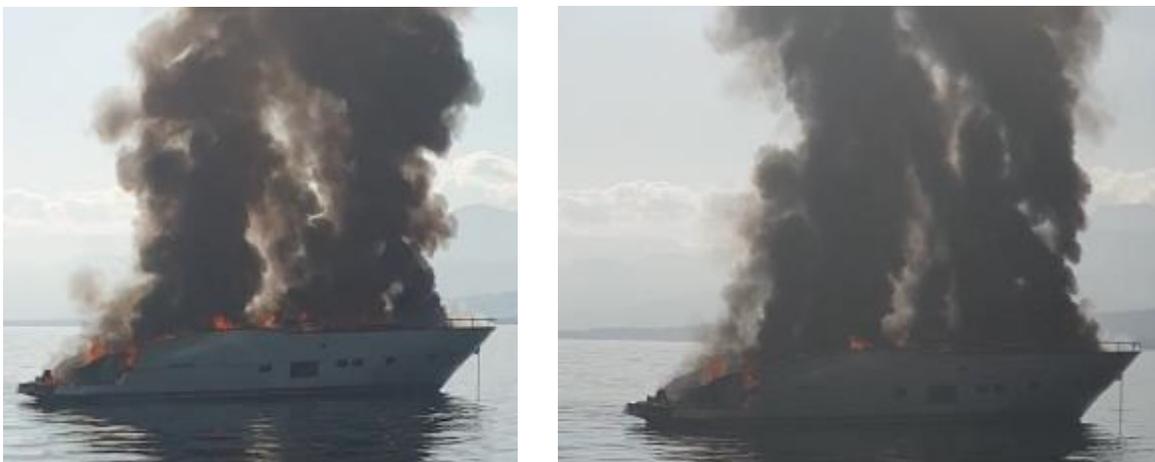
**FIG 13 a) & b) Accommodation collapsed and smoke full vessel length**

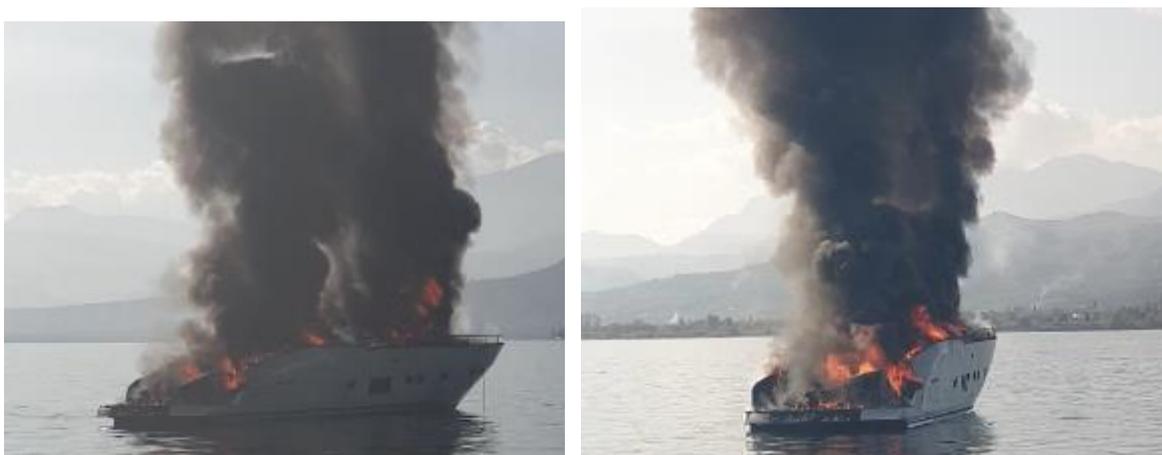
**FIG 14 a) & b) Flames expand full length of vessel abaft collision bulkhead.**

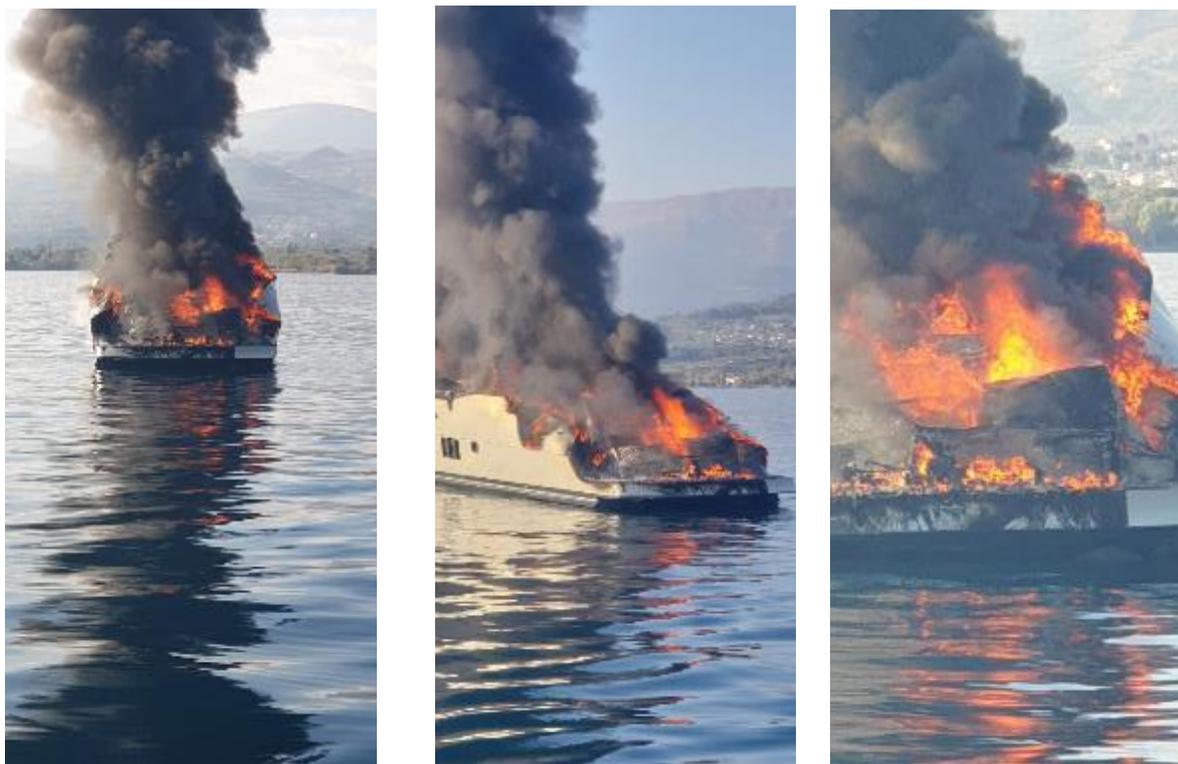
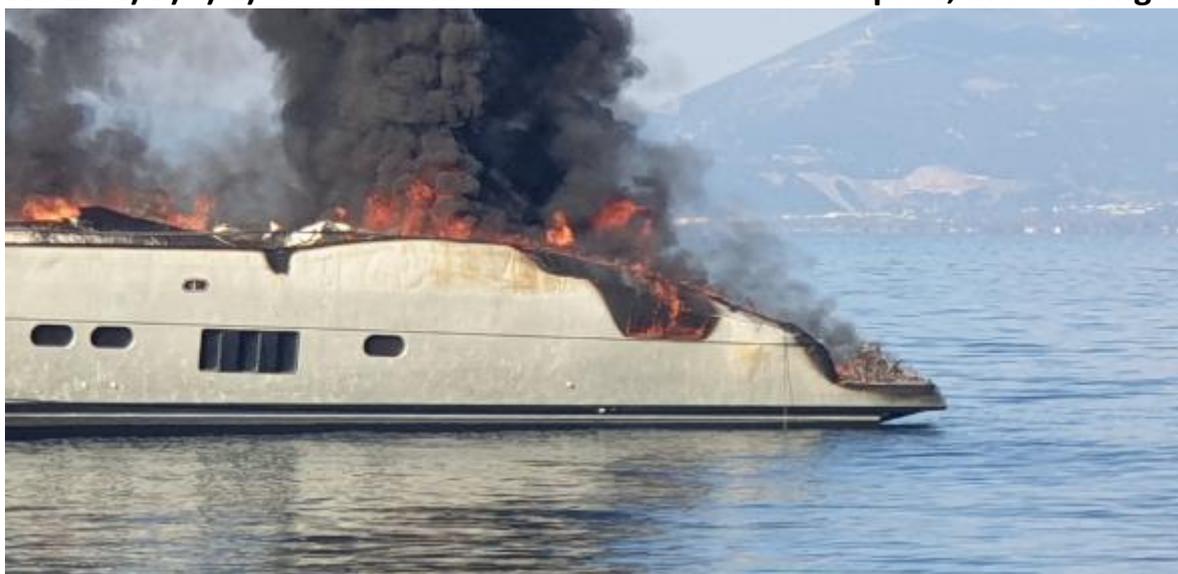
**FIG 15 a) b) c) d) accommodation above main deck collapsed, fire full length**
