**MARITIME INCIDENT
INVESTIGATION REPORT INTO THE
ENGINE ROOM FIRE AND
SUBSEQUENT SINKING OF
PLEASURE VESSEL
“JUST MINE”
13TH NOVEMBER 2020**

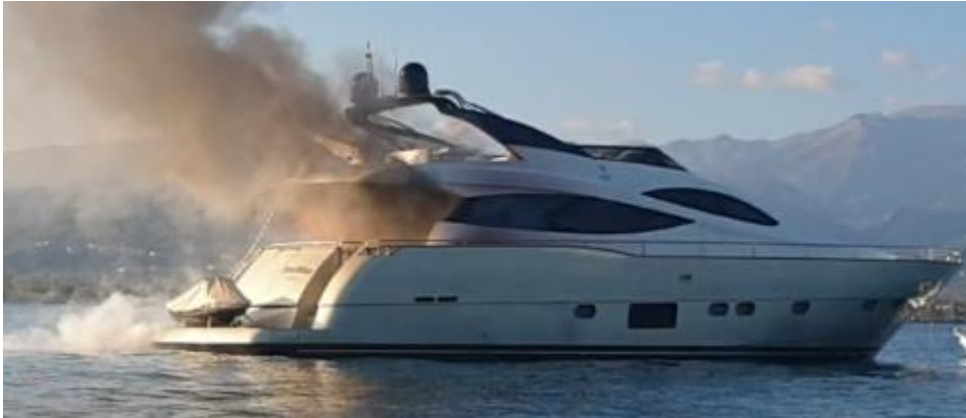
FIG 1 - Smoke darkening and first flames visible. At anchor with small open FV approaching bow. Taken by crew from tender.

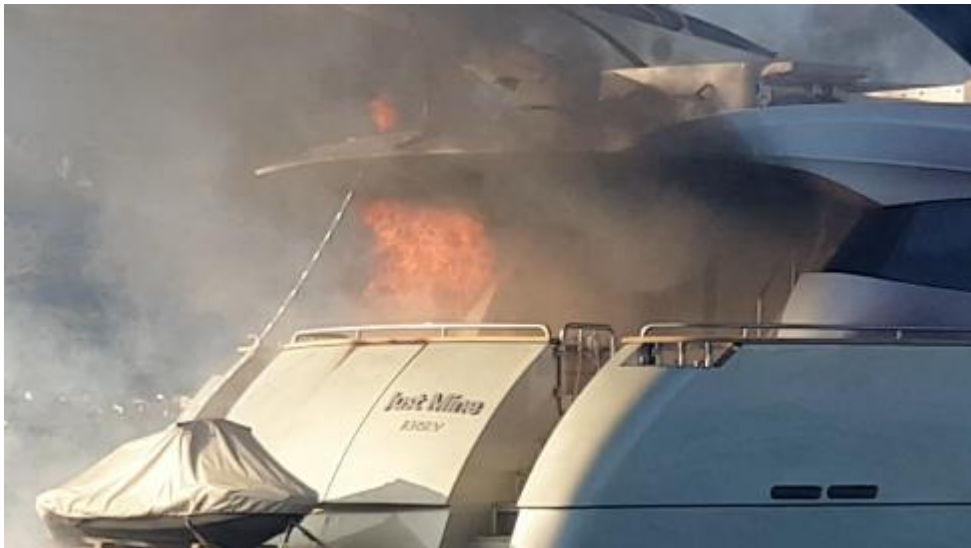
FIG 2 - Significant fire on port side of aft main deck

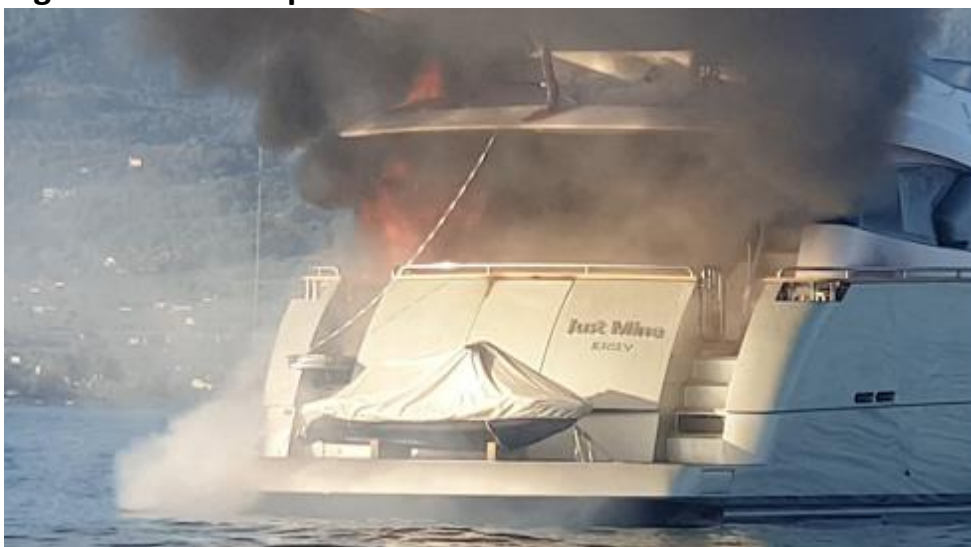
FIG 3 - Steam on surface of water Port Qtr.

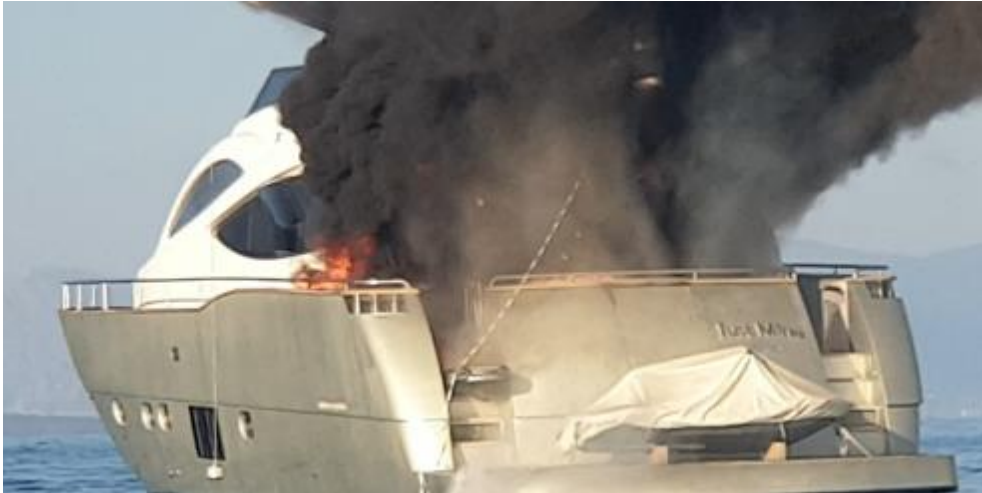
FIG 4 – Flames now visible above height of bulwark

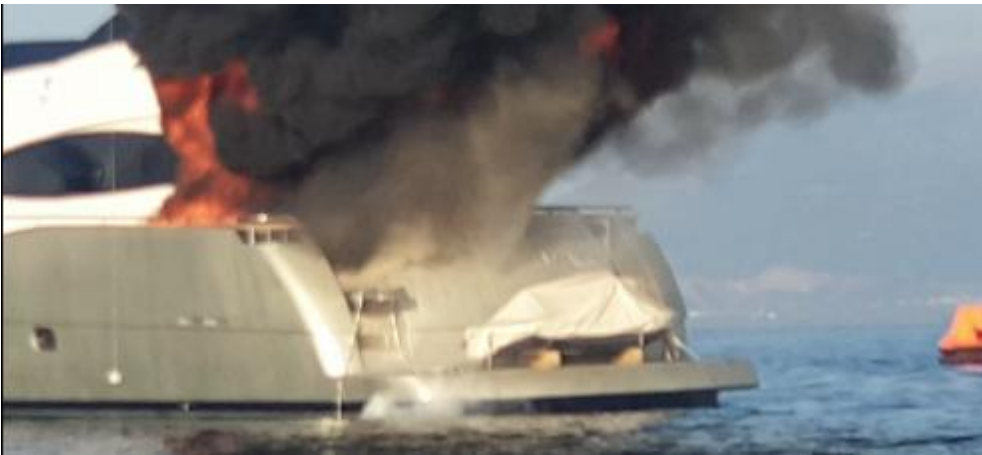
FIG 5 – Flames increasing on Port Quarter to height of flying bridge

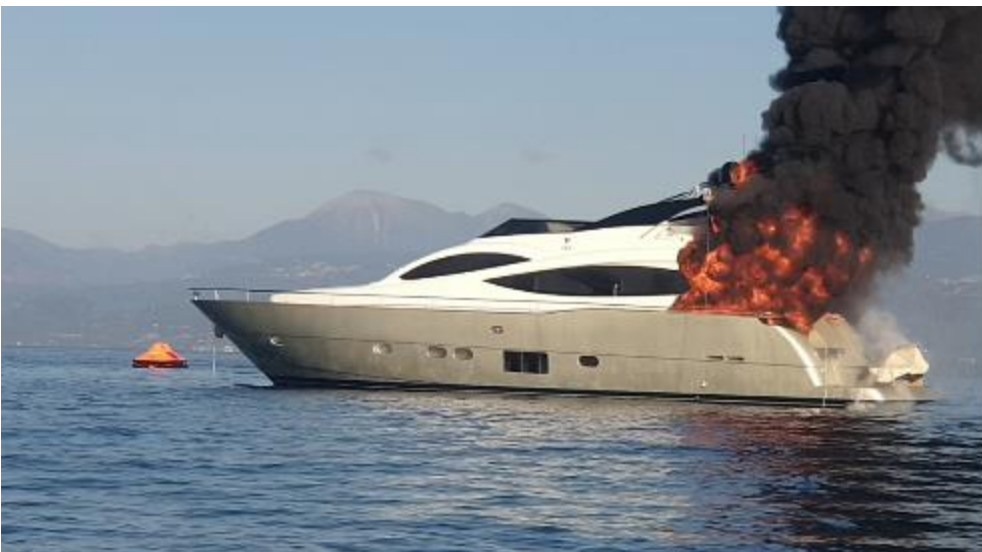
FIG 6 – Stbd Qtr. Showing, now drifting, life raft (taken from tender)

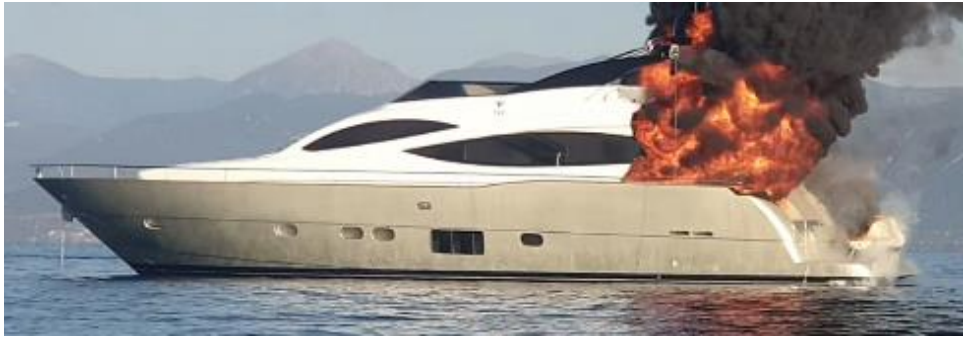
FIG 7- Flames moving forward on Port quarter, cover of PWC catches fire

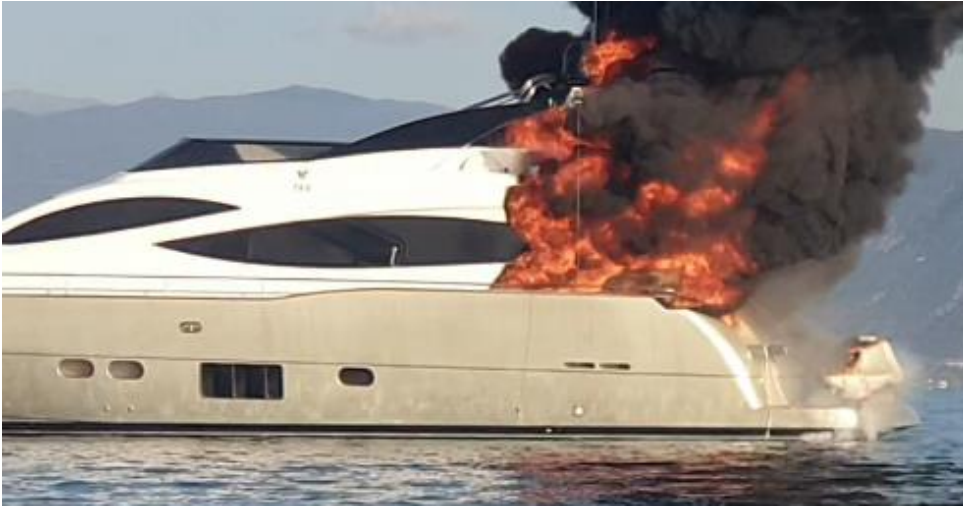
FIG 7a – PWC itself on fire

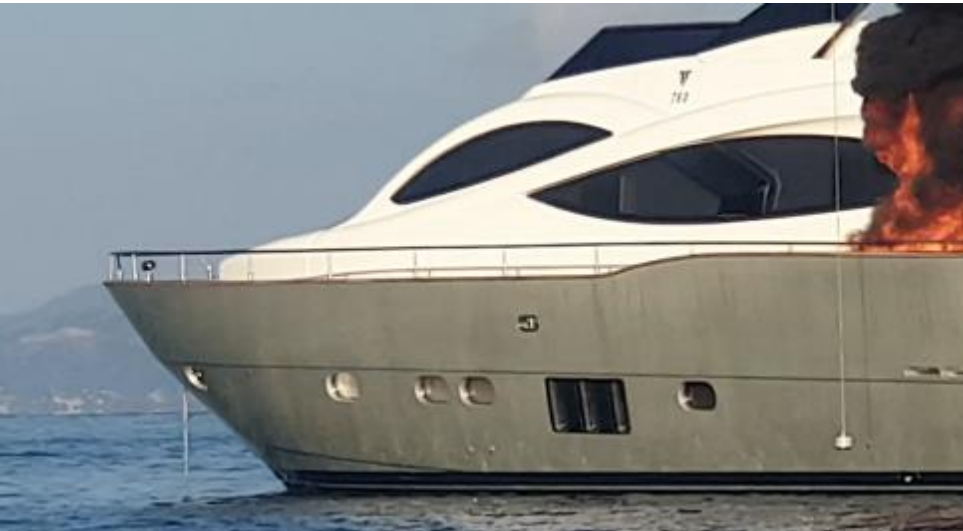
FIG 8 – Port Qtr showing crane wire in position used to deploy tender.

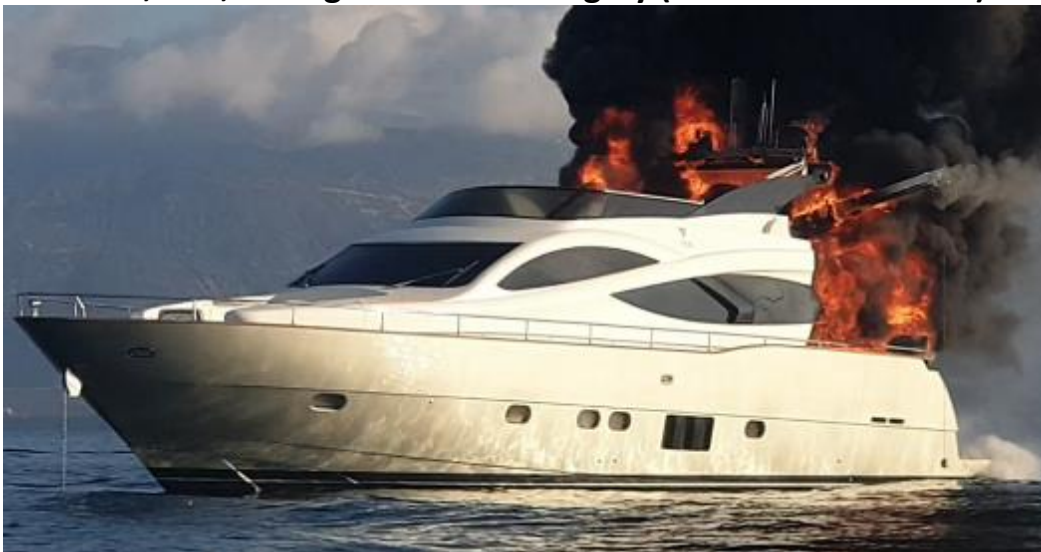
FIG 10 – Stern of the vessel well ablaze – crane position (tender launched Port Qtr.)

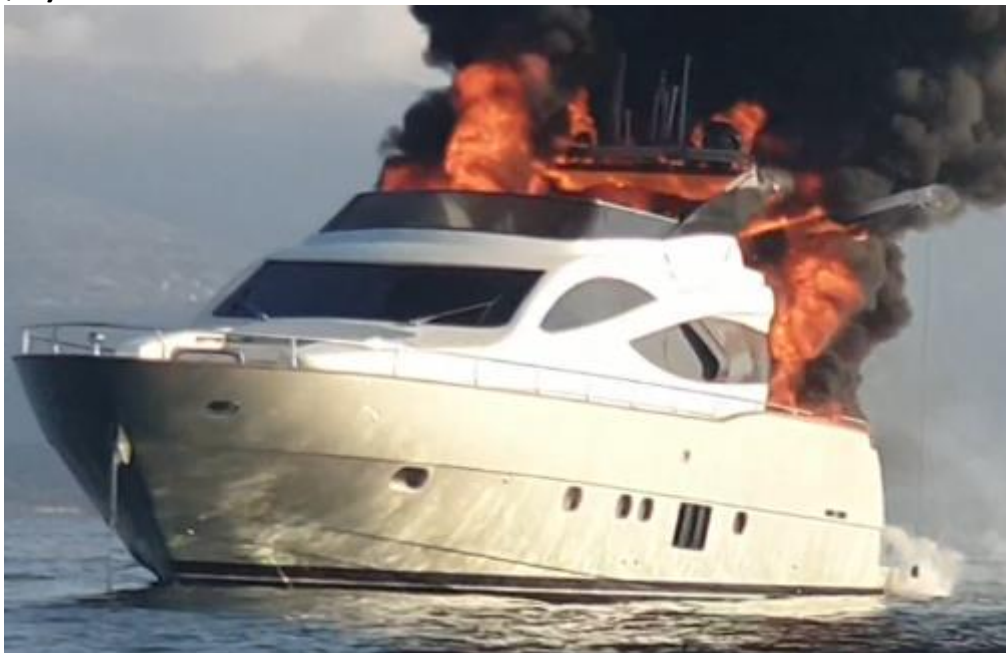
FIG 11 – Fire engulfs the accommodation and spreads to the flying bridge

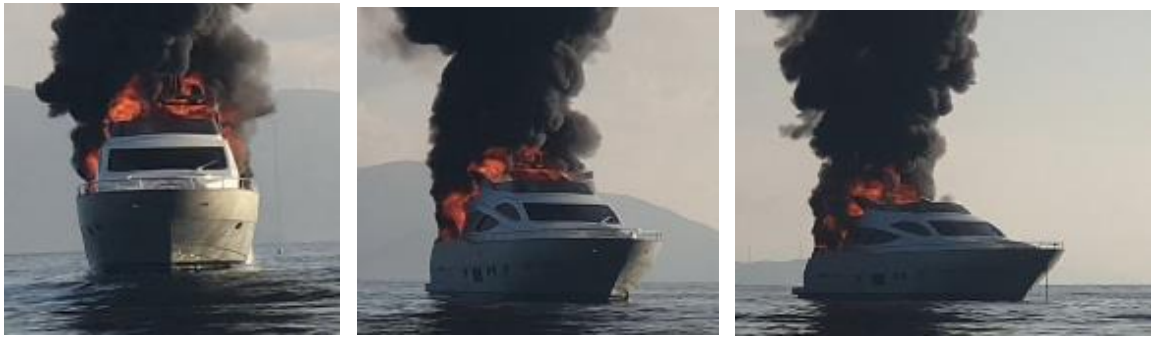
FIG 12 a) b) & c) – Fire spreads over the accommodation to the flying bridge and across full breadth of vessel

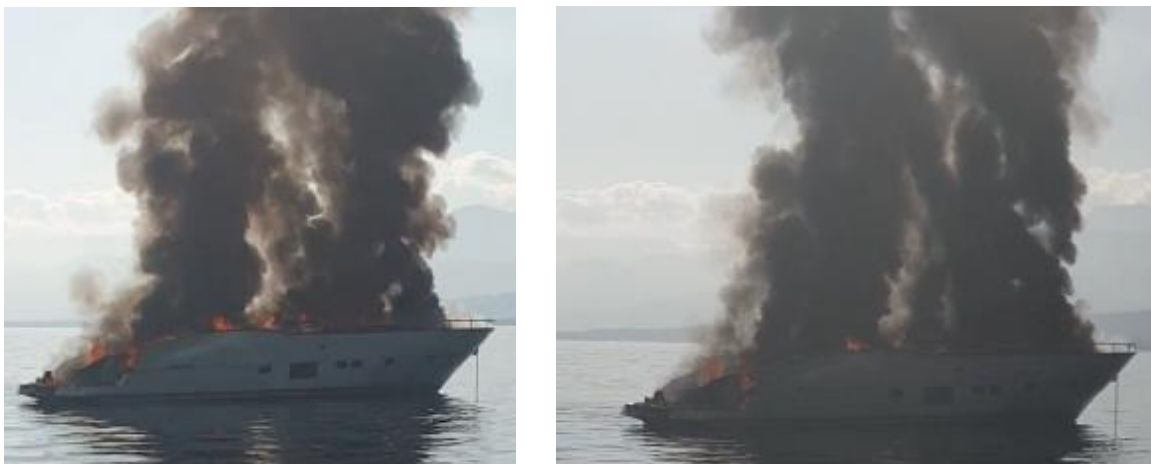
FIG 13 a) & b) Accommodation collapsed and smoke full vessel length

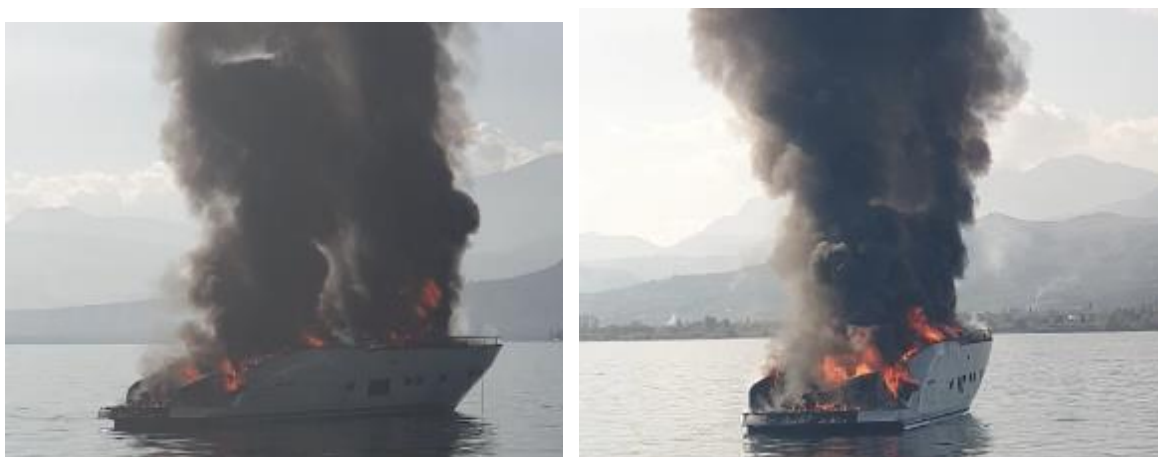
FIG 14 a) & b) Flames expand full length of vessel abaft collision bulkhead.

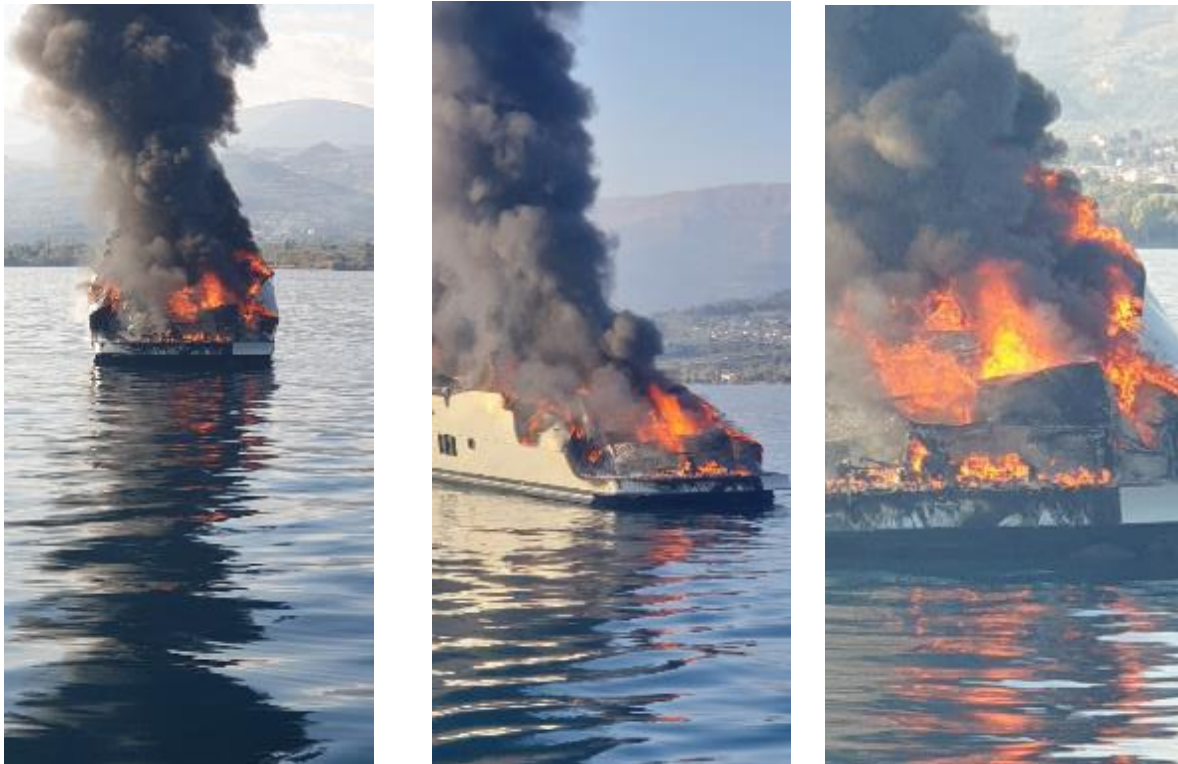
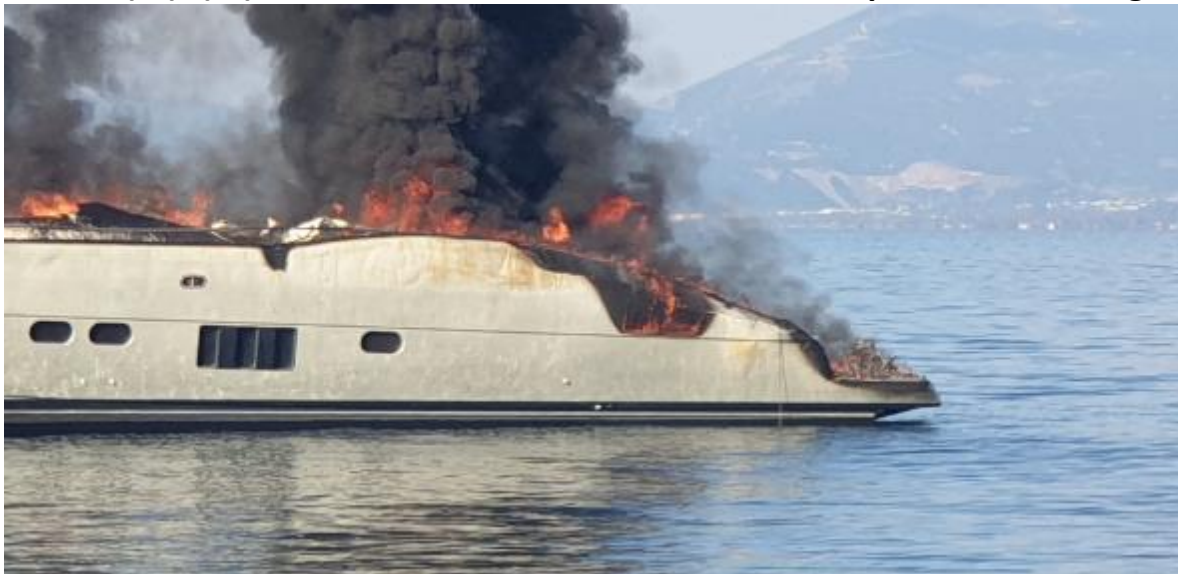
FIG 15 a) b) c) d) accommodation above main deck collapsed, fire full length
