MARITIME INCIDENT INVESTIGATION REPORT:

**Stranding, temporary
abandonment, and subsequent
re-floating of Fishing Vessel**

L'ECUME II (J158)

14TH MAY 2020

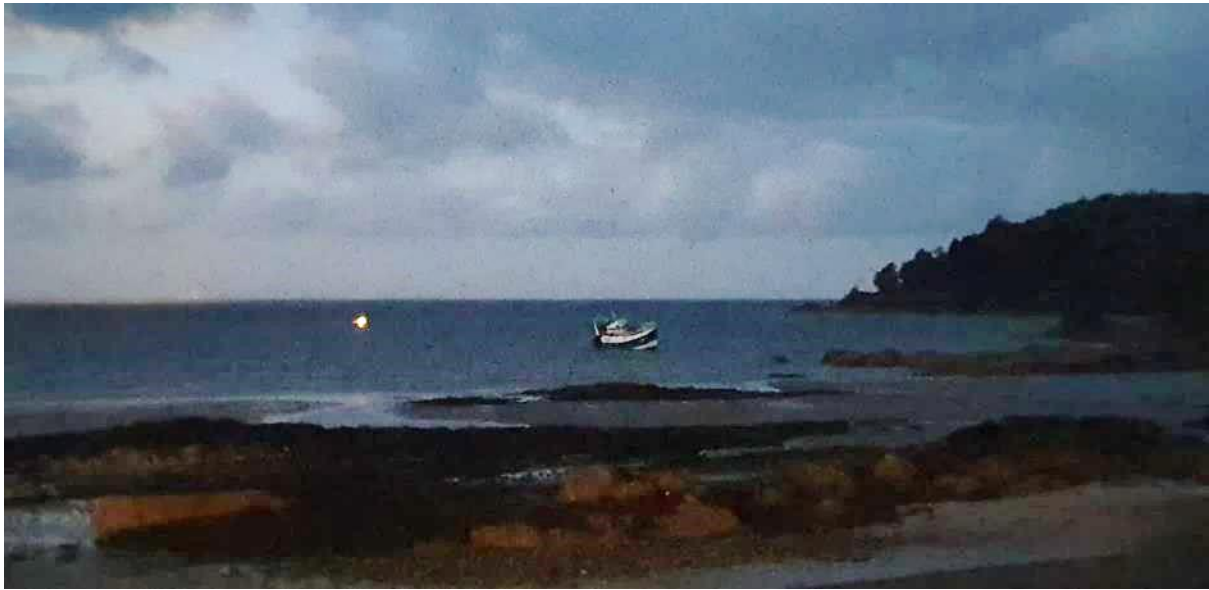
FIG 1 – L'ECUME II aground in Belcroute Bay

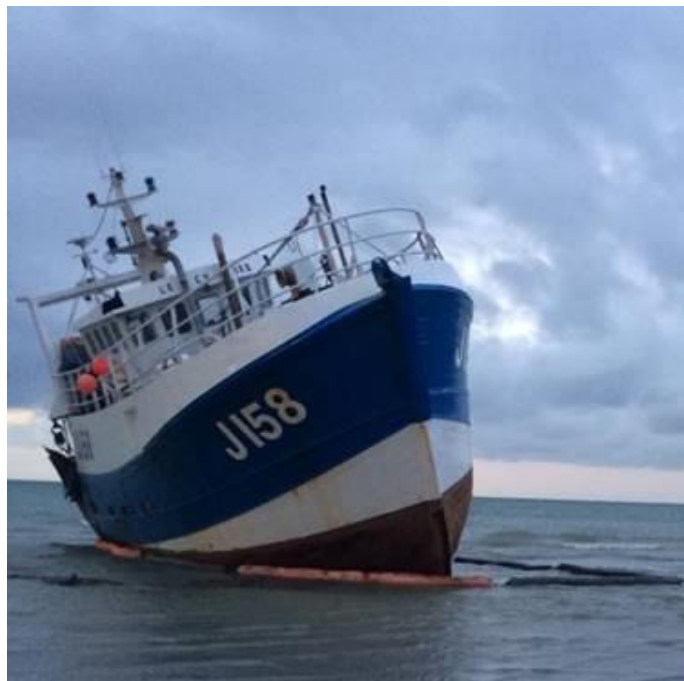
FIG 2 – L'ECUME II, aground with pollution control boom in place.

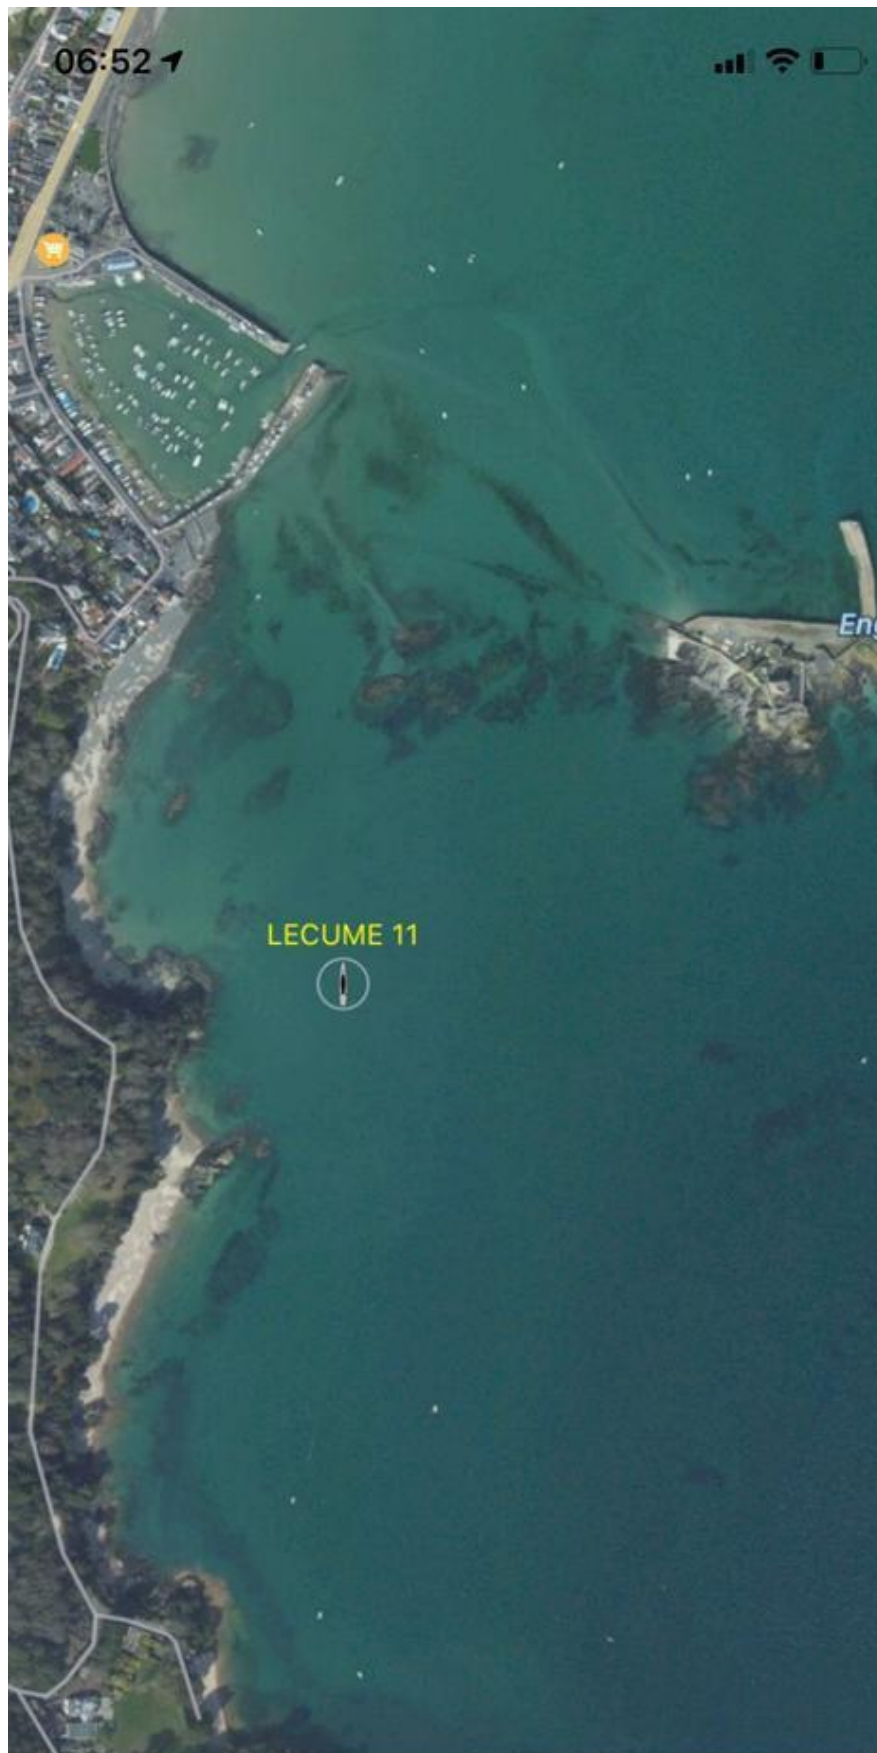
FIG 14 – Position of Grounding

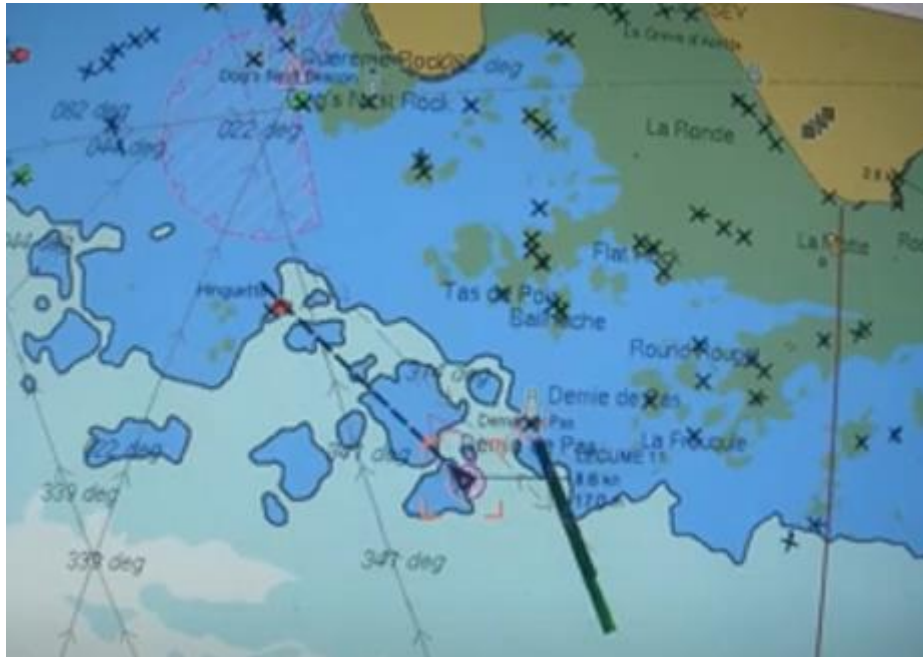
2.2.10 **L'ECUME II** passed Demie de Pas light (Fig 17) with a track in safe water between the South East Passage and the South Passage approaches, at which point she would have normally contacted St Helier VTS on VHF Ch 14, she left the Hinguette light buoy (Port Lateral mark with Quick flashing Red light) to port (Figs 18 & 19), before crossing both the Small Roads leading marks to Saint Helier (Fig 20) and the Western Passage leading marks for vessels transiting to or from the west (Fig 21).

FIG 17 L'ECUME II passes Demie de Pas (VTS screenshot)

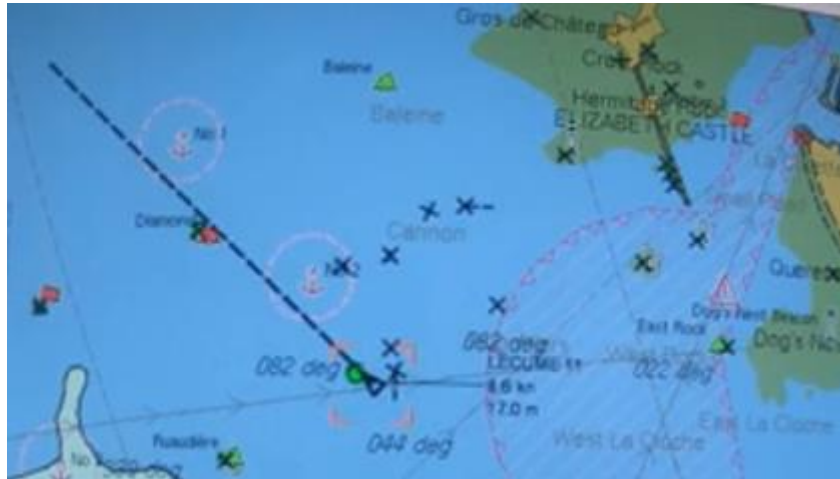
FIG 21 L'ECUME II crosses Western Passage Leads for turn to west (heading towards Diamond buoy)

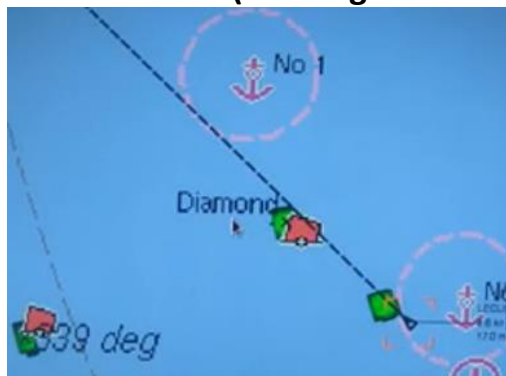
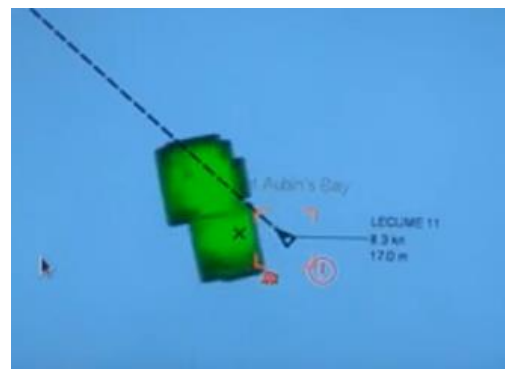
2.2.11 After crossing the Western Passage **L'ECUME II** continued into Saint Aubin's Bay, and passed close to the Diamond Buoy (Port hand lateral mark, Fl (2) R 6s) (Figs 22 & 23).

FIG 22 & 23 L'ECUME II leaves Diamond Buoy to port

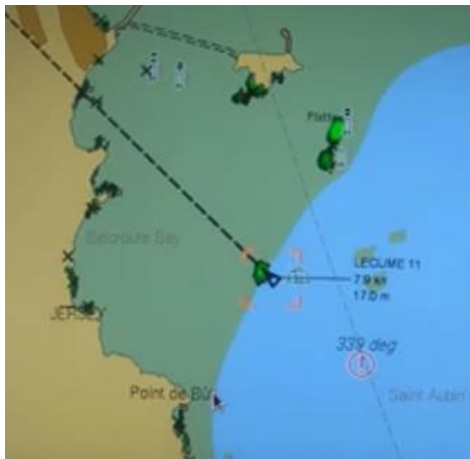
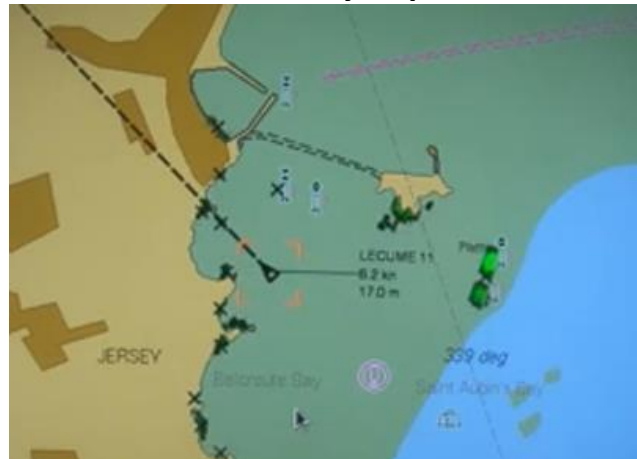
FIG 24 & 25 L'ECUME II having passed south of the outlying rocks crosses the 0m sounding and then runs aground at 8 knots.
