REPORT ON THE COLLISION OF CABIN CRUISER **P6T2 WITH RUAUDIERE LATERAL BUOY AND SUBSEQUENT SINKING OF THE VESSEL**

17th November 2017

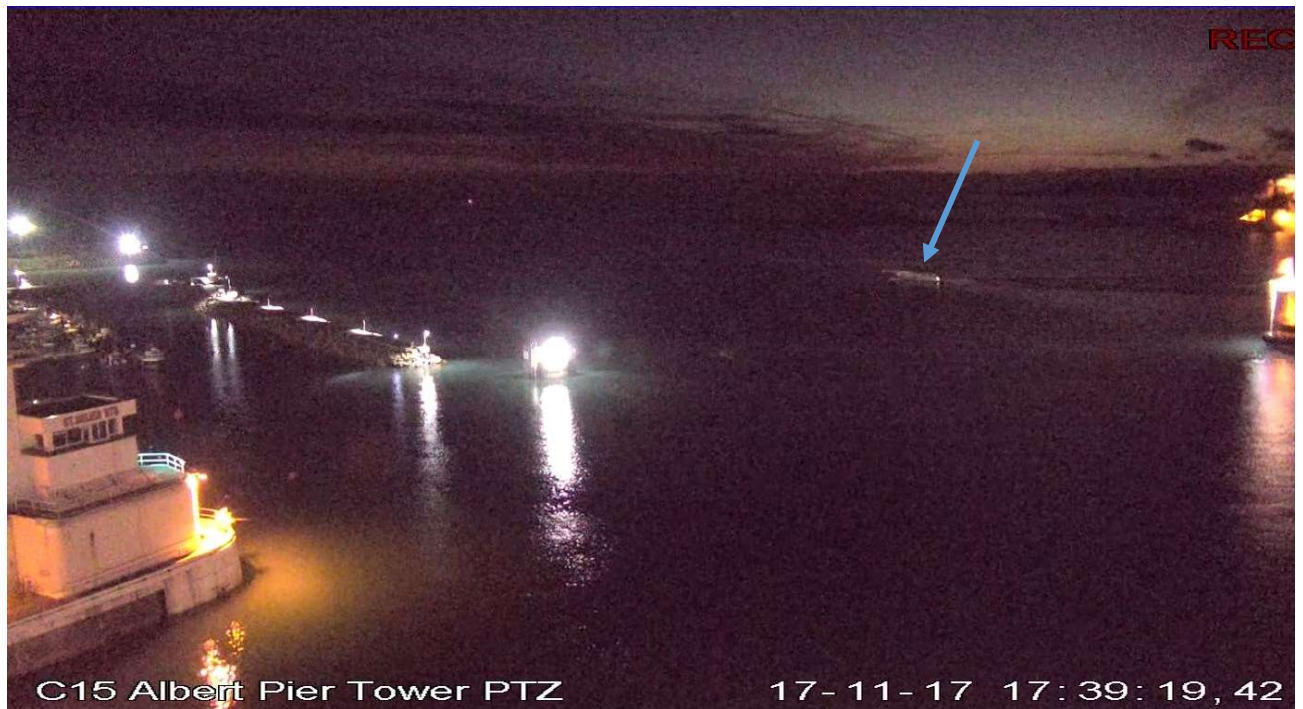
Image 1 shows the vessel P6T2 departing Elizabeth Marina Channel. Only Deck Lights are shown.

- 9.3 The vessel was observed on CCTV Camera departing down the Small Road without navigation lights. There was some light emanating from some of the cabin ports and the shore lights reflected against the high gloss hull of the vessel.

- 12.2 Navigation lights should be exhibited before leaving the berth.
- 12.3 Mariners should familiarise themselves with night passages including the location of buoys and beacons and undertake appropriate training with more experienced skippers.

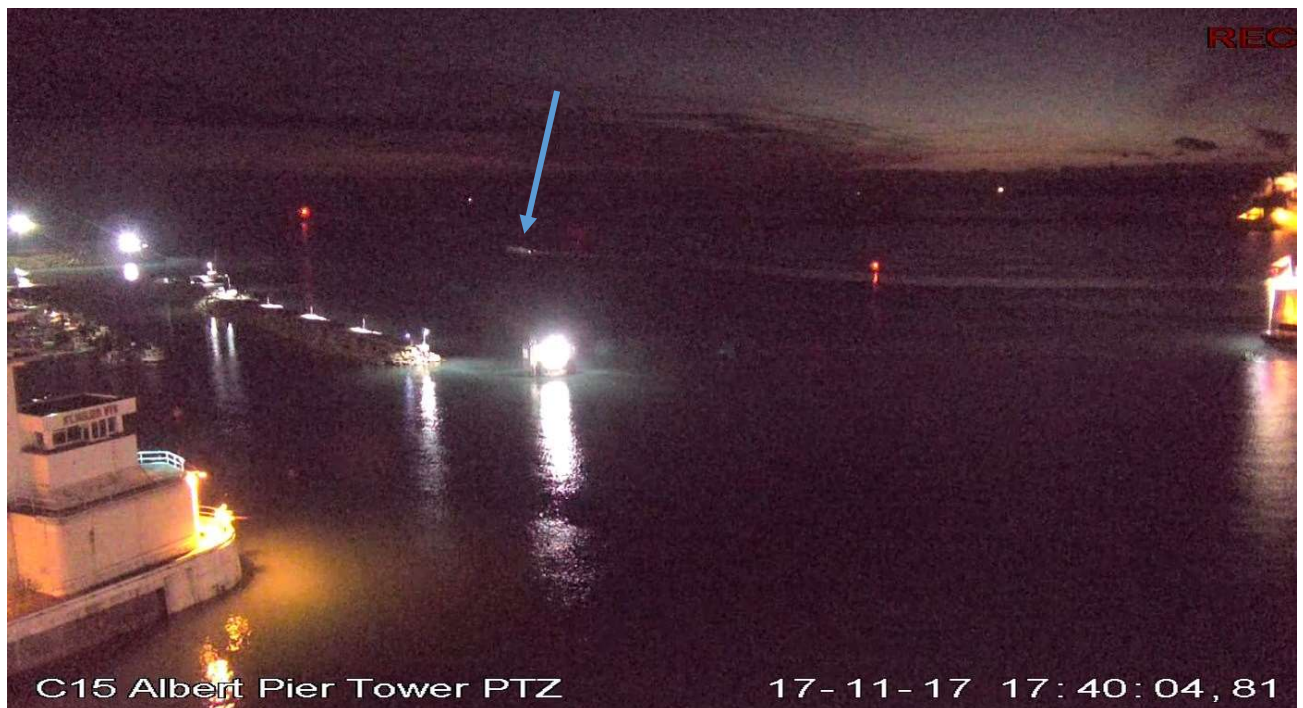
Image 2 shows vessel P6T2 departing down Small Road, Navigation lights not exhibited.

- 10.3 CCTV footage shows the navigation lights only switched on once the vessel had passed down the length of the Small Road.
- 10.4 The speed in the Elizabeth Marina Channel and in the Small Road was in excess of the 5 knot speed limit.

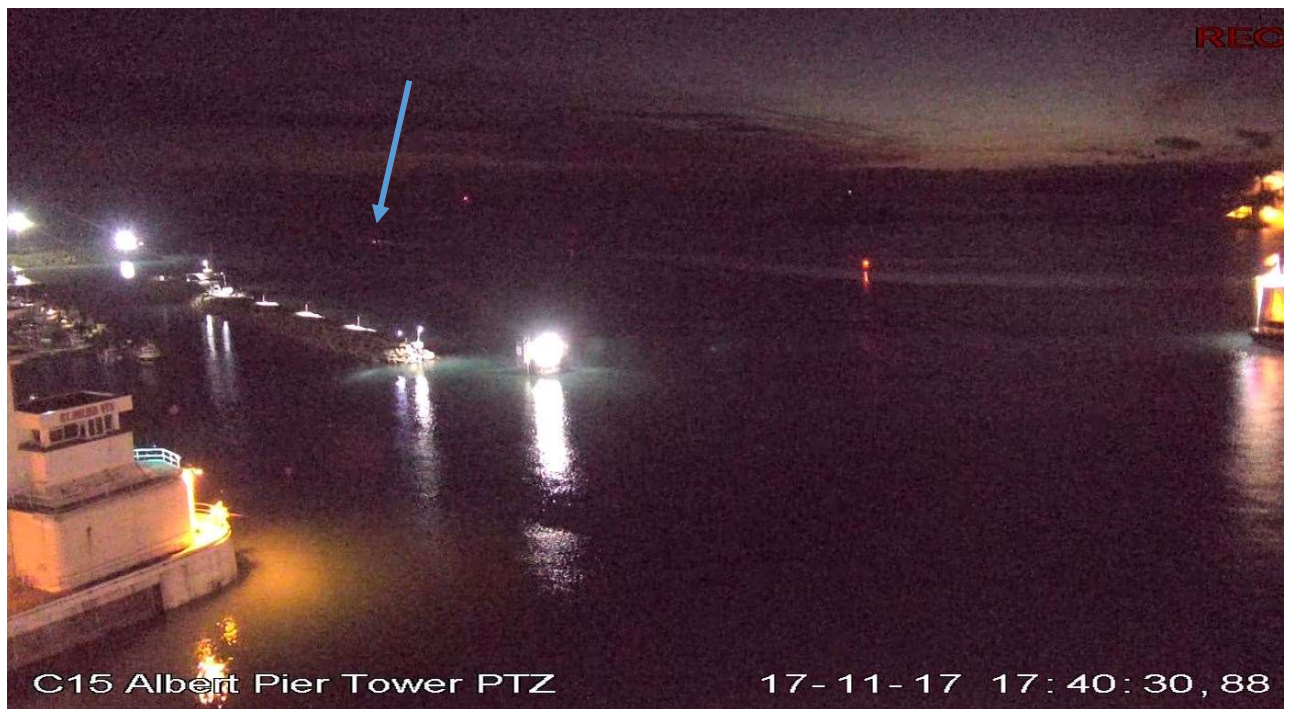
Image 3 shows P6T2 outbound via the Tanker Berth

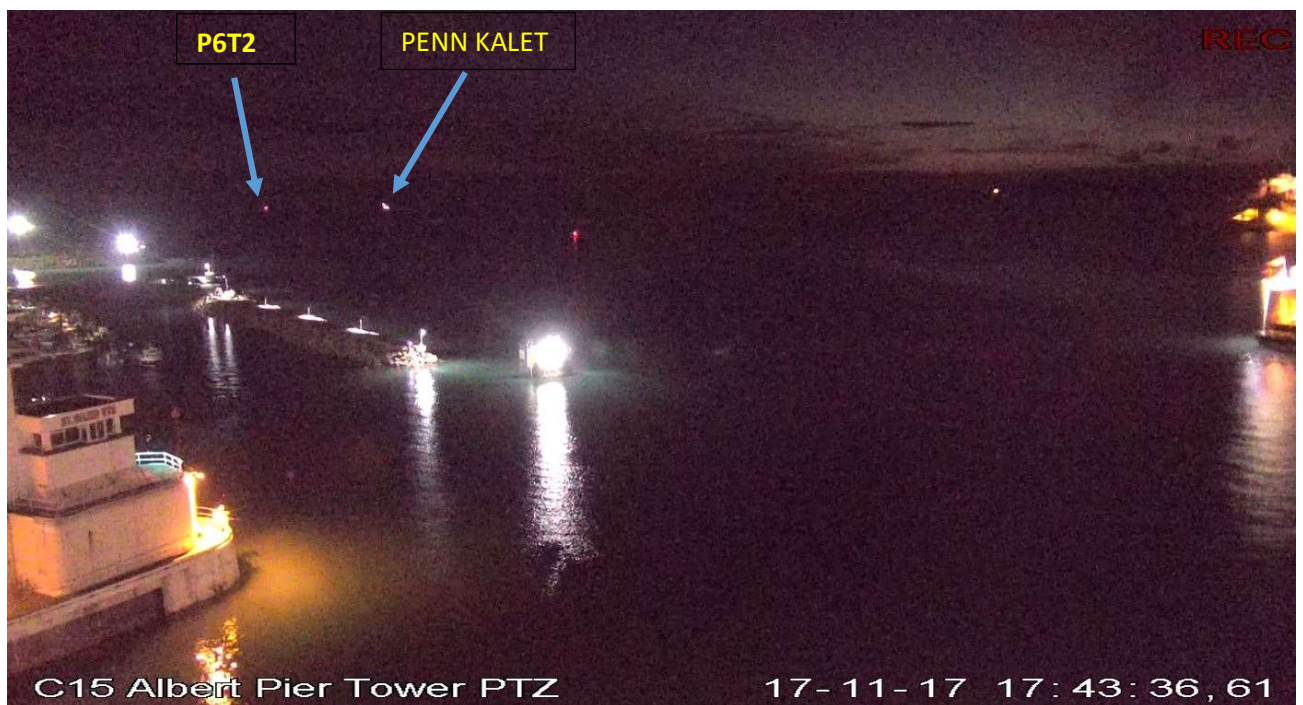
Image 4 shows P6T2 turning west in the precautionary area. The other bright light is PENN KALET inbound on Danger Rock Passage. Navigation lights now showing.

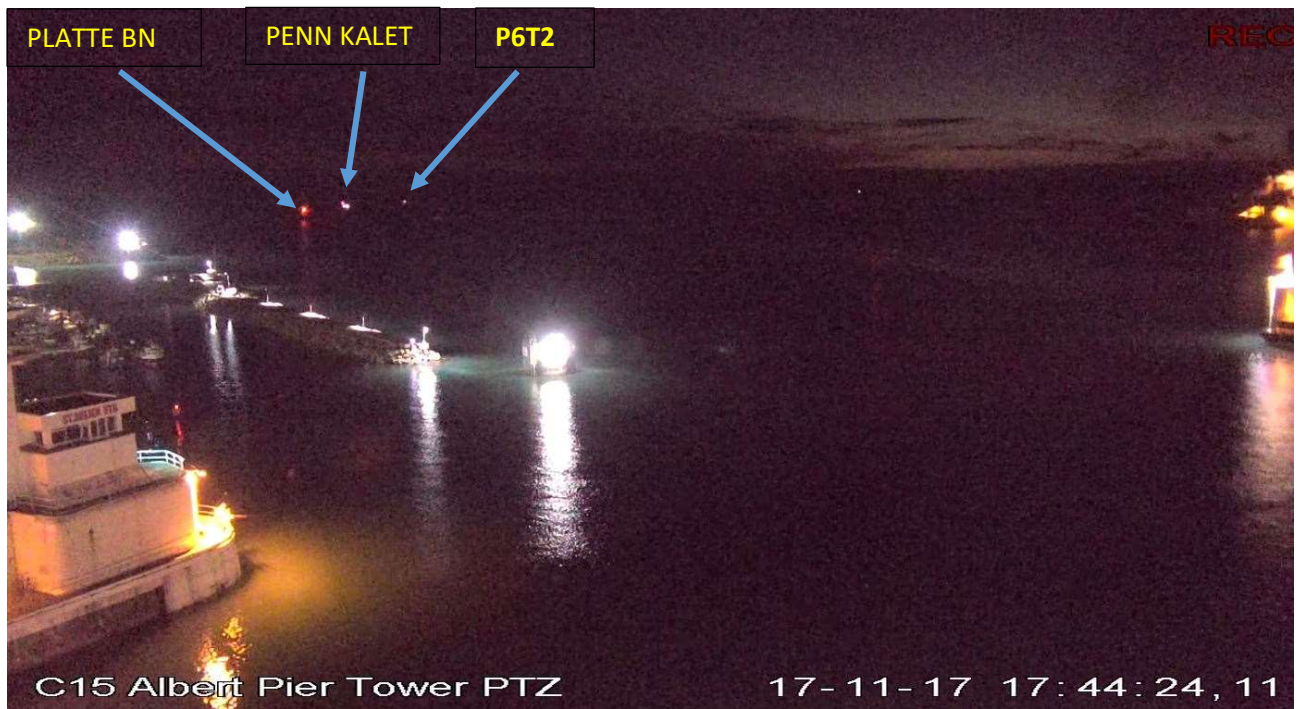
Image 5 shows P6T2 passing south of PENN KALET and heading outbound to the west

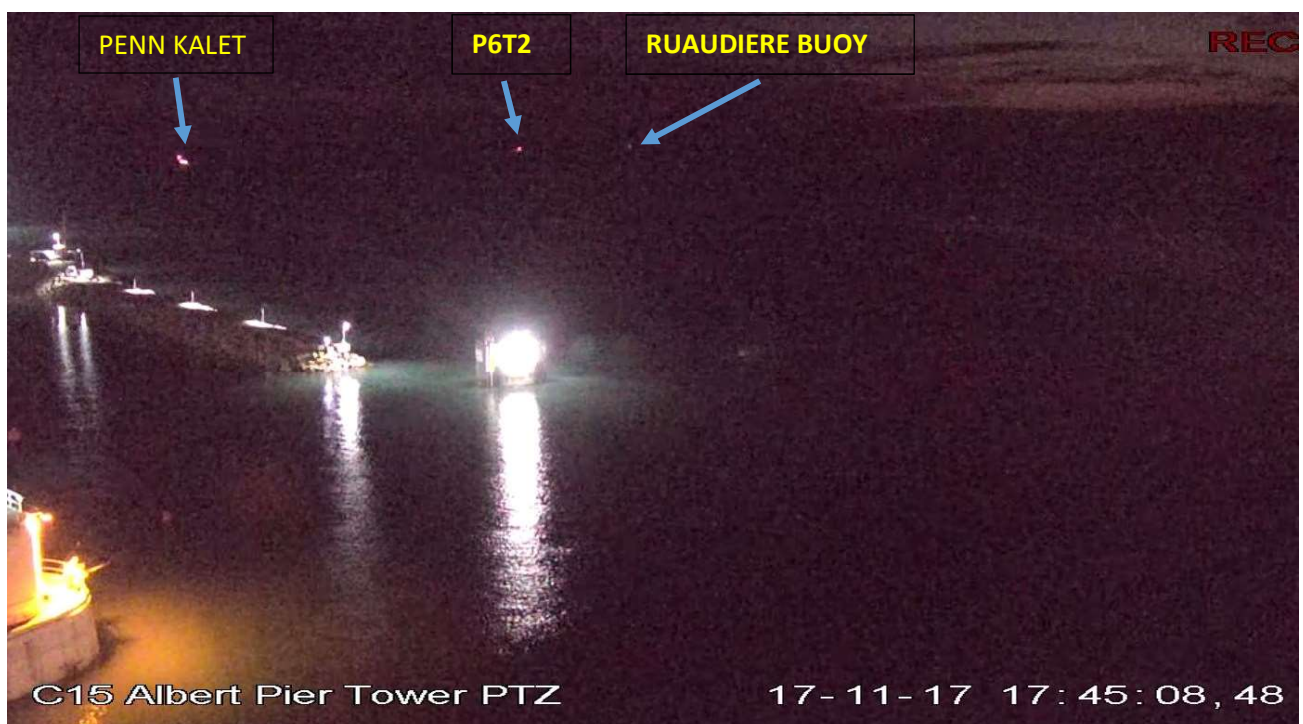
Image 6 shows P6T2 heading outwards towards the west with Ruaudiere Buoy right ahead

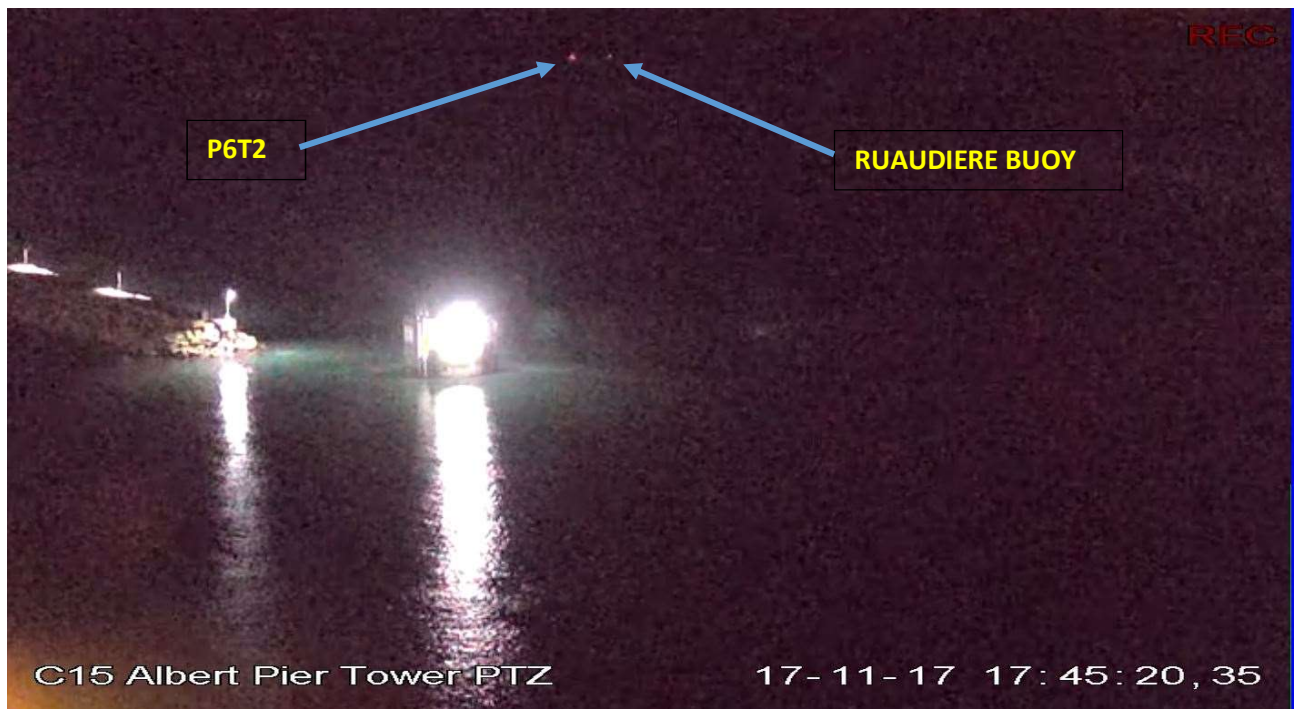
Image 7 shows P6T2 in very close proximity to Ruaudiere approximately 1 second before impact

- 9.5 The inbound fishing vessel **PENN KALET** is clearly visible on camera throughout the video sequence.
- 9.6 The vessel **P6T2** tracks west with the Ruaudiere Buoy flashing in sequence. The final flash was exhibited approximately one second before the vessel collides with it.

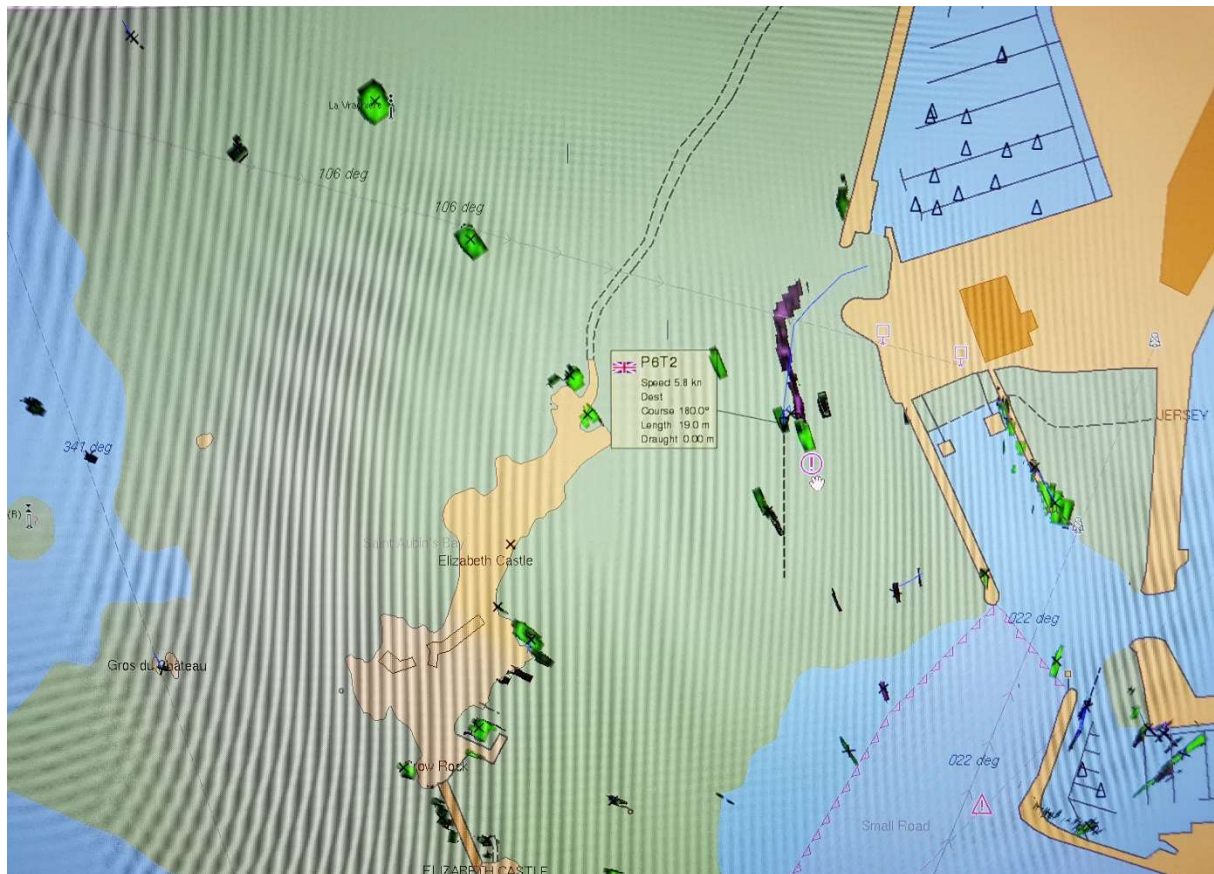
Image 8 shows P6T2 departing Elizabeth Marina

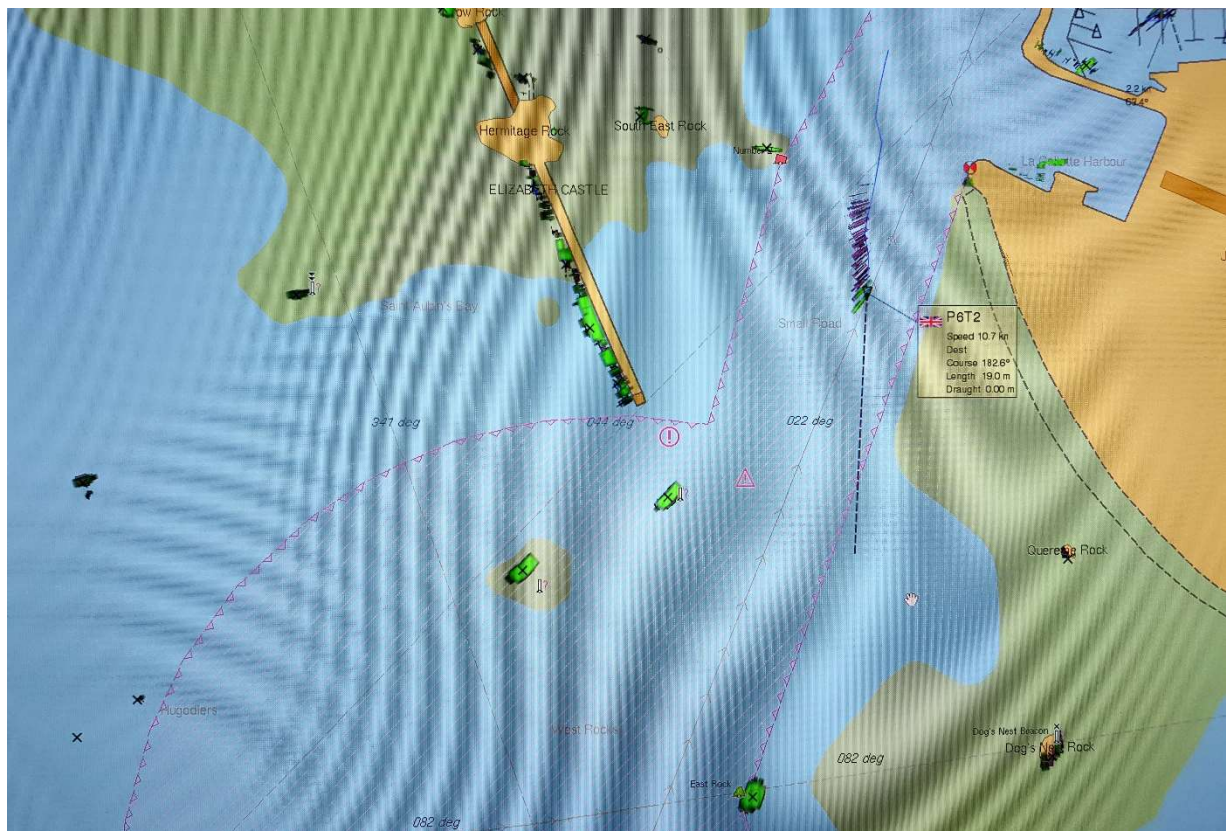
Image 9 shows P6T2 departing down Small Road at 10 knots

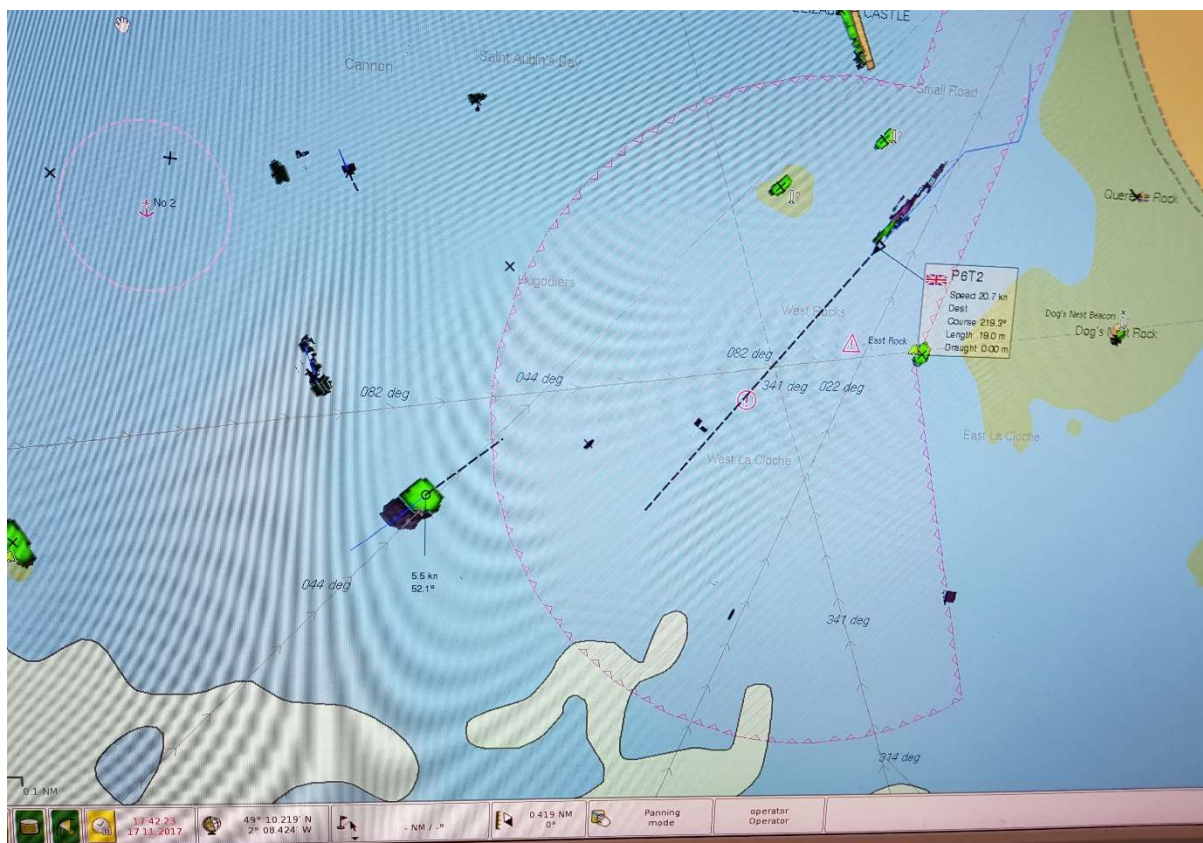
Image 10 shows P6T2 approaching Western Passage at 20 knots with fishing vessel PENN KALET approaching St Helier via Danger Rock Passage.

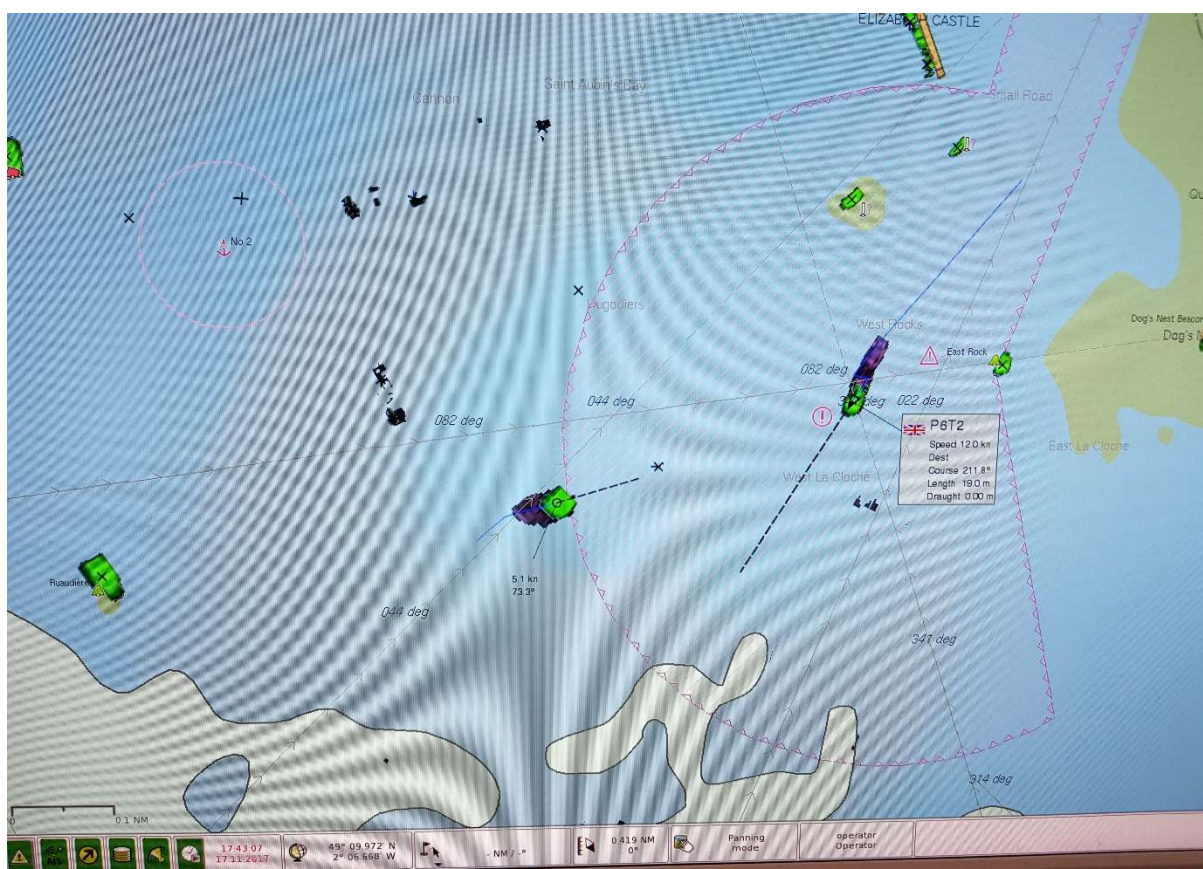
Image 11 shows PENN KALET altering to Starboard, whilst the P6T2 makes a slight alteration to port to cross ahead on the fishing vessel.

- 9.7 Initially the aspect between the two vessels was nearly end on and would require a manoeuvre as prescribed in COLREGS Rule 14. There was sufficient sea room for **P6T2** to alter course to the west, to starboard, and pass port to port with the inbound **PENN KALET**. Despite this the skipper stood on and allowed a close quarter situation to develop. He then created a crossing situation elected to pass starboard to starboard and cross ahead of the vessel in contravention of COLREGS Rule 15. This action put the outbound vessel well south of the Western Passage leads.

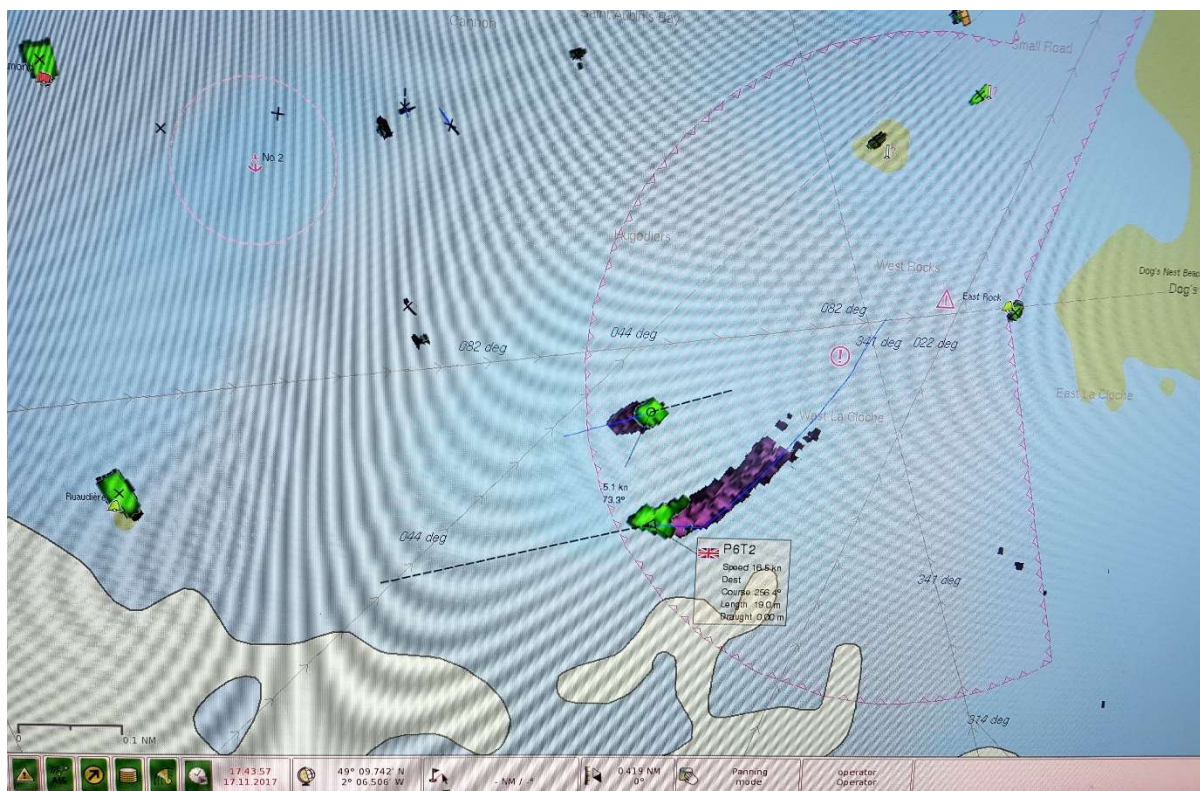
Image 12 shows P6T2 passing south of PENN KALET and turning to starboard to regain the Western Passage leads

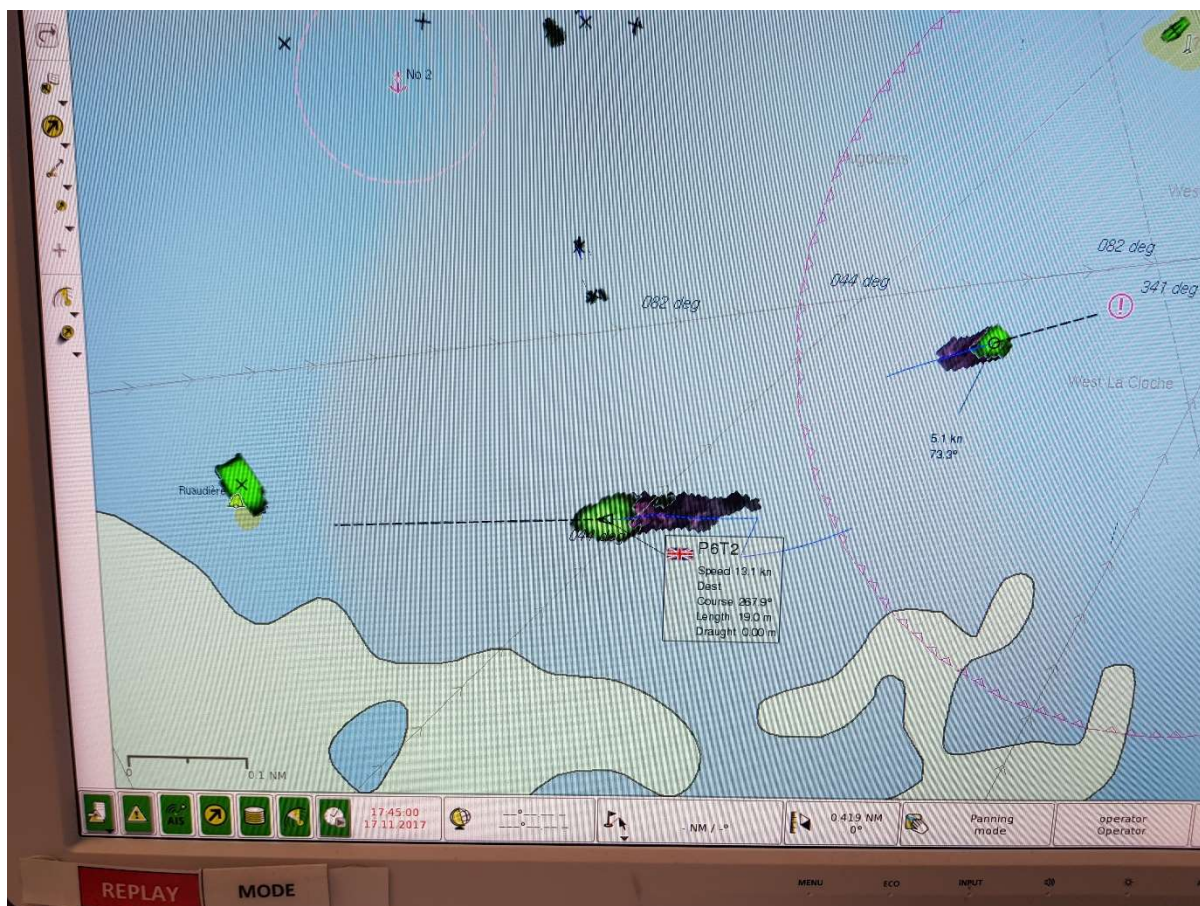
Image 13 shows P6T2 at 13 knots heading towards the Rauaudiere Buoy

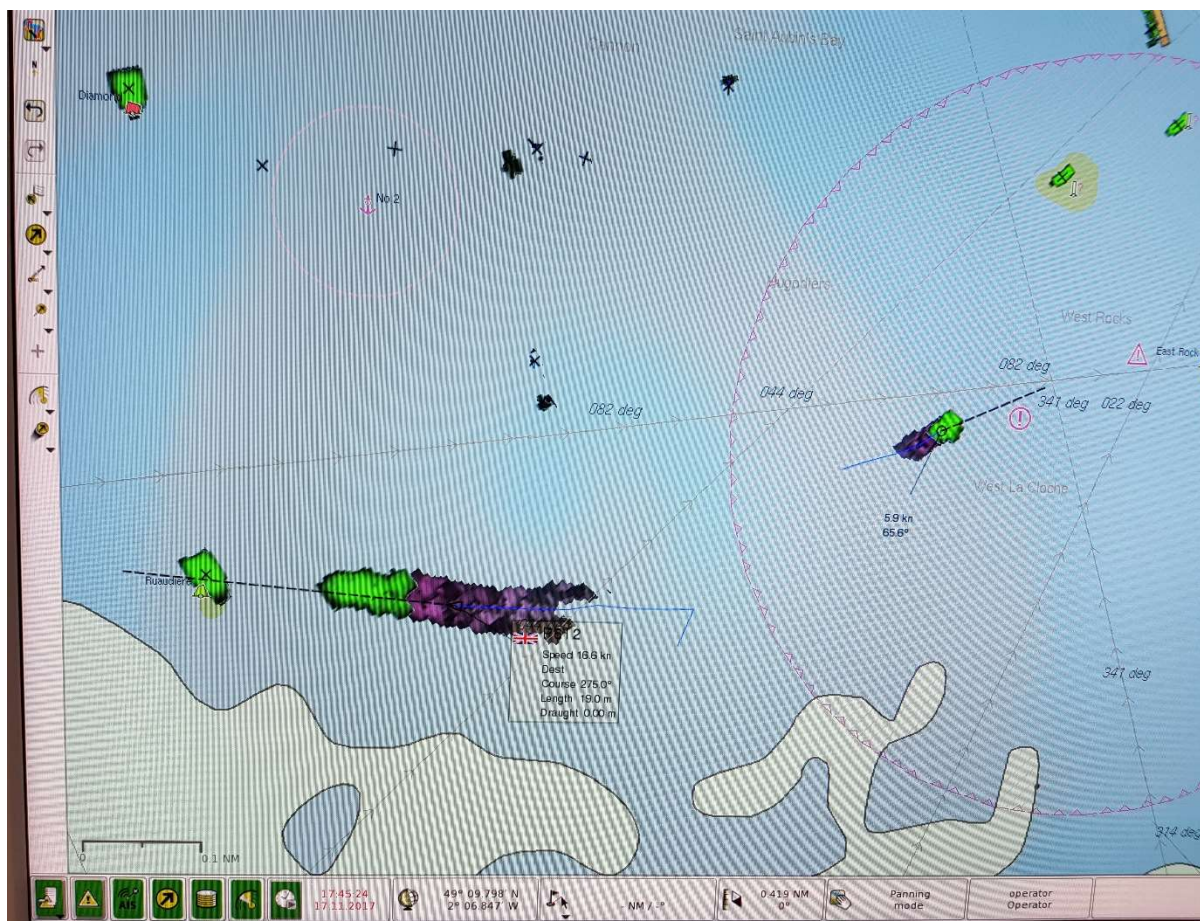
Image 14 shows P6T2 speeding up to 16 knots and heading straight towards Ruaudiere Buoy

- 9.10 From that time the vessel continues to accelerate and head straight for the Ruaudiere Buoy. At the moment before impact the vessel's AIS was reading 277°T at 21.1 knots. It should be noted that the vessel's speed was increasing as shown by AIS but there is a time lag between the GPS calculation of speed, transmission over AIS and being processed by ECDIS therefore actual speed at time of impact may have been higher.

- 12.4 All mariners should be familiar with the definition of a safe speed, which is defined as one in which proper and effective action can be taken to avoid collision and be stopped in a distance appropriate to the prevailing circumstances and conditions.

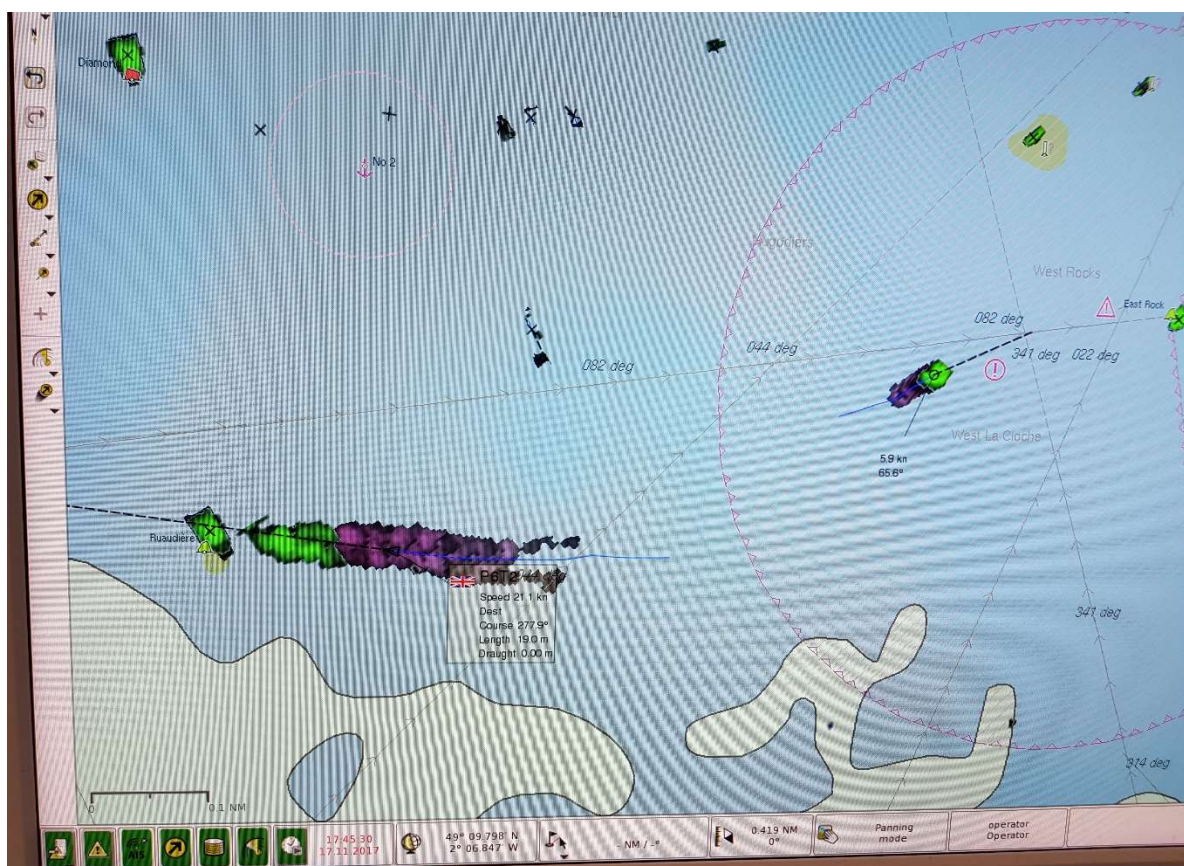
Image 15 shows P6T2 immediately prior to impact with Ruaudiere Buoy

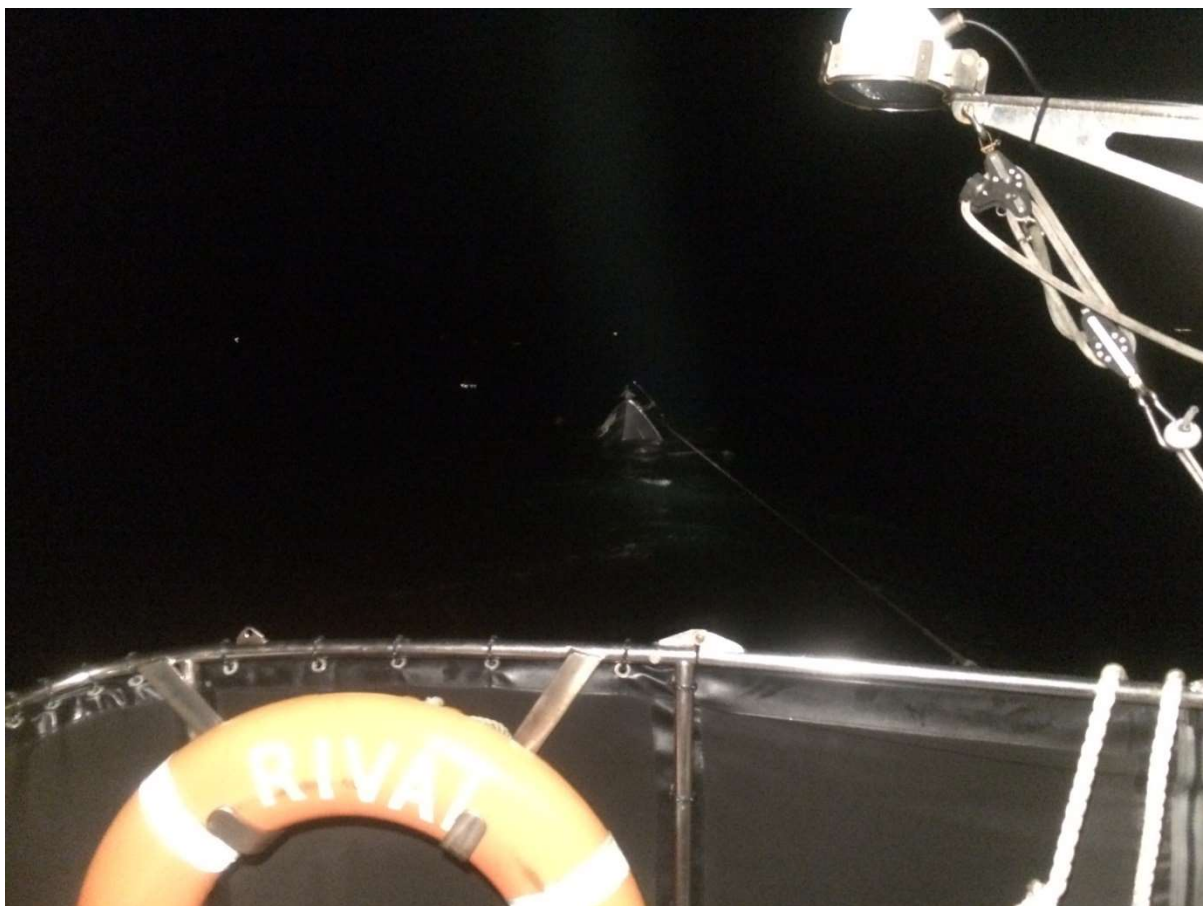
Image 16 – Bow of *P6T2* under tow by pilot cutter *Rival*

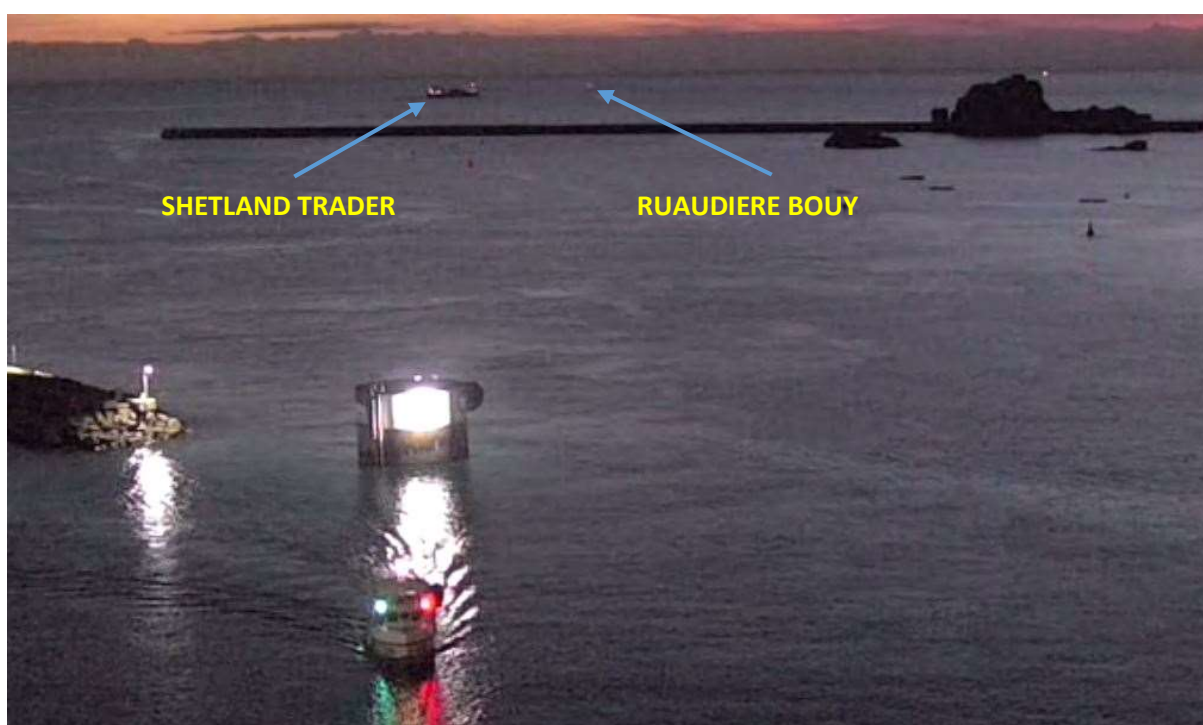
Image 17 shows SHETLAND TRADER departing on Western Passage at 1715
