# Application to remove

## Crane 13

New North Quay, St.Helier, Jersey

# JERSEY CRANE REFURBISHMENT CRANE 13 - NEW NORTH QUAY

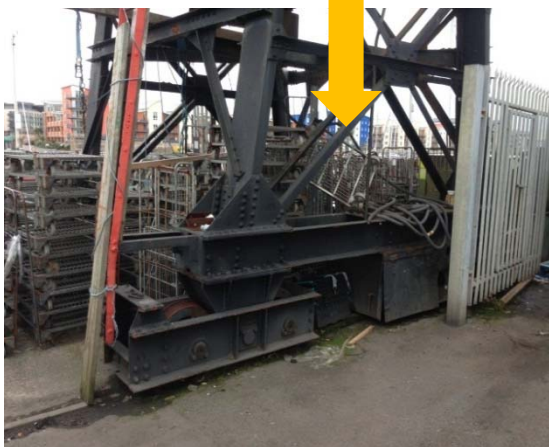
The Access ladder does not have a **safety** cage.

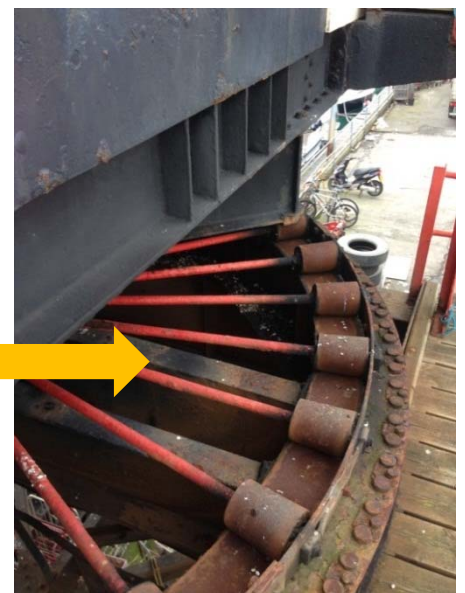
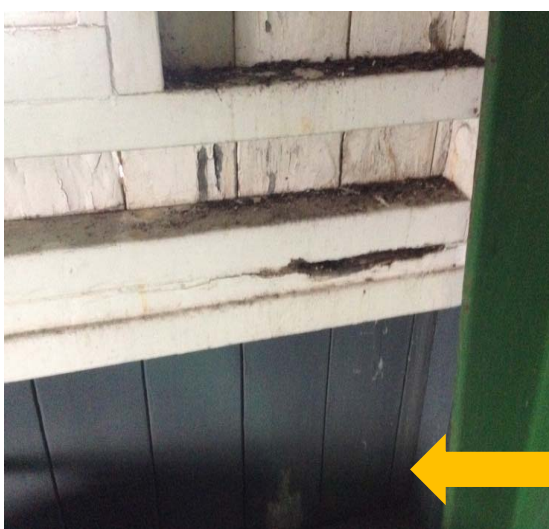
The crane has an exposed roller bearing slew ring. This type of slew ring is robust but no longer used for a number of **Health & Safety** reasons.

The crane also has wooden access platforms that do not comply with current regulations.

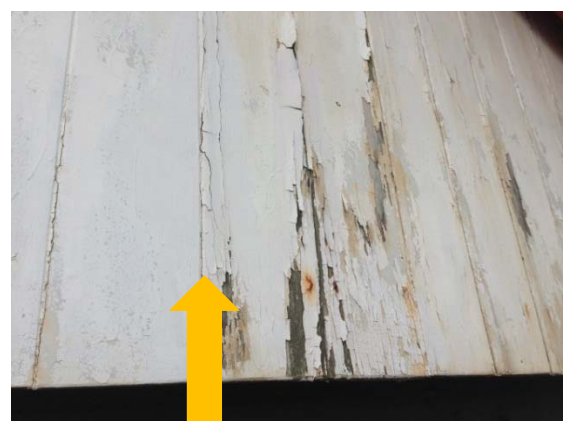
The timber frame and cladding generally is rotting and **unsafe** for access

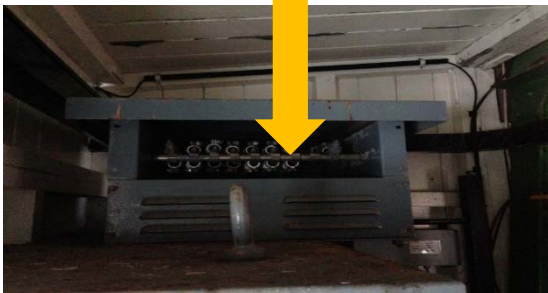
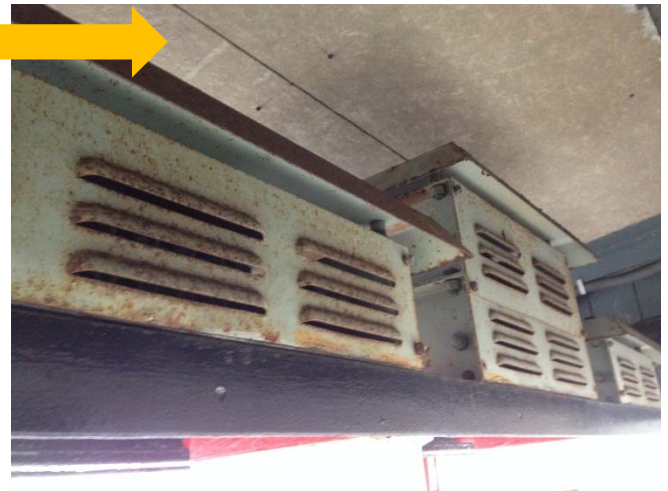
There are asbestos lagged resistors that need to be removed

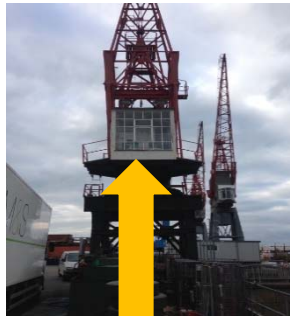
Machinery and 400volt switching attached to the driver's controls pedestal do not meet current regulations.

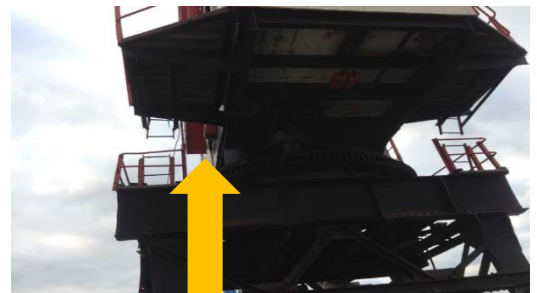
The field of vision for the driver is very restricted due to the small glazing panels and the vertical windows. Operation of Crane 13 on such a congested quay would cause considerable Health & Safety issues.

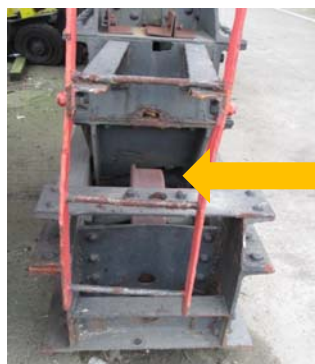
Bolts and fixings are completely rusted through making them ineffective.

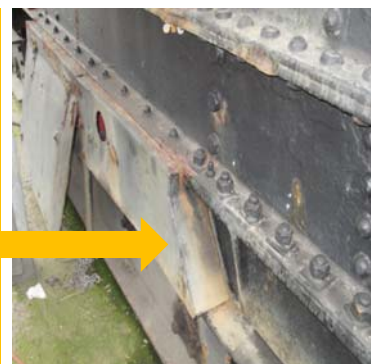
There are significant signs of collision damage to several major elements, other components are warped and twisted, causing **considerable Health & Safety issues**.

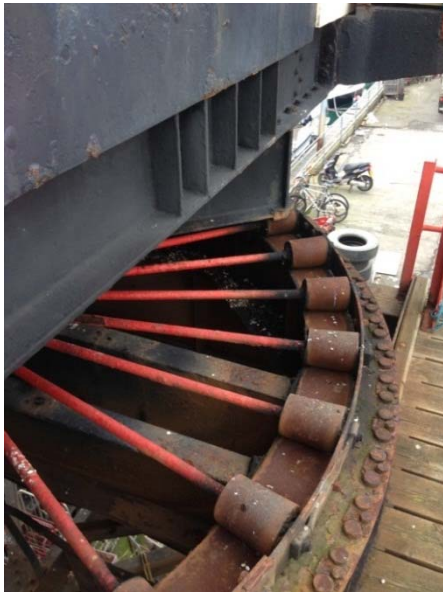
Figure 3 - Slew ring and access platform

The crane has an exposed roller bearing slew ring. This type of slew ring is robust but no longer used for a number of H&S reasons.

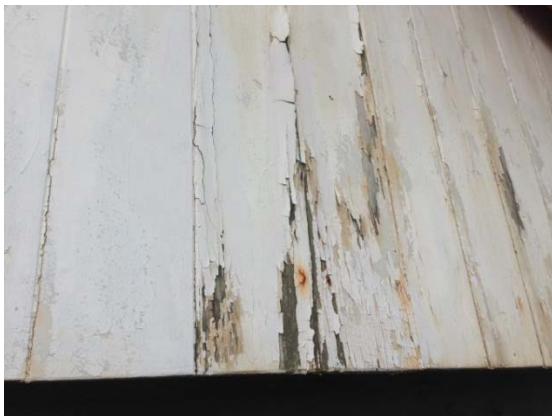
Figure 4 - Timber cladding

The timber cladding material is starting to rot due to a lack of maintenance of the paint system.

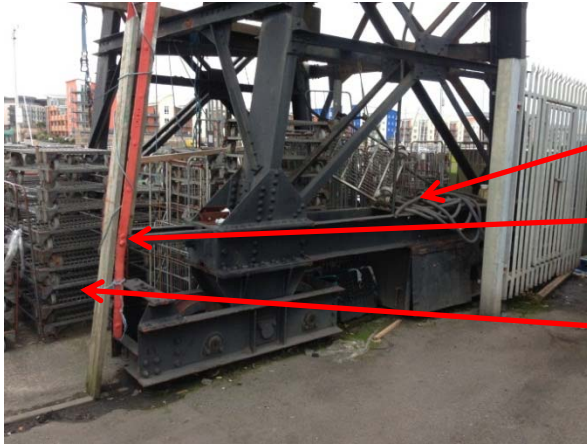
Figure 5 - Crane base

The crane is disconnected from the 3Phase supply.

The Access ladder does not have a safety cage.

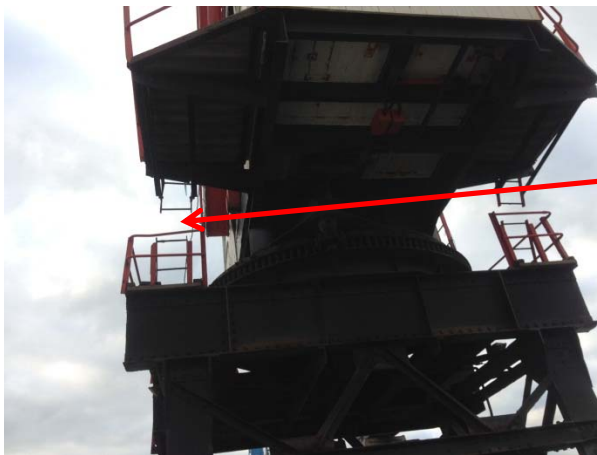
Figure 6 - View from the underside of the cab

Access to and from the cab is restricted/not possible unless the crane is properly parked. This means that if the crane breaks down out of position there is no safe access to the cab.

Even when properly parked the access is not suitable for use under current regulations.

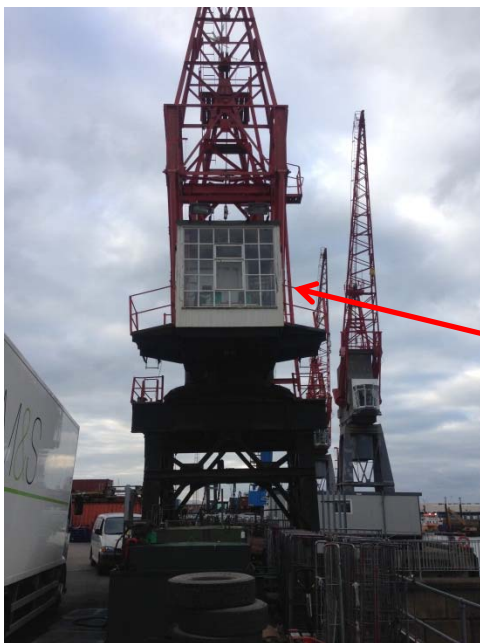
Figure 7 - Front view of crane

The field of vision for the driver is very restricted due to the small glazing panels and the vertical windows.

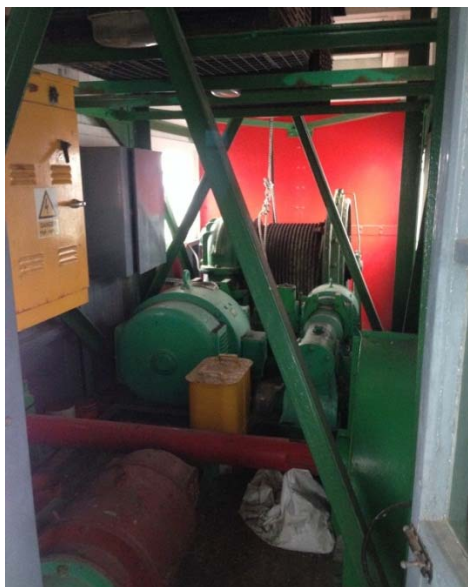
Figure 8 - General View - Machine House

Visually the machinery seems in generally good order but as previously stated is very dated and does not meet current regulations

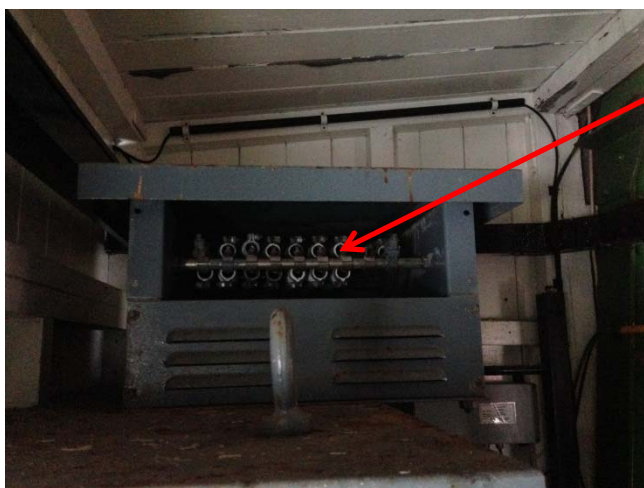
Figure 9 - Resistors with asbestos rope heat lagging

As with other old cranes on Jersey there are asbestos lagged resistors that need to be removed prior to any other works being carried out

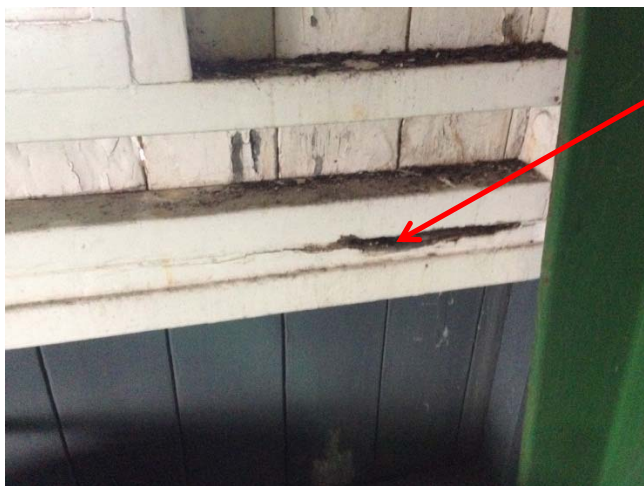
Figure 10 - Machine House frame localised not to the machine house timber frame

The timber frame is starting to rot and although not serious yet, without attention it will deteriorate further.

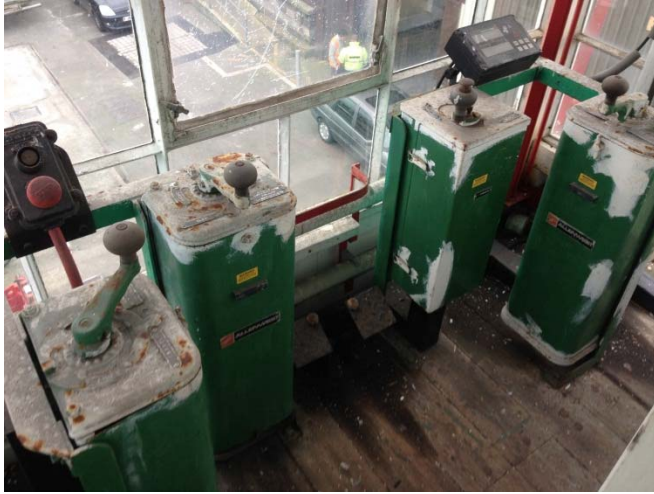
Figure 11 - Crane controls

The crane controls are as you would expect of a crane this age but are dated and do not meet current regulations

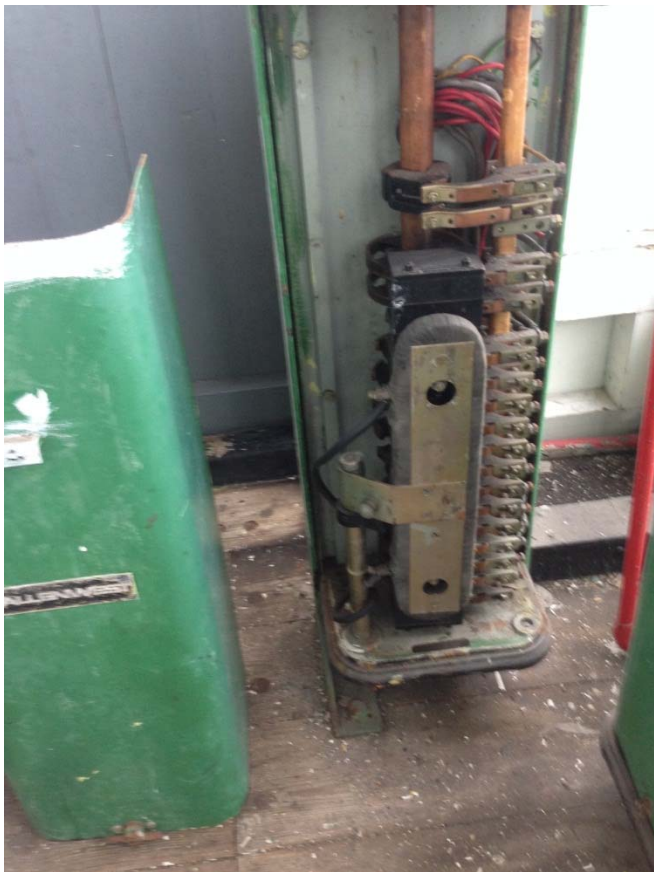
Figure 12 - Controls - detail

400volt switching is attached to the driver's controls pedestal. This does not meet current regulations.

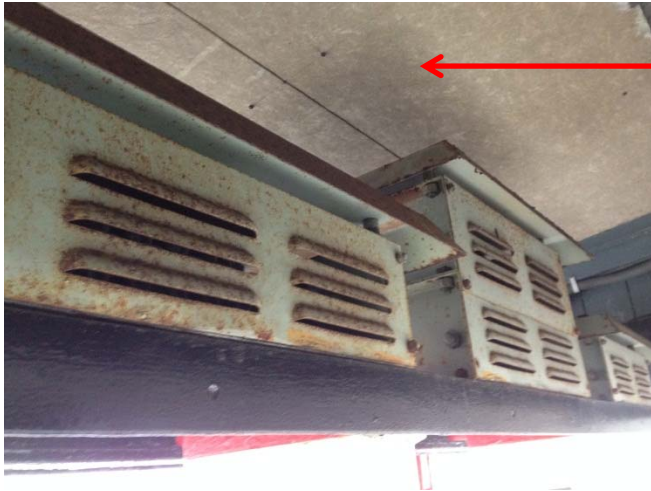
Figure 13 - Cab Roof

Asbestos or Superlux fitted as heat protection to the cabin roof over the asbestos insulated resistor banks

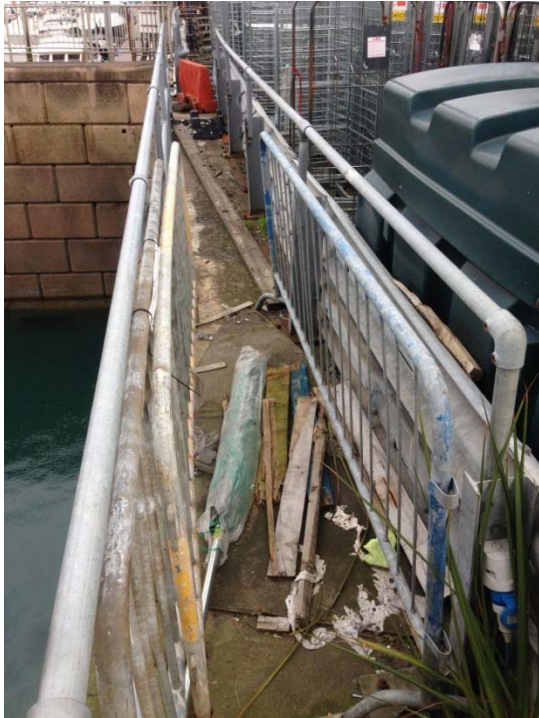
Figure 14 - Unusable crane rails

Over the years the areas of crane rail that are no longer used have been built over. Here it can be seen that an oil tank and crash barrier have been fitted over the rails

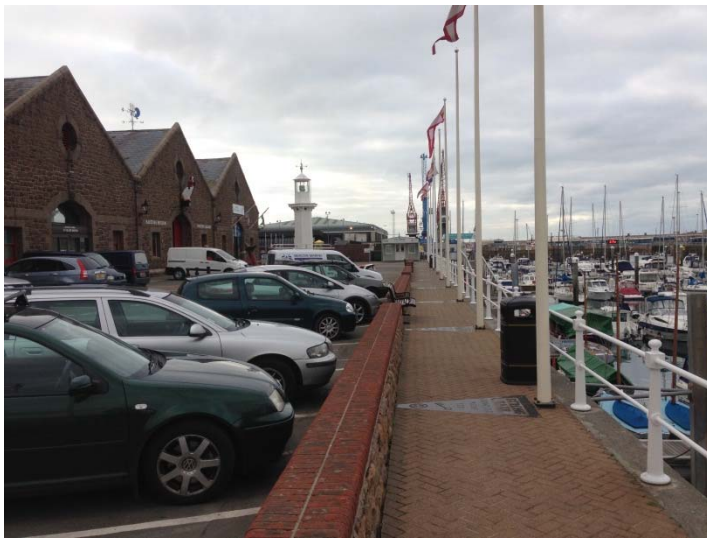
Figure 15 - Old rails built over adjacent to St Helier Marina

We were informed that the crane rails are still in position but under the block paving / tarmac

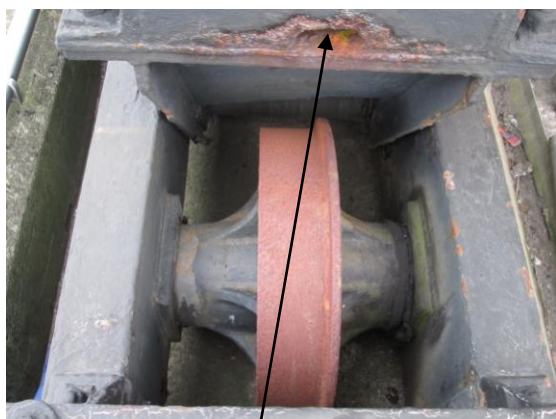
Signs of held water

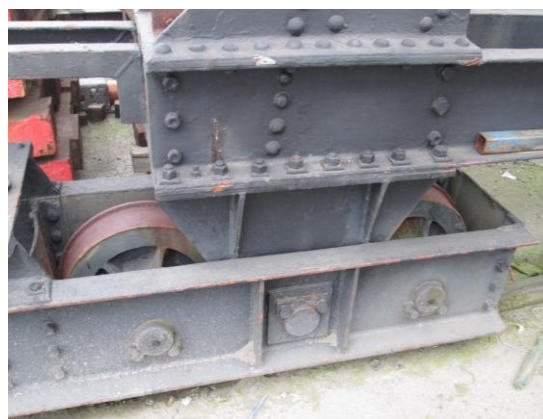
Picture of trailing wheels

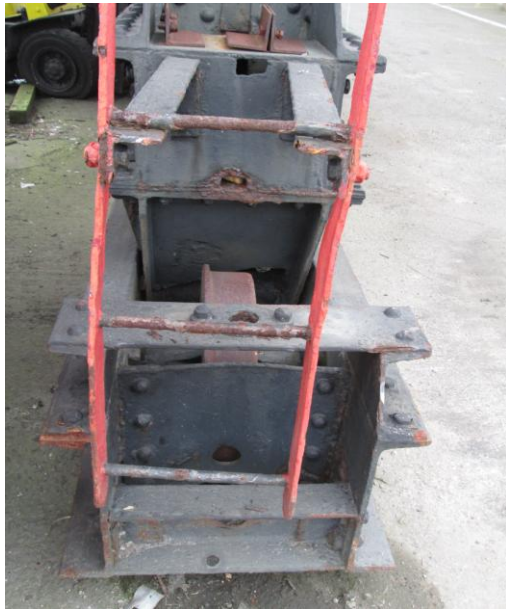
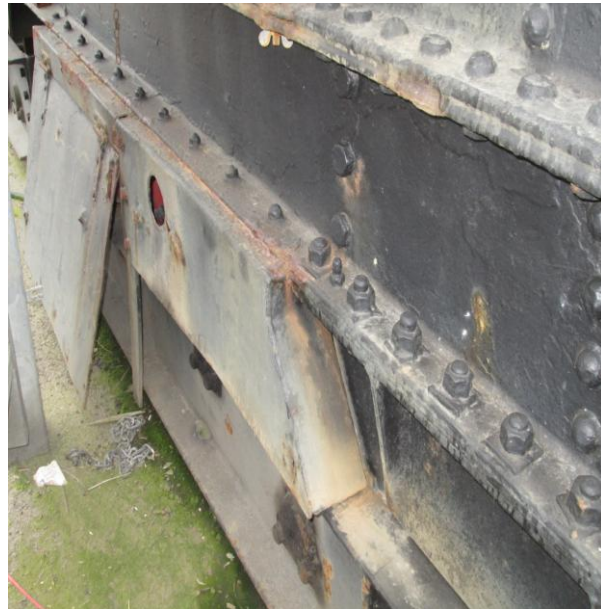
One long travel brake has been removed from the crane and the remainder were clamped in position. These brakes were corroded into their location and could not be operated at the time of the inspection.

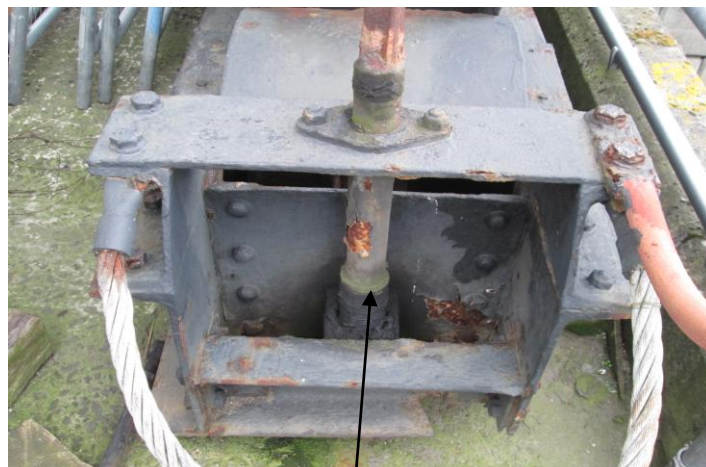
Seized brake applicator

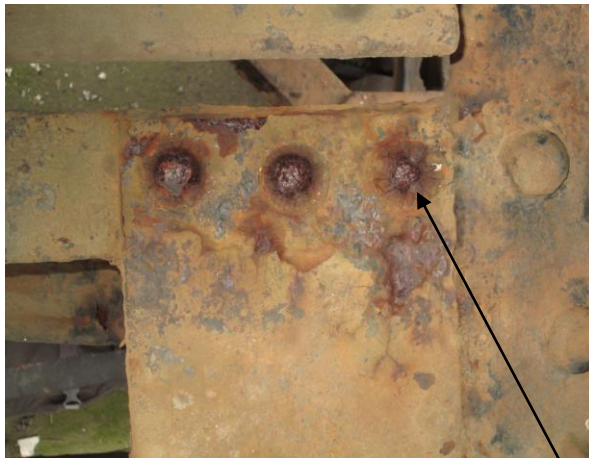
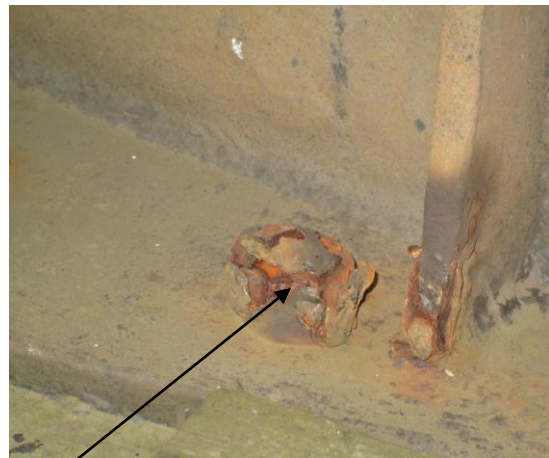
The fixings above have completely wasted away rendering them ineffective

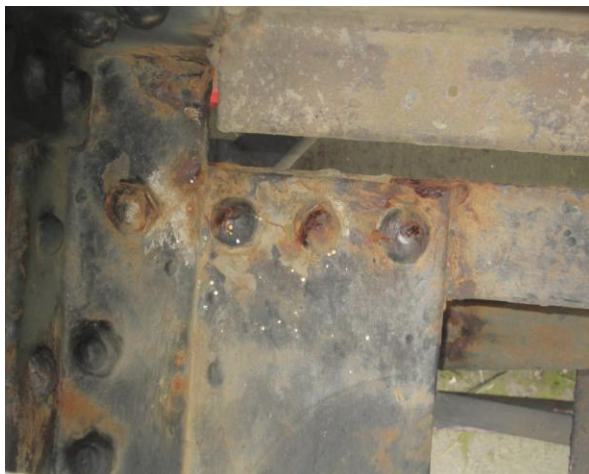
General condition of components

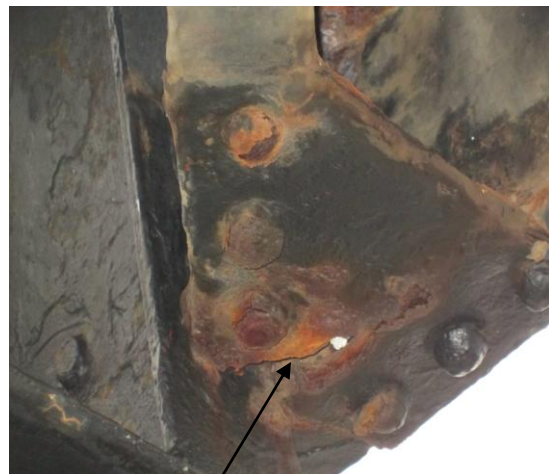
Fracture to one joining plate

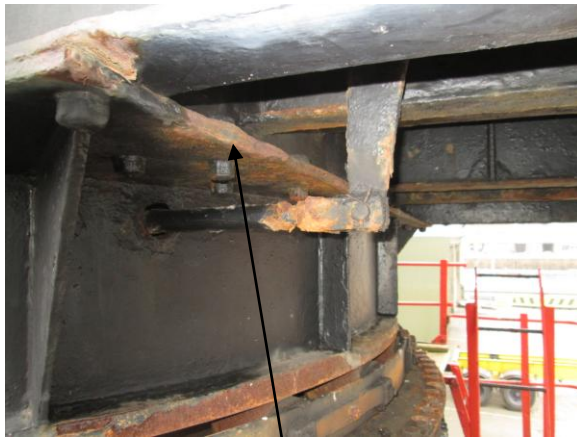
Corrosion to load bearing components

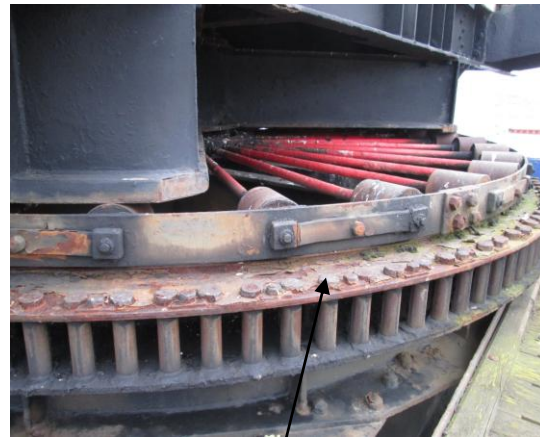
Corrosion on slew bolts and structure surface

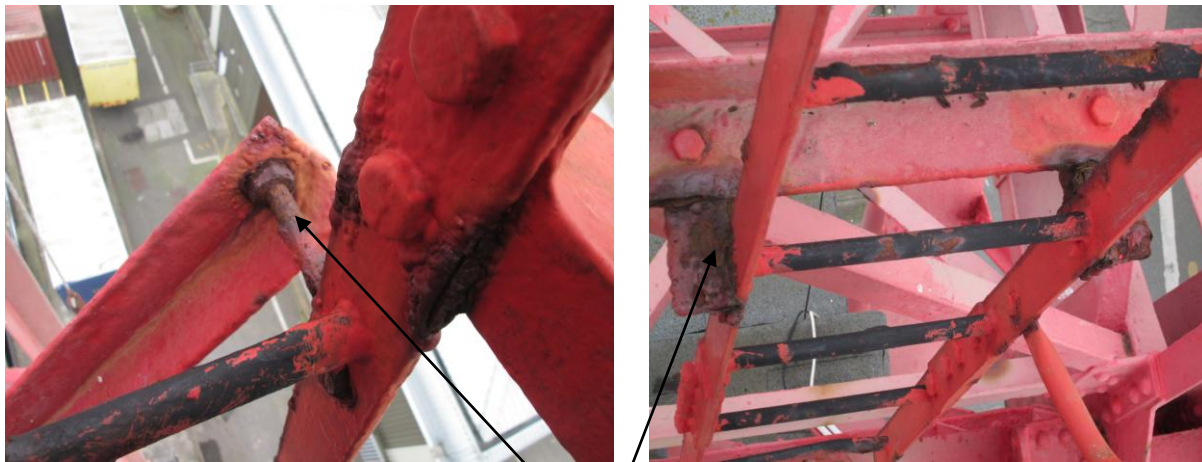
The majority of the access ladders were distorted, heavily corroded and secured via means of severely corroded fasteners. At present we would not deem the current fixed ladders as safe for operational use and a risk assessment should be carried out to ascertain the most appropriate way for accessing and egressing the crane.

Corroded ladder section fixings and fasteners

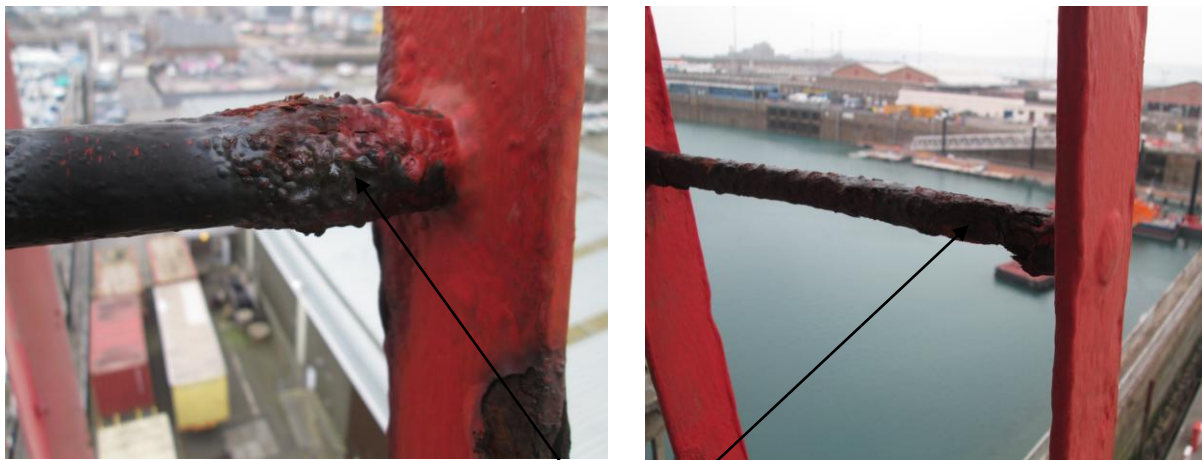
Heavy corrosion and wastage on rung sections

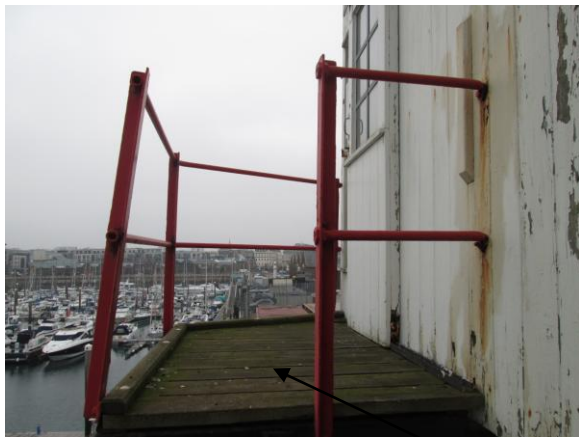
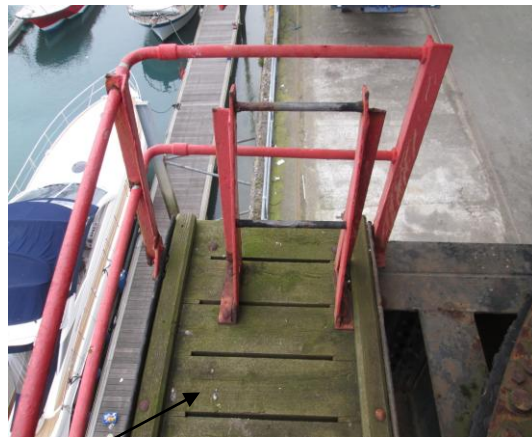
Surface build up causing slipping hazard

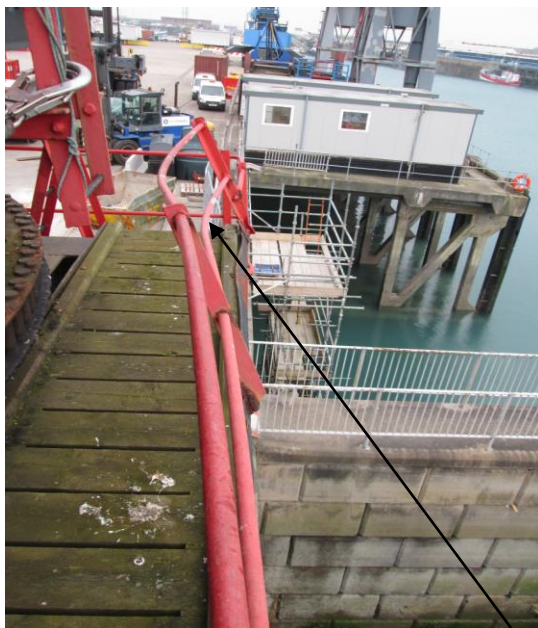
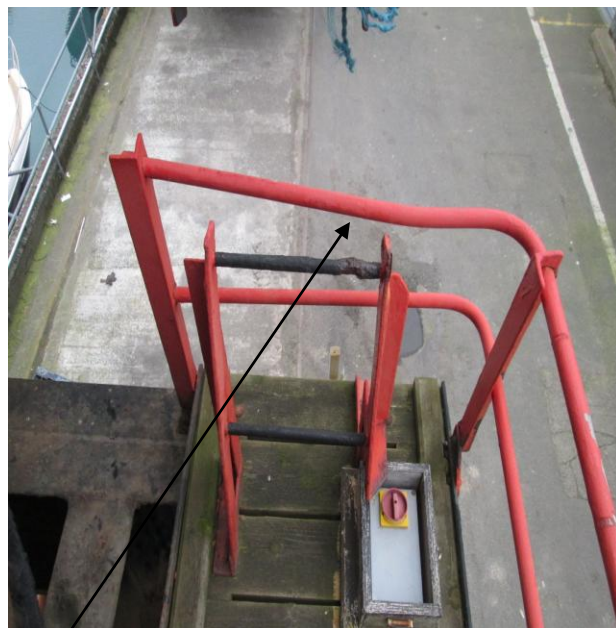
The safety railings that are erected in various areas of the machine are in a poor state. In general they are constructed of pipe sections welded to vertical angle iron members. The majority of them show distortion, severe corrosion and missing sections.

Deformation to safety rails

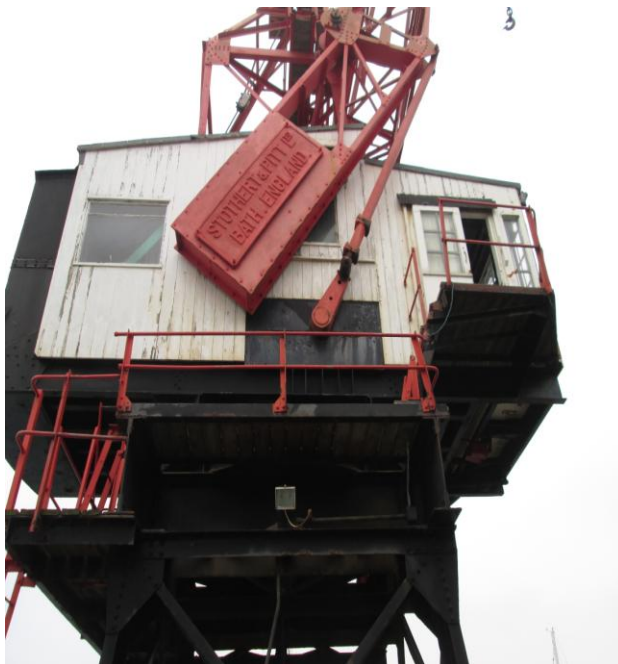
The cab is constructed of wooden slats bolted on to steel bracings. The slats have been painted on numerous occasions. The paint is flaking in most areas showing exposed areas of damp and rotten wood. The floor of the control cab is also constructed from wooden sections which are in a condition commensurate with the machines age. The drivers screen is comprised of steel frames with single glazed glass throughout. The frame shows minor corrosion.

External construction of cab

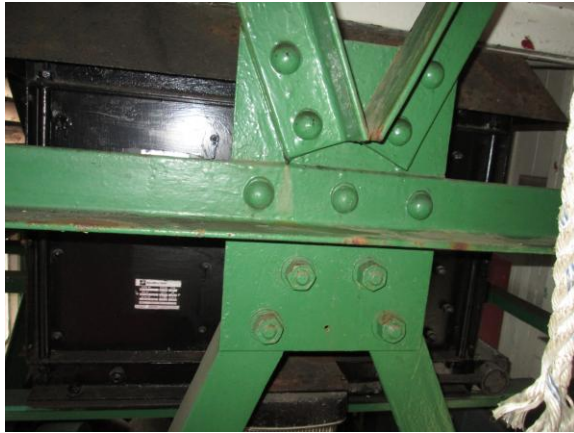
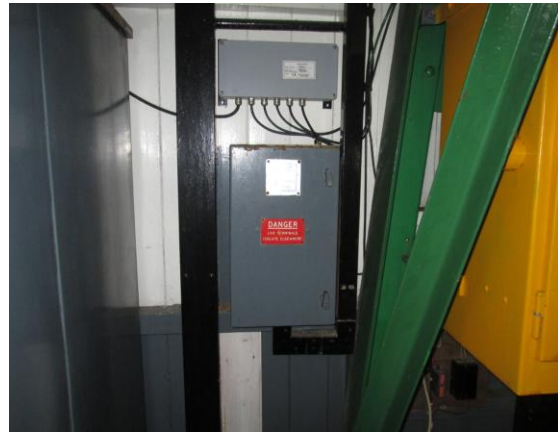
The above photographs show the generally good condition of the internal structure

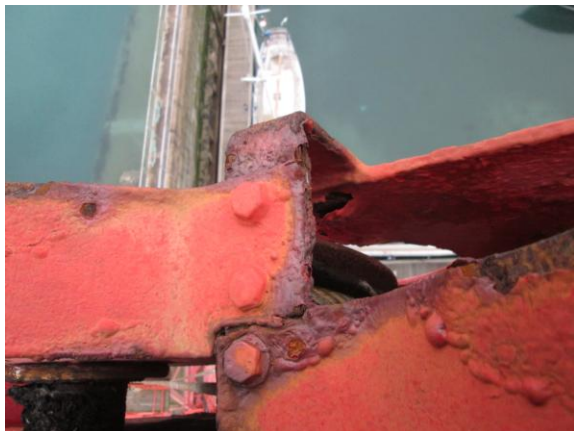
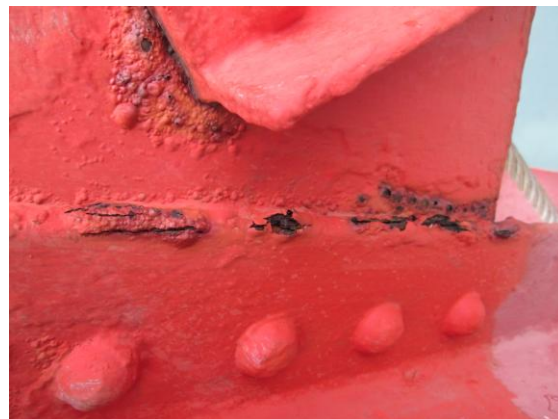
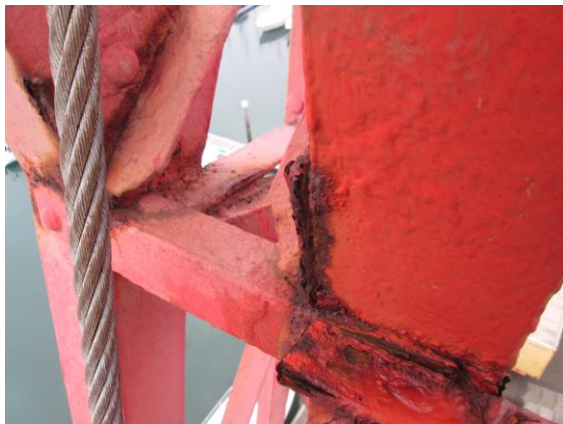
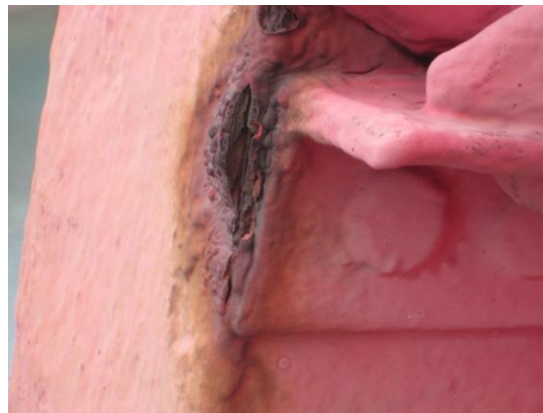
The jib section has been painted on numerous occasions since the crane was brought into service. The corrosion that has been subjected to the jib suggests that the painting process was not carried out correctly. The jib sections shows varying degrees of corrosion from mild paint flaking to heavy wastage of material.

The above photographs show the extent of the corrosion in various parts of the jib

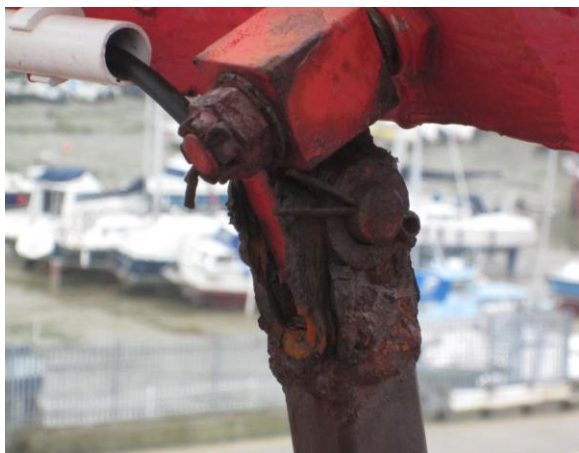
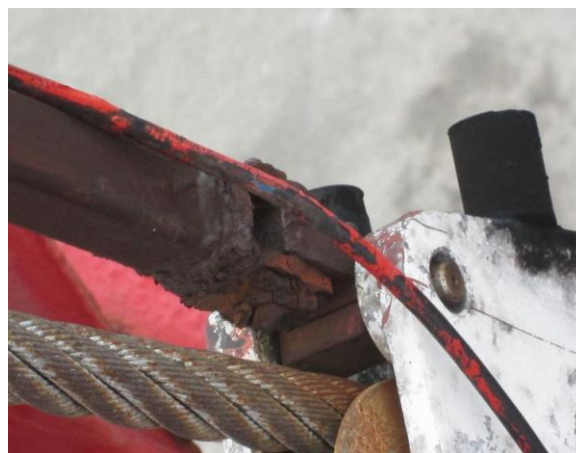
The above shows the extent of the corrosion to the bracket that secures the cranes load cell in position.

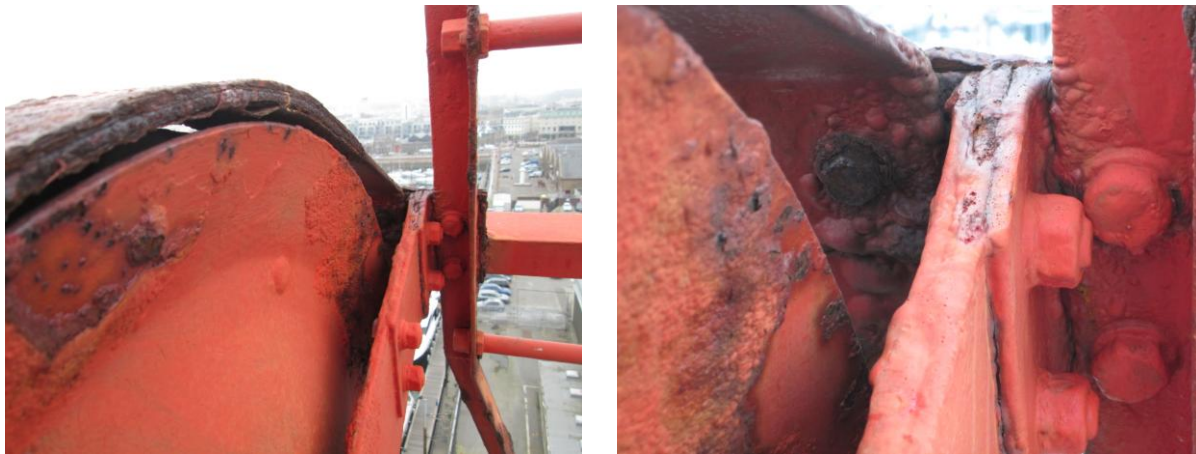
The above shows the fixings to the cat head sheave guard. Both the fixings and the guard are corroded severely.

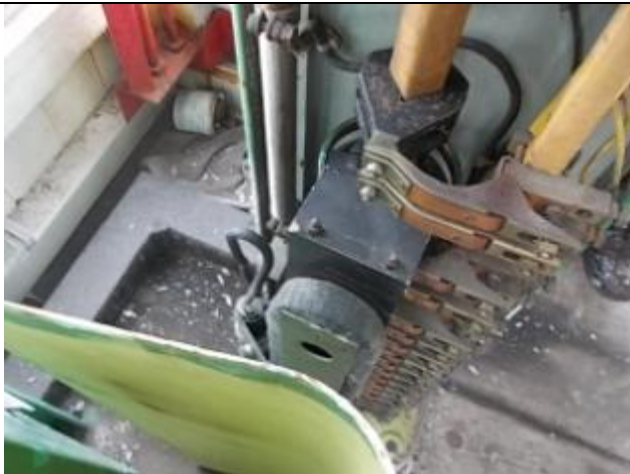
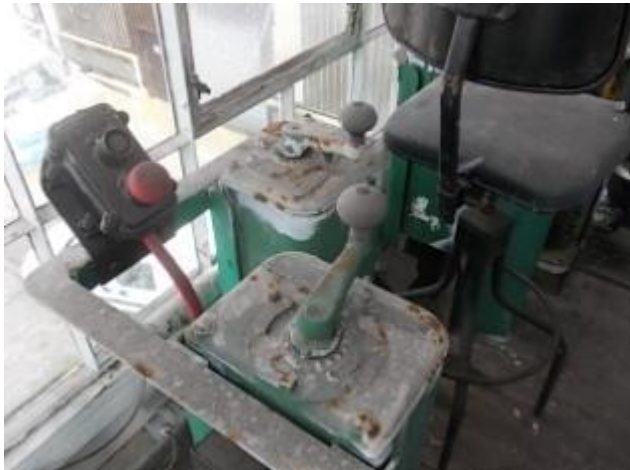
<b>Sample No. / inclusion reference:</b>	<b>15JB6500 – SP05</b>

<b>Location &amp; description of material:</b>	Crane 13 Control Room Within Control Panels	
<b>Material type</b>	Board	
<b>Asbestos:</b>	Yes (Strongly Presumed)

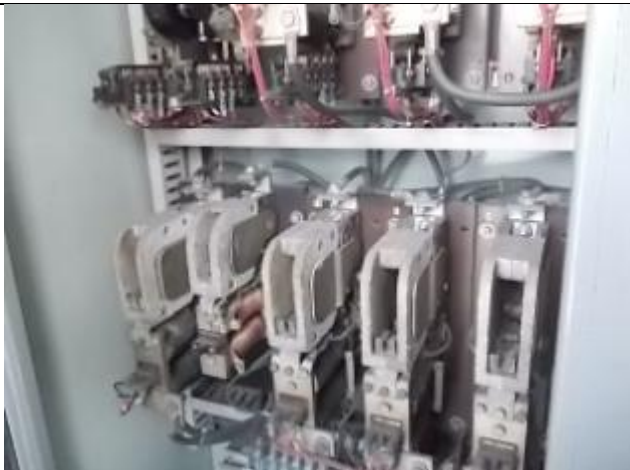
<b>Sample No. / inclusion reference:</b>	<b>15JB6500 – SP06</b>

<b>Location &amp; description of material:</b>	Crane 13 Main Intake Box Flash Guards	
<b>Material type</b>	Cement	
<b>Asbestos:</b>	Yes (Strongly Presumed)

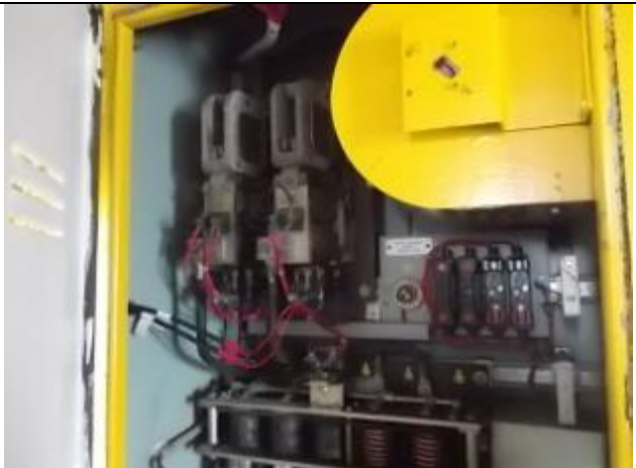
<b>Sample No. / inclusion reference:</b>	<b>15JB6500 – SP09</b>

<b>Location &amp; description of material:</b>	Crane 13 Motor Room Electrical Intake Box Flash Guards	
<b>Material type</b>	Cement	
<b>Asbestos:</b>	Yes (Strongly Presumed)

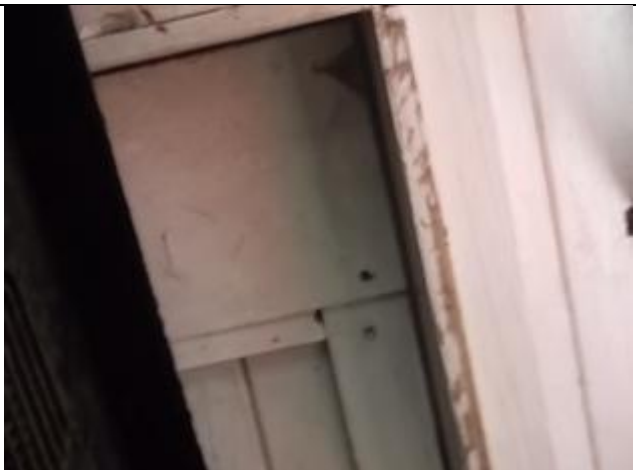
<b>Sample No. / inclusion reference:</b>	<b>15JB6500 – SP07</b>

<b>Location &amp; description of material:</b>	Crane 13 Motor Room Panel Around Hatch	
<b>Material type</b>	Cement	
<b>Asbestos:</b>	Yes (Strongly Presumed)

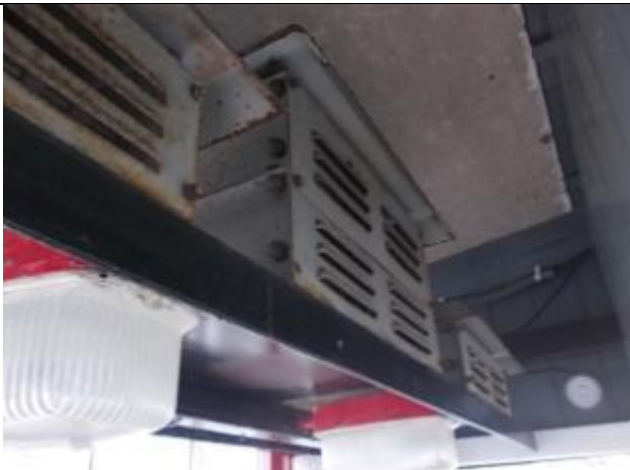
<b>Sample No. / inclusion reference:</b>	<b>15JB6500 – SP08</b>

<b>Location &amp; description of material:</b>	Crane 13 Control Room Resistance Banks Internal Lining of Sleeves	
<b>Material type</b>	Rope	
<b>Asbestos:</b>	Yes (Strongly Presumed)

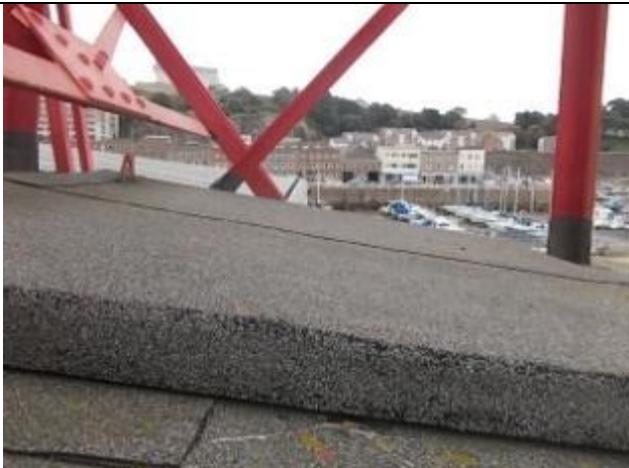
<b>Sample No. / inclusion reference:</b>	15JB6500 – P01

<b>Location &amp; description of material:</b>	Roof to Motor Room	
<b>Material type</b>	Bitumen / Felt	
<b>Asbestos:</b>	Yes (Presumed)
