**MARITIME INCIDENT
INVESTIGATION REPORT
INTO
SERIOUS INJURY TO PASSENGER
ON
RIGID HULL INFLATABLE BOAT
ISLAND VOYAGER
30 JULY 2018**

1.1 At 1020 BST on Monday 30th July 2018 the commercially operated rigid hulled inflatable boat (RHIB) **Island Voyager** departed the Albert Quay Pontoons at No 5 berth in Saint Helier harbour, Jersey bound for Sark with 14 persons on-board (2 crew and 12 passengers). After passing North of Elizabeth Castle and transiting St Aubins bay at approximately 20 Knots the vessel encountered a series of larger waves whilst passing south of Noirmont Point, due to the moderate SSW'ly winds and low swell being opposed by a strong westerly ebb tide. Despite some reduction in speed, Island Voyager slammed heavily and two passengers were injured. Following assessment of the injured in the relative shelter of Portelet Bay the voyage was aborted and the vessel returned to Saint Helier; where the injured, one of whom had sustained serious back injuries, were transferred to hospital by ambulance.

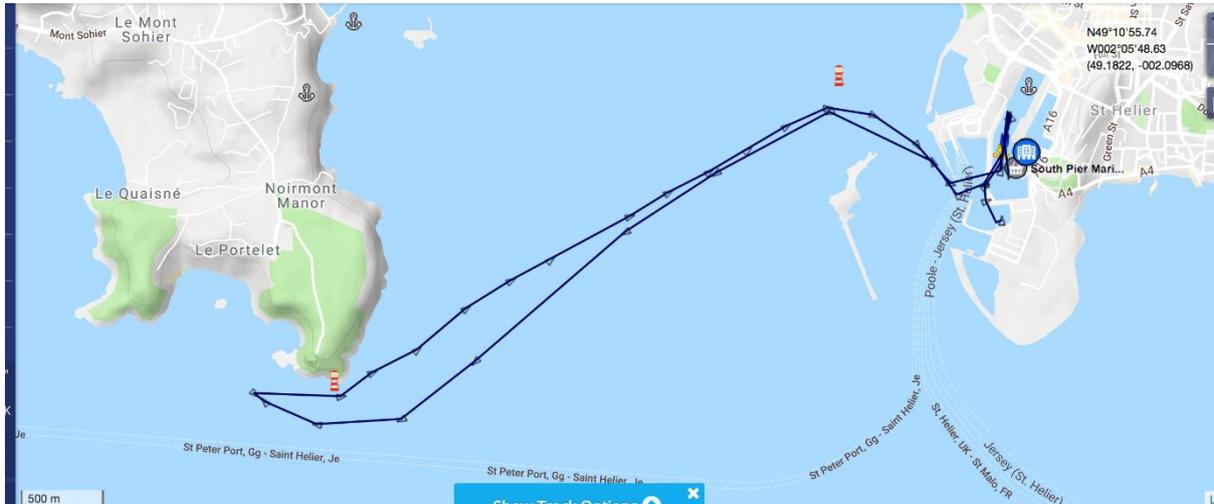
2.1.2 Wind conditions were SSW'ly 17 knots and the forecast sea conditions were approximately 1.2m. After leaving the shelter of the port, the skipper decided to take the vessel to the north of Elizabeth Castle (see Fig 1) in order to provide some protection from the elements. The vessel then transited Saint Aubin's Bay at approximately 20 Kts.

FIG 1 - Route of Island Voyager on the day concerned (Vessel GPS and AIS Information)

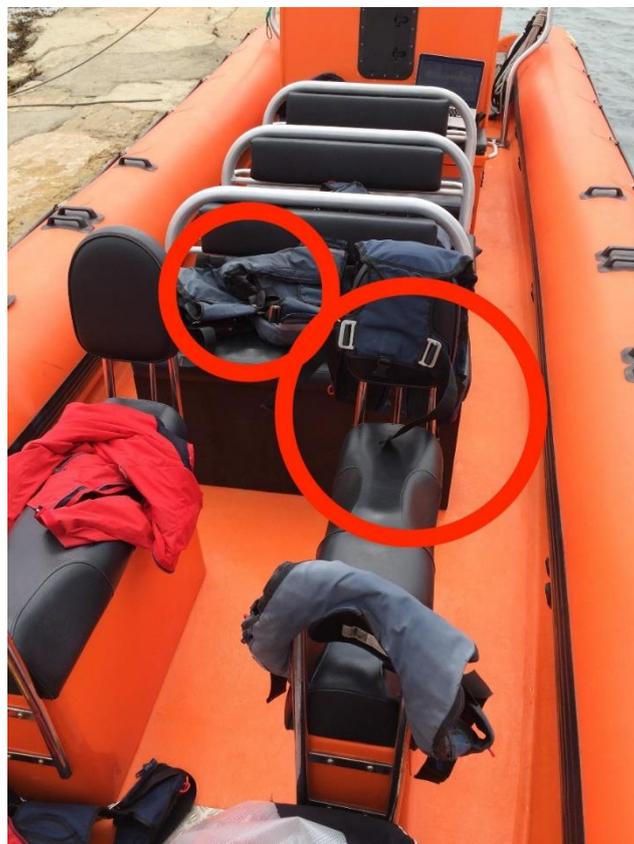
2.8.1 The impact from the largest wave caused two young female passengers seated on the starboard "Jockey" seat to fall from their seats against the starboard tube. Both were able quickly to regain position unaided. The male passenger (Passenger A) on the aft "Jockey" seat on the Port side was lifted from his seat and impacted heavily with his seat. The lady (Passenger B) on the starboard side of the foremost bench seat also impacted heavily and complained of back pain.

FIG 2 – Seating arrangement on Island Voyager; Passenger A was seated on the Port Jockey seat and Passenger B on the starboard side of the forward bench seat.

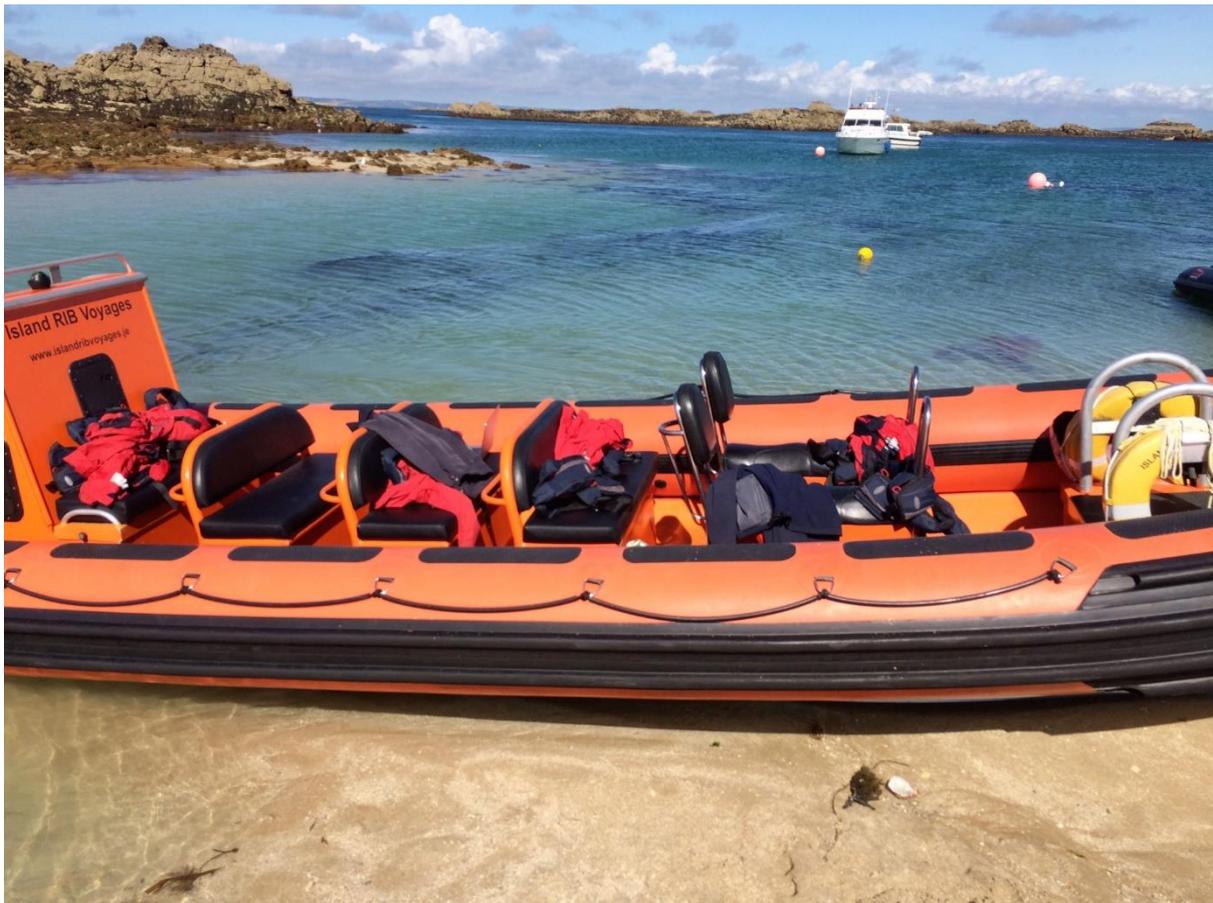
FIG 3 – Seating arrangement on Island Voyager;

2.4.1.4. Both the vessels have an identical seating layout of passenger seats consisting of two “Jockey seats” in the forward part of the vessel each capable of taking two passengers, abaft which are four rows of bench seats each capable of holding two/three passengers (See Fig 2). **Island Voyager** was originally constructed with such five bench seats but the arrangement was changed in 2016 to mirror that of the newer **Intrepid Voyager**. The boats’ original outfitters in Wales carried out the change.

2.4.1.5 It is noted that MECAL, the vessel’s certifying authority, acting for Jersey’s Registry of Shipping, was not formally advised of the change, but have indicated that it would have approved the request had it been made as such seats are generally considered to be safer than bench seating in such vessels.

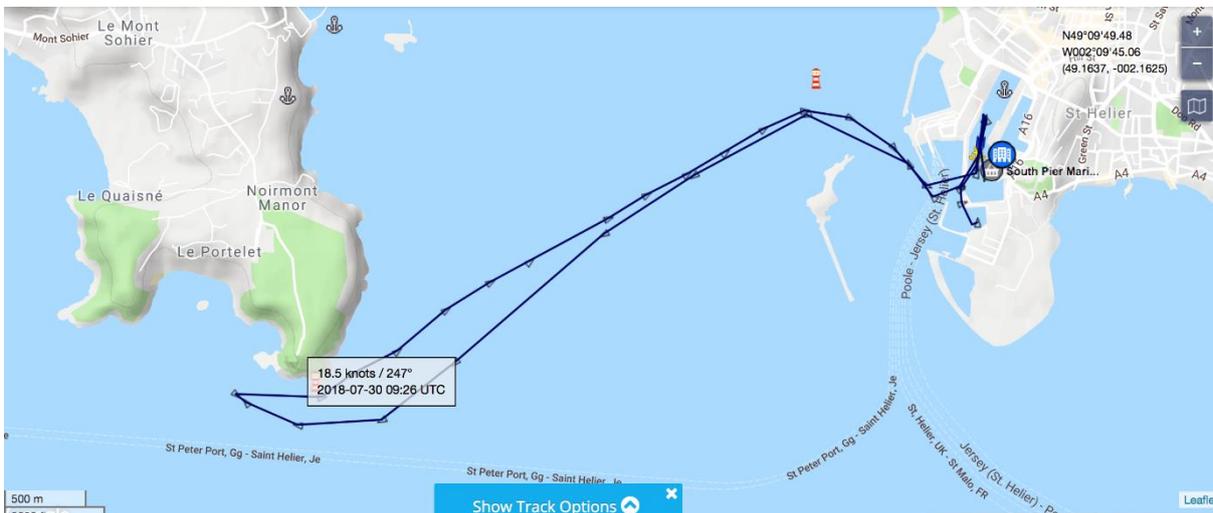
FIG 4 – Island Voyager on-board Instrumentation AIS/GPS course and Speed approaching Noirmont

4.8.8 The reduction in speed and the way in which the increasing waves were handled as Noirmont was approached were not fully effective. In particular, the guidance in the “ RYA Guidance Notes on Passenger Safety on Small High Speed Craft”, with which the skipper as an RYA Power boat instructor was familiar, states that “in approaching an area known to be hazardous in the prevailing conditions, stop and reassess your passage plan”. If followed, this guidance would have enabled the way in which the passengers were dealing with the conditions to have been assessed; and either the speed very much reduced or alternative action taken to enable the area to have been safely crossed. A decision to abort the voyage at this stage may have been necessary depending on the passenger’s reaction.

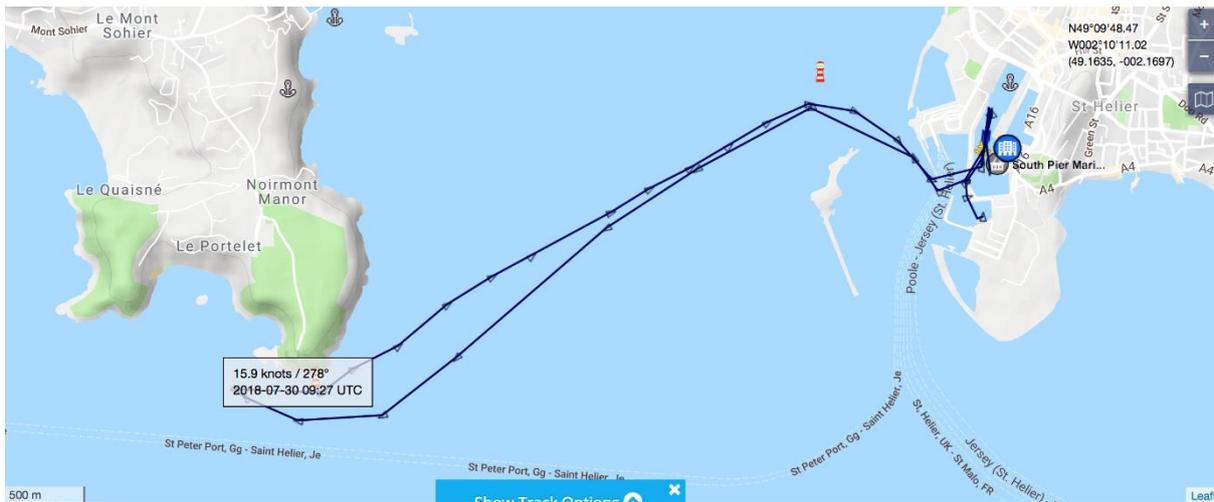
FIG 5 – Island Voyager on-board Instrumentation AIS/GPS course and speed passing Noirmont Point

4.8.9 The **Island Voyager** rounded Noirmont point at a speed of between 16 and 19 knots and encountered a pattern of approximately four waves of increasing size, which caused heavy slamming. On the last wave, two passengers were injured. Two other passengers fell from their seats against the inflatable hull. Although these passengers were able to regain their seats unaided it is considered from witness statements that there was, for a brief period, a potential risk of these passengers falling overboard.

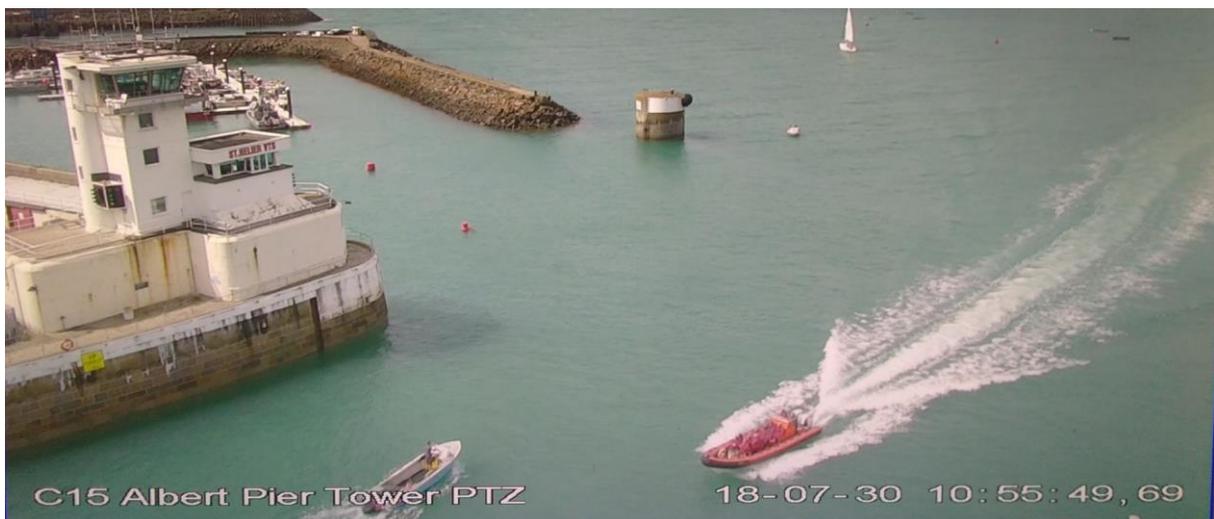
2.9.4 The skipper of **Island Voyager** failed either to reduce speed on entering the port's 5 knots limit, or to request permission from VTS to maintain speed; consequently, he went through the pier heads at 10.7 knots passing an outbound small fishing vessel whilst doing so. The increased wash caused the **Island Voyager** to roll whilst subsequently berthing on Albert Pontoon (No 5 Berth) when she arrived at 1056.

FIG 7 – ISLAND VOYAGER ENTERING PIERHEADS AT SPEED AND PASSING OUTBOUND FISHING VESSEL

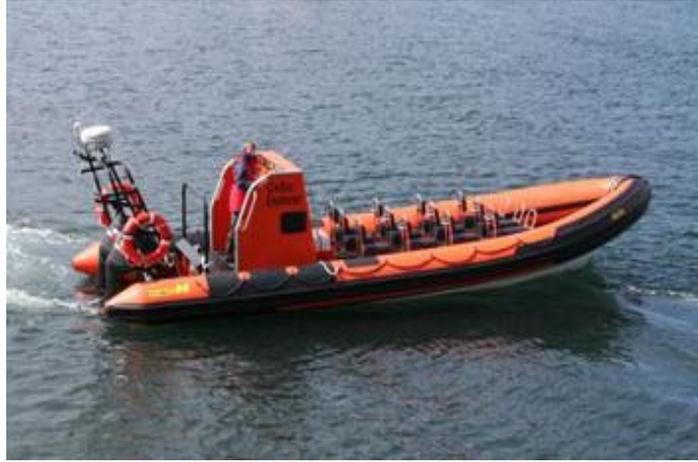
FIG 8 - AN ALTERNATIVE SEATING ARRANGEMENT OF THE SAME CLASS OF VESSEL WITH INDIVIDUAL JUMP SEATS

4.4.4. For RIBs that may operate in rougher sea conditions, individual seating is generally considered preferable and “Jockey seats” can, in some cases, be considered an improvement on bench seats.
