**MARITIME INCIDENT
INVESTIGATION REPORT INTO
INJURY TO CREW MEMBER ON
PRIVATE SAILING CATAMARAN
“SKYLARKS”**

13TH MAY 2021

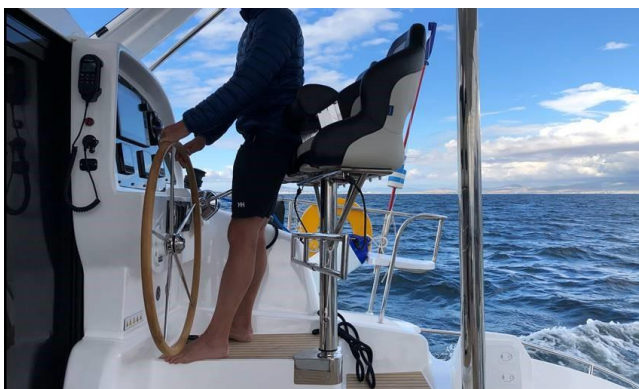
(Fig 1- Helm seat as originally fitted)

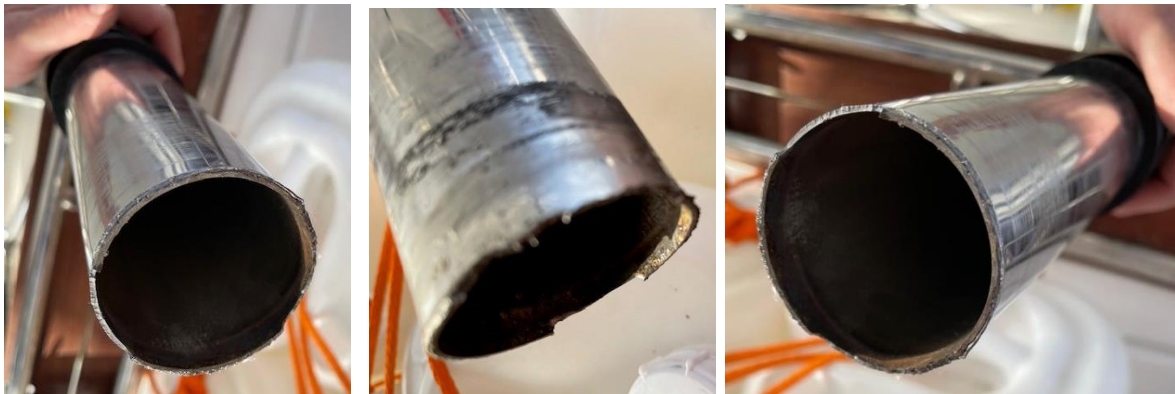
(Fig 4, 5, & 6: bottom of seat support pillar following failure)

4.2 The seat -mounting was constructed with a stainless-steel base and a stainless-steel tube pillar. A second stainless-steel tube, with a stainless-steel plate at the top onto which the actual seats are mounted, fitted over the first to enable the seat to rotate. A locking pin, when inserted, stopped the seat from rotating. (Fig 1) The failure involved a complete fracture of the weld between the seat mounting pillar and the base plate (see Figs 2 to 6)

4.3 The builders were notified of the accident, by the owners, and tried to ascertain the cause of the failure. From the photos received they were unfortunately not able to determine why the welding at the base of the seat pillar broke. Their consultant engineer reported that the failure could have been caused by a number of factors, but that no definite cause could be identified.

5.3 From the photos available, the builders were unfortunately not able to determine precisely why the failure occurred. A consultant engineer concluded that the failure could have been caused by a number of factors, but no definite cause could be identified.

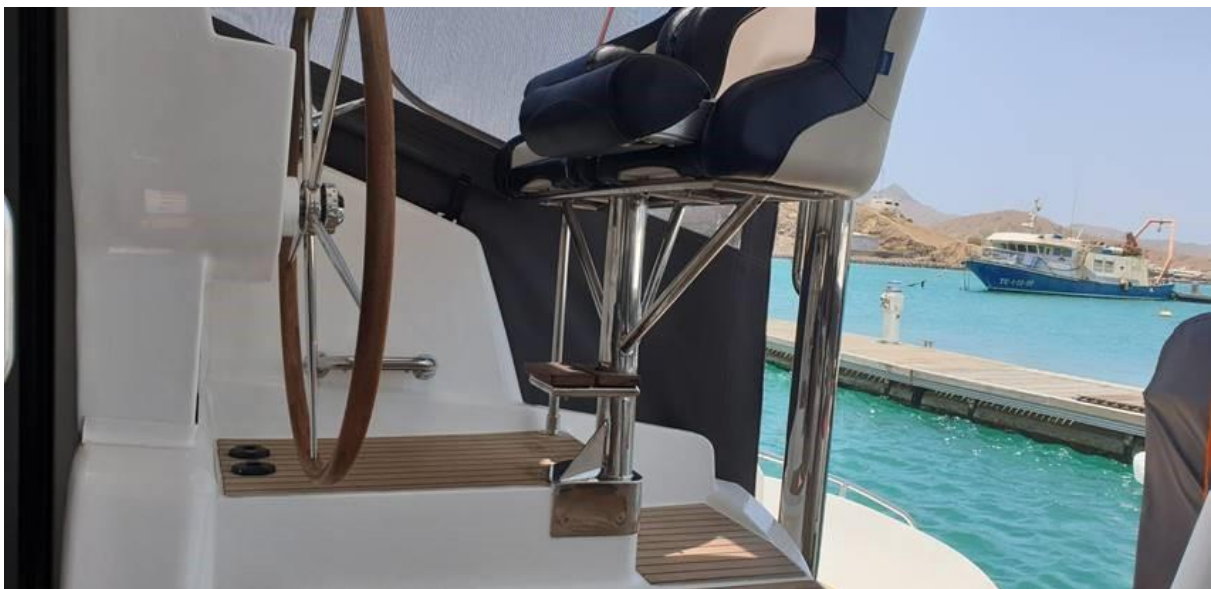
Fig 7 Helm seat as modified (from Port side)

4.15 The subsequent modifications to the Helm seat, along the lines proposed by the skipper, were carried out in Cape Verde. They increased support but at the expense of the ability of the seat to rotate

5.5 The seat was been repaired by the owners in Cape Verde; gussets being added to the base of the original pillar together with an additional support pillar to starboard. This modification however prevents the seat from being able to rotate as was possible in the original design (see Figs 1, 7 & 8)
