## Safety Bulletin 05 of 2019

### Near miss gangway fall

<b>THE BRISTOL PORT COMPANY</b>	<h2>SAFETY ALERT</h2>	SY059 S&T Ref: Gangway Fall Date: 20/11/19
<b>Leadership</b>	<b>Ownership</b>	<b>Learning</b>

### NEAR MISS: Gangway Fall

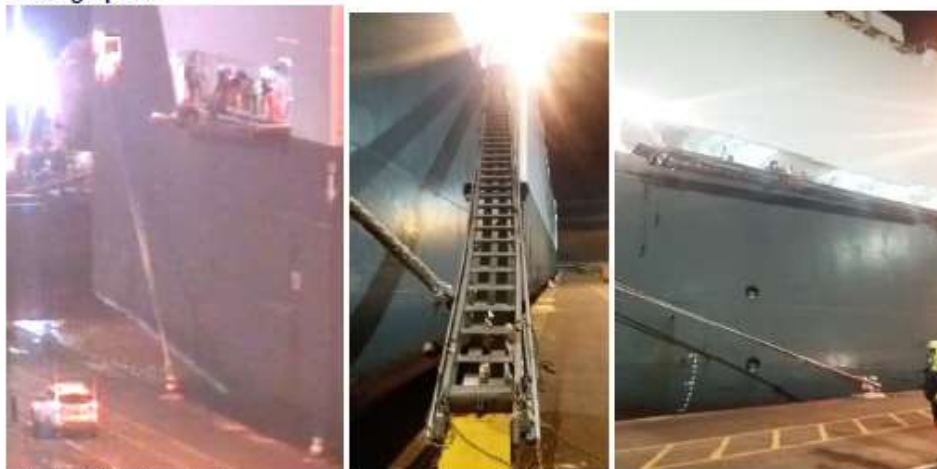
With the vessels stern ramp raised the Pilot was boarded via a gangway. When the ships crew recovered the gangway during its final stow it fell outboard and down from one end (falling approx. 16-18 metres) onto the quayside, narrowly missing a parked line handlers' vehicle.

1. A wire parted during the lift of the gangway.
2. Line handler was parked in an operational area.
3. The gangway was not stowed when the line handler arrived putting him in close proximity to a lifting operation.

\*Not vehicle involved

1. Introduce an exclusion zone for line handlers until it is safe to undertake mooring operations. This will be confirmed between Pilot and Master during the Master Pilot Exchange (MPX).
2. Vehicles to be kept clear of operational areas unless required for the task.
3. This alert should be cascaded, immediately, to the relevant parties.
