MARITIME INCIDENT INVESTIGATION REPORT:

**Stranding, temporary
abandonment, and subsequent
re-floating of Fishing Vessel**

L'ECUME II (J158)

14TH MAY 2020

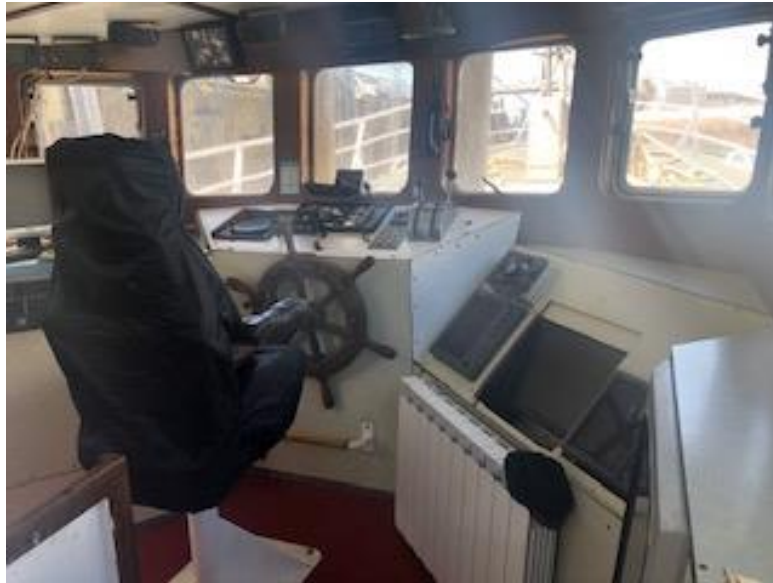
FIG 10 – L'Ecume II wheelhouse looking forward

2.2.7 Seating himself in the bridge chair the Deck Hand then watched “a few YouTube videos”, he last recalled being that there were 28 minutes to run. His next recollection was waking up on the wheelhouse deck adjacent to the heater (see figure 10) after the vessel had run aground. The bridge windows were closed, and it is likely that the bridge heater was on.

2.3.1 The Deck Hand awoke on the wheelhouse deck adjacent to the heater (Fig10) to find the vessel aground, he went to the throttles and placed the engine astern. The Skipper, awoken by the slowing engine RPM, immediately proceeded to the wheelhouse. He took over the con from the deck hand and unsuccessfully attempted to manoeuvre the vessel back into deep water. The skipper then contacted St Helier VTS on VHF Channel 14 to advise them of the incident. As there is a difference of several minutes between times reported by **L'ECUME II** and the MOC the MOC times from the time of grounding are being used throughout for clarity).

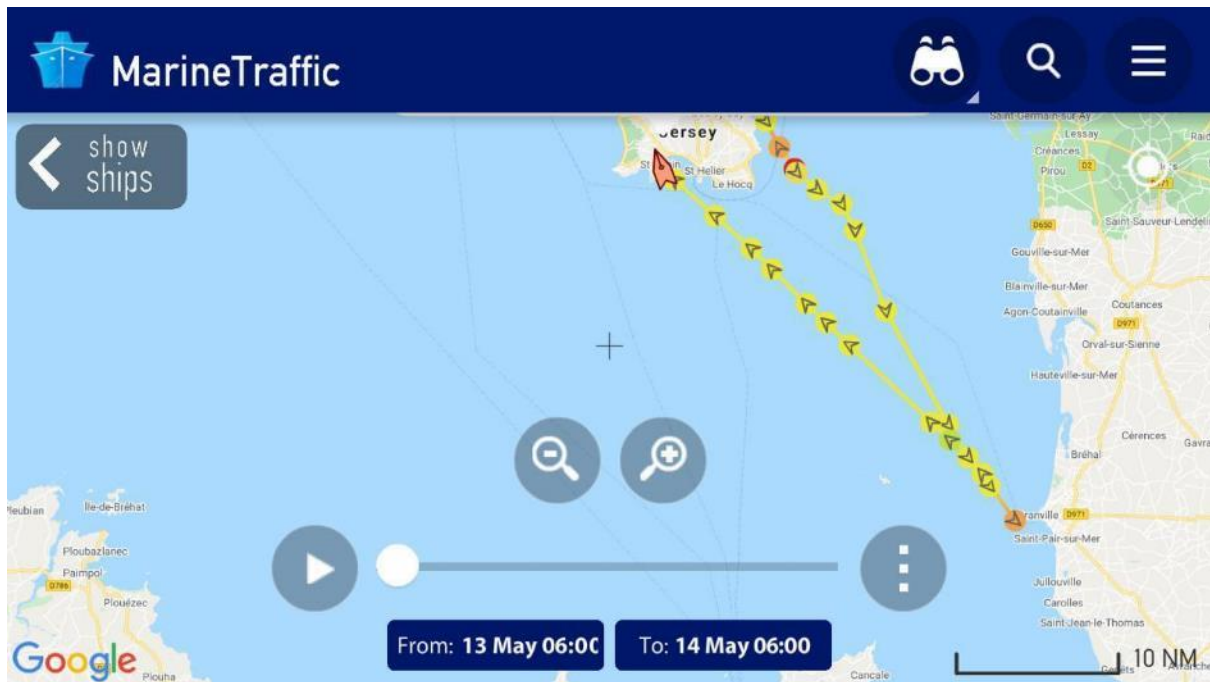
FIG 15 – L'Ecume II AIS Track (download from Marine Traffic)

2.2.8 With the Deck Hand asleep **L’ECUME II** remained on autopilot at a speed of approximately eight knots and entered the VTS TOS Area. (Figures 15 &16)

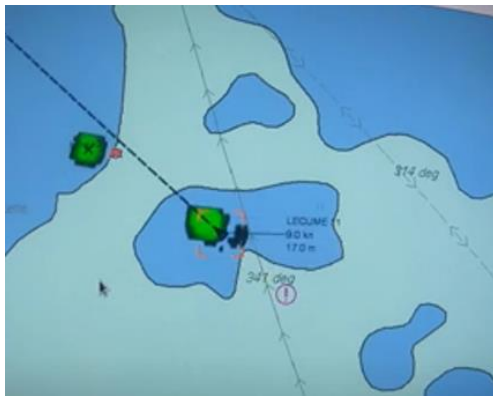
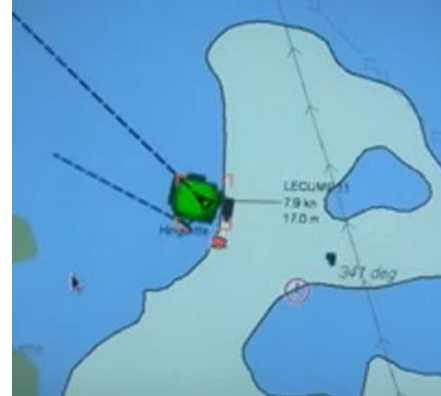
FIG 18 & 19 L'ECUME II leaves Hinguette Buoy to port

2.2.10 **L'ECUME II** passed Demie de Pas light (Fig 17) with a track in safe water between the South East Passage and the South Passage approaches, at which point she would have normally contacted St Helier VTS on VHF Ch 14, she left the Hinguette light buoy (Port Lateral mark with Quick flashing Red light) to port (Figs 18 & 19), before crossing both the Small Roads leading marks to Saint Helier (Fig 20) and the Western Passage leading marks for vessels transiting to or from the west (Fig 21).
