REPORT ON THE COLLISION OF CABIN CRUISER **P6T2 WITH RUAUDIERE LATERAL BUOY AND SUBSEQUENT SINKING OF THE VESSEL**

17th November 2017

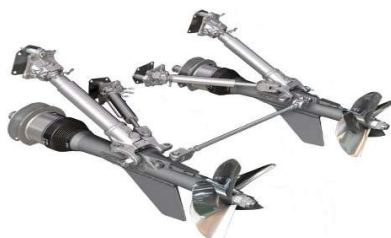
- 2.14 The manoeuvring characteristics of this vessel are somewhat different to a standard propeller driven planning craft. The vessel is fitted with a ZF surface drive system as illustrated in the image below. To get the vessel on the plane the drives are set half way down and the throttles advanced. In normal sea conditions the speed increases steadily and the bow does rise slightly, until 24-28 knots at which time the vessel is fully planning.
