# Application to remove

## Crane 13

New North Quay, St.Helier, Jersey

# JERSEY CRANE REFURBISHMENT CRANE 13 - NEW NORTH QUAY

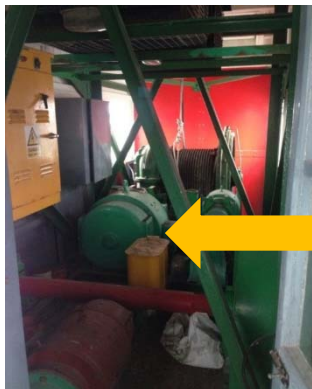
Machinery and 400volt switching attached to the driver's controls pedestal do not meet current regulations.

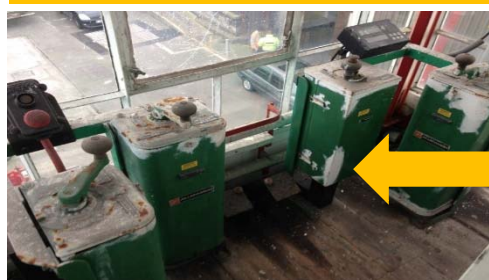
The crane controls are as would be expected of a crane this age but are extremely dated and do not meet current regulations

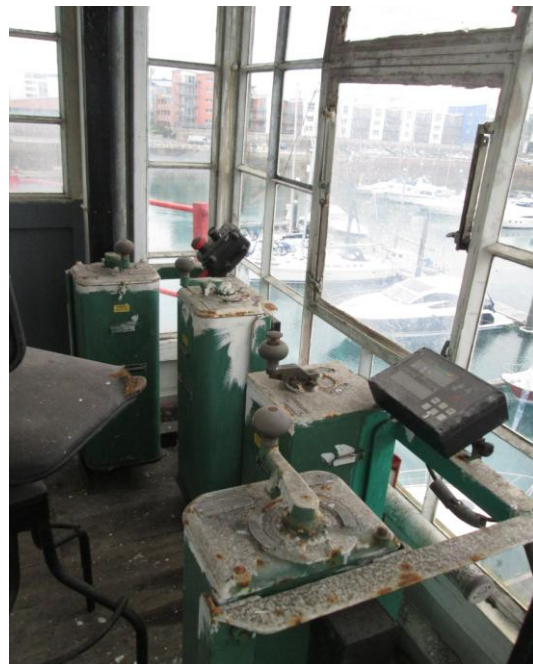
Operators controls
