PORTS OF JERSEY

MV TRINITY

INCIDENT REVIEW AND RISK MITIGATION ASSESSMENT

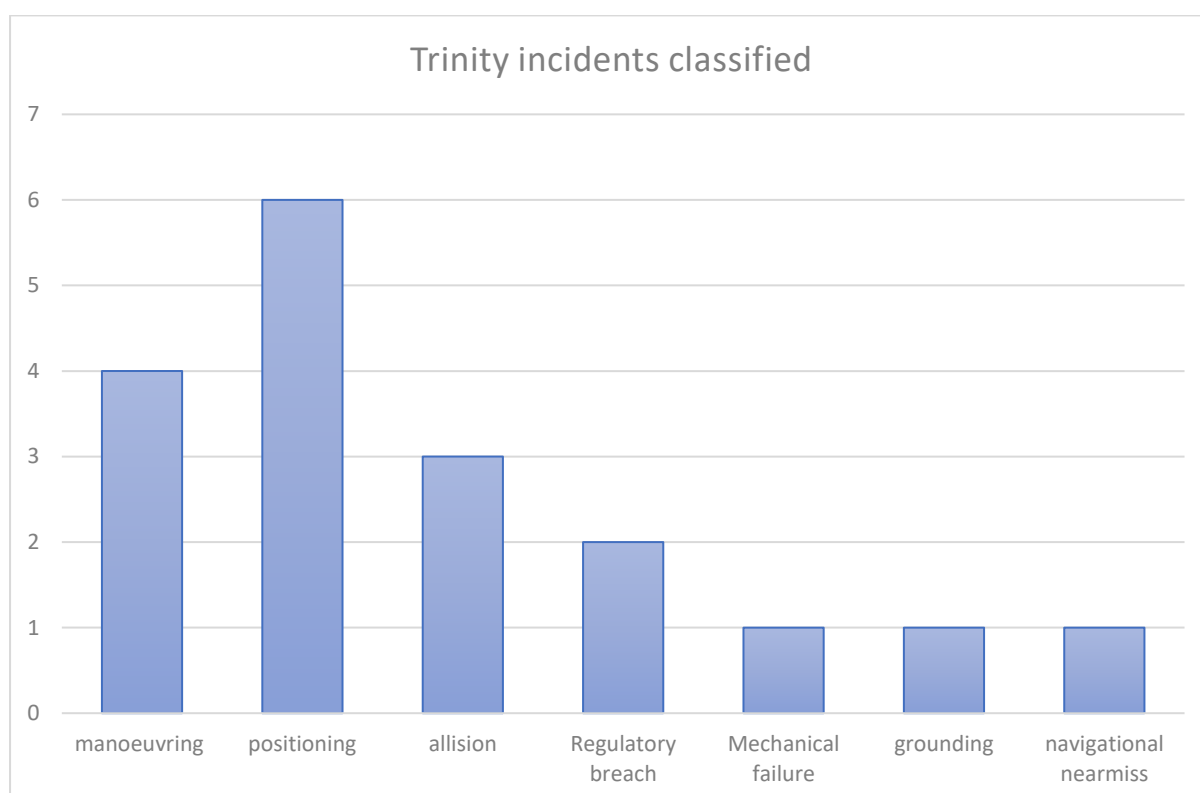
Figure 1 Incidents classified by causation or outcome

Figure 1 shows how the incidents have been broadly classified, these classifications cover causation and outcome.

The risk causation must also be considered. The potential cause of each incident outlined in the Q Pulse risk shown in **Figure 6** have been ranked on likelihood, using the scale used by the Ports of Jersey 5x5 risk assessments shown in **Figure 7**. The number of incidents related to causation factor have also been shown, some incidents have more than one causation factor, causation factors for each incident are shown in **Figure 1**.

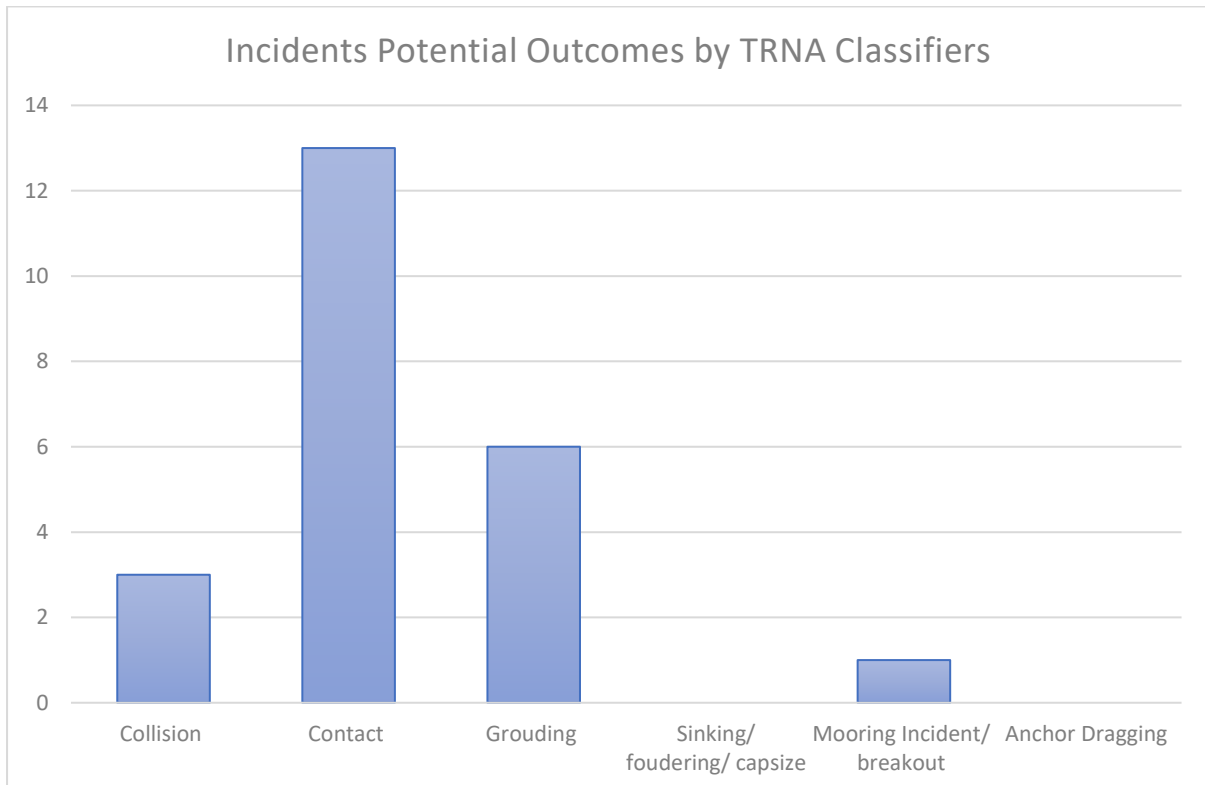
Figure 2 Incidents classified by potential risk outcomes considering the TRNA hazard categories

To understand the potential impact of each incident, the hazard categories identified within the Ports of Jersey Tactical Navigational Risk Assessment (TNRA) (**Table 2**) should be considered. In some cases, the possible outcome that may have occurred if corrective/preventative action was not taken or was not effective should be considered. These ‘forecasted’ results are shown in **Figure 2**.

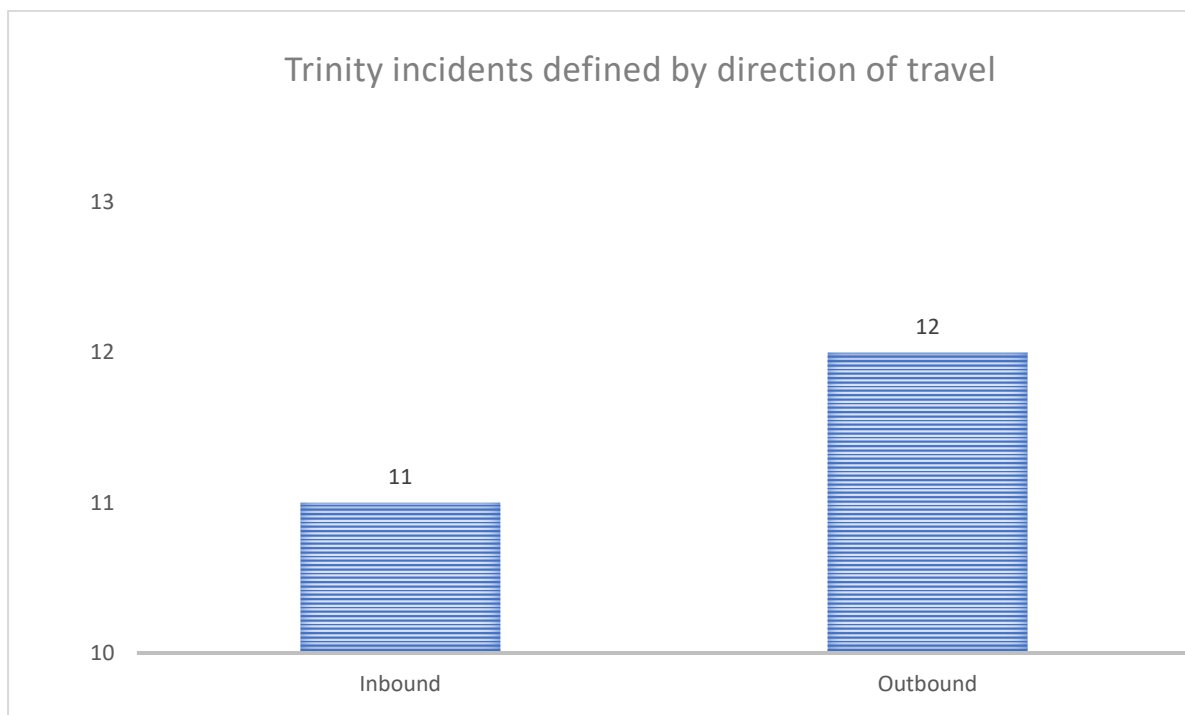
Figure 3 Trinity incidents defined by direction of travel

To assess if the vessel's direction of travel (inbound or outbound) is a contributing factor for each incident, the statistics have been plotted in **Figure 3**. The difference is insignificant as the results are almost equal.

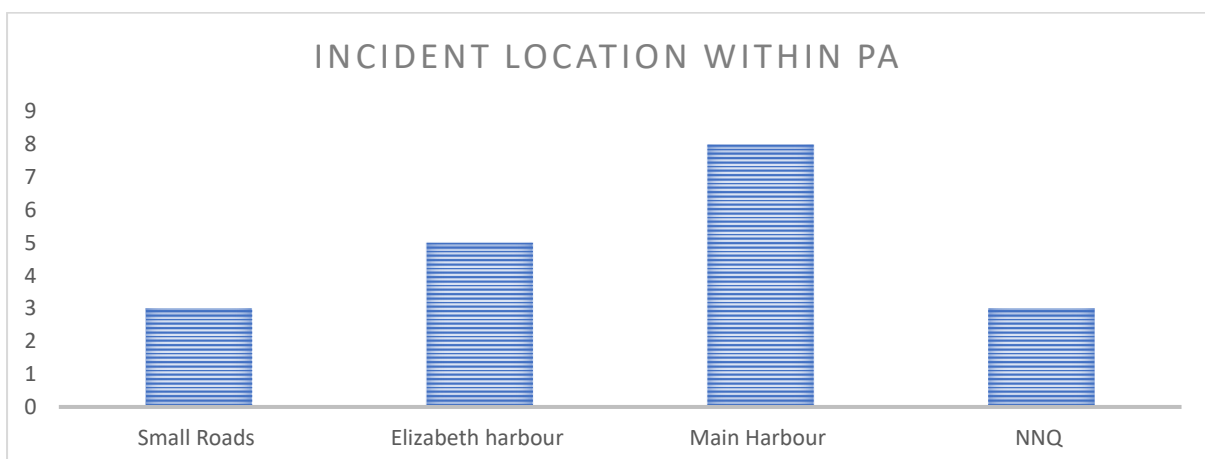
Figure 5 Location detail for incidents that occurred within the precautionary area

Further detail of where the 19 incidents that occurred within the precautionary area is shown in **Figure 5**.

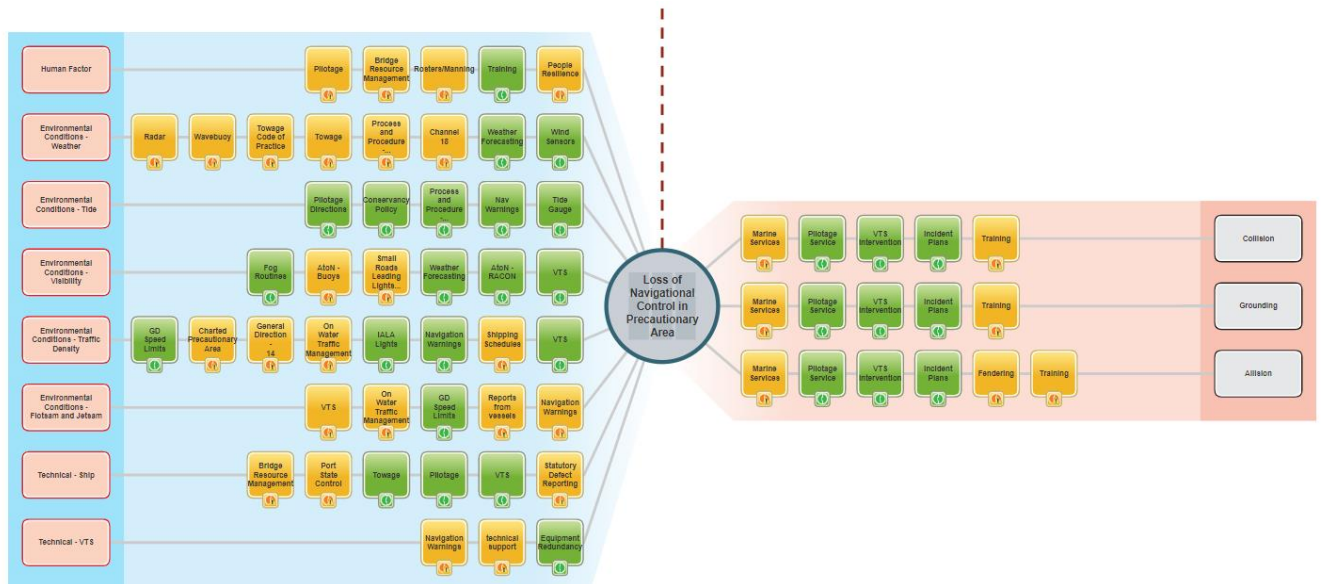
Figure 6 Q Pulse Risk Bowtie, for 'Loss of Navigational control within the Precautionary area'

When considering the evidence in **Figure 4**, it is clear the biggest risk is within the precautionary area. Therefore, the most relevant risk assessment is the ‘loss of navigational control within the precautionary area’. This assessment provides a broad overview of the potential causes for a contact or grounding and comprehensive list of mitigations that are in place to prevent these outcomes. **Figure 6** shows an overview of the bowtie.
