Condor Liberation Safety, Suitability and Performance

Independent Report

Prepared for States of Guernsey and Jersey

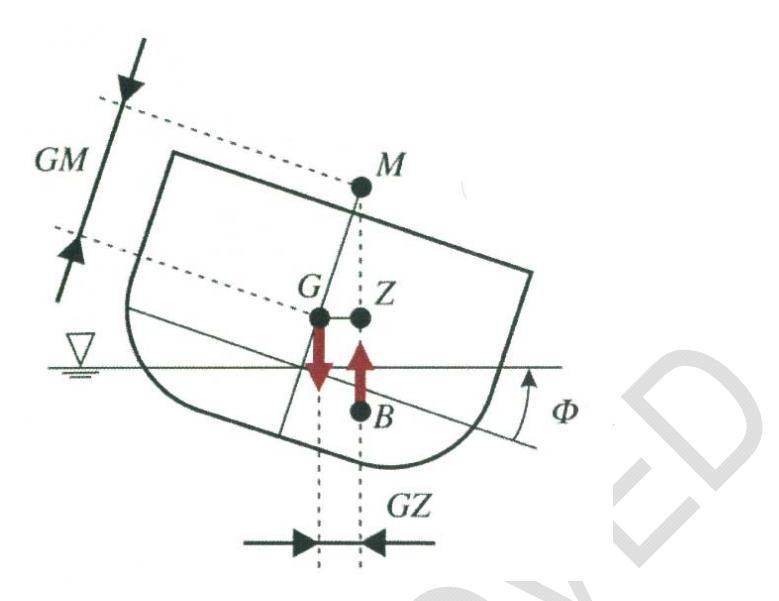
Figure 1 Diagram of stability principles

Figure 1 gives a graphical illustration of the principles of stability. It can be seen that as the centre of gravity rises the distance GZ will decrease as will GM, this will make the vessel less stable. If the centre of gravity is above the metacentre the vessel will be unstable.

As can be seen illustrated in Figure 1, GZ is the horizontal distance between the centre of buoyancy, the point through which the buoyancy force acts vertically upwards, and the centre of gravity, the point through which the weight of the vessel acts vertically downwards. GZ is the righting lever and a measure of the stability of the vessel. Figure 2 illustrates how GZ varies as various vessels are heeled (i.e. takes up an angle of inclination from the vertical). There are rules that govern the required area under the curve and the location of the peak. There are three key parts to the GZ curve.

- 1. The slope at the origin, this tells us how stable the upright vessel will be, the steeper the angle the more stable the vessel is.
- 2. The height of the peak of the GZ curve, this indicates the ability of the vessel to resist heeling forces, noting than many heeling forces will reduce as the vessel rolls.
- 3. The angle at which GZ becomes zero, this is called the angle of vanishing stability, it can be considered as the point of no return.

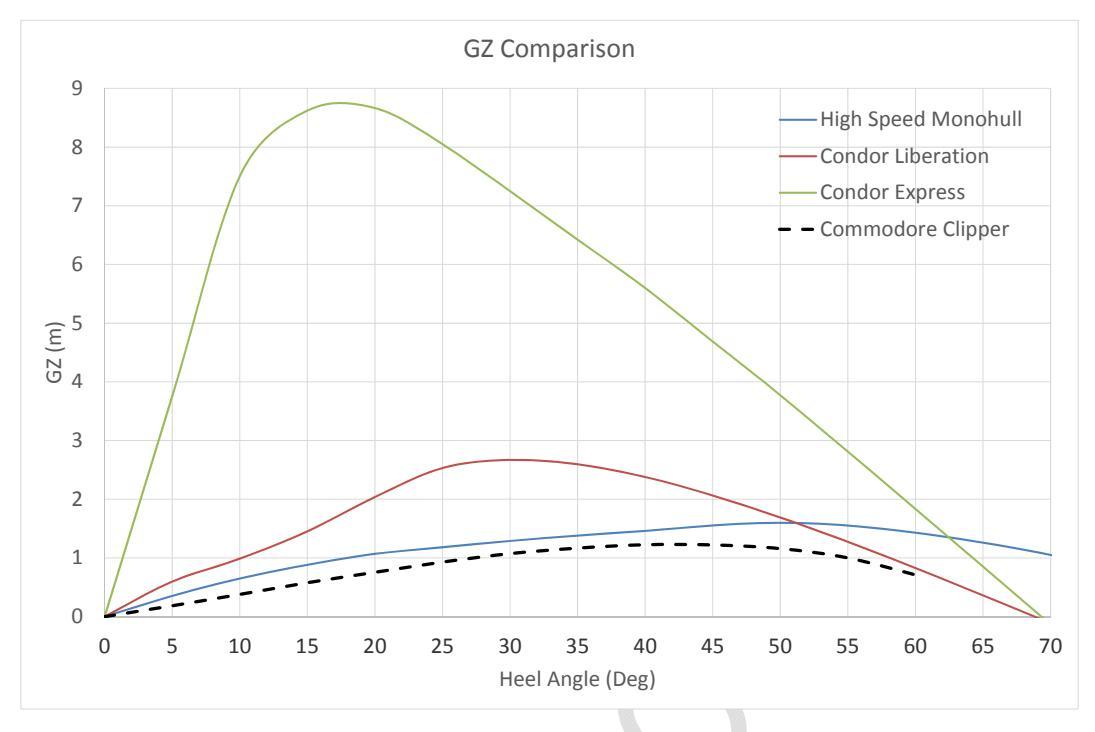
Figure 2 GZ Comparison

The different GZ curves shown in Figure 2 are for a typical high speed monohull, the Condor Express (high speed catamaran), and the Condor Liberation (Trimaran). By comparison the stability curve for the Commodore Clipper, at its maximum passenger carrying draft of 5.6m, is also illustrated. The Commodore Clipper's GZ curve is consistently lower than all the other vessels.

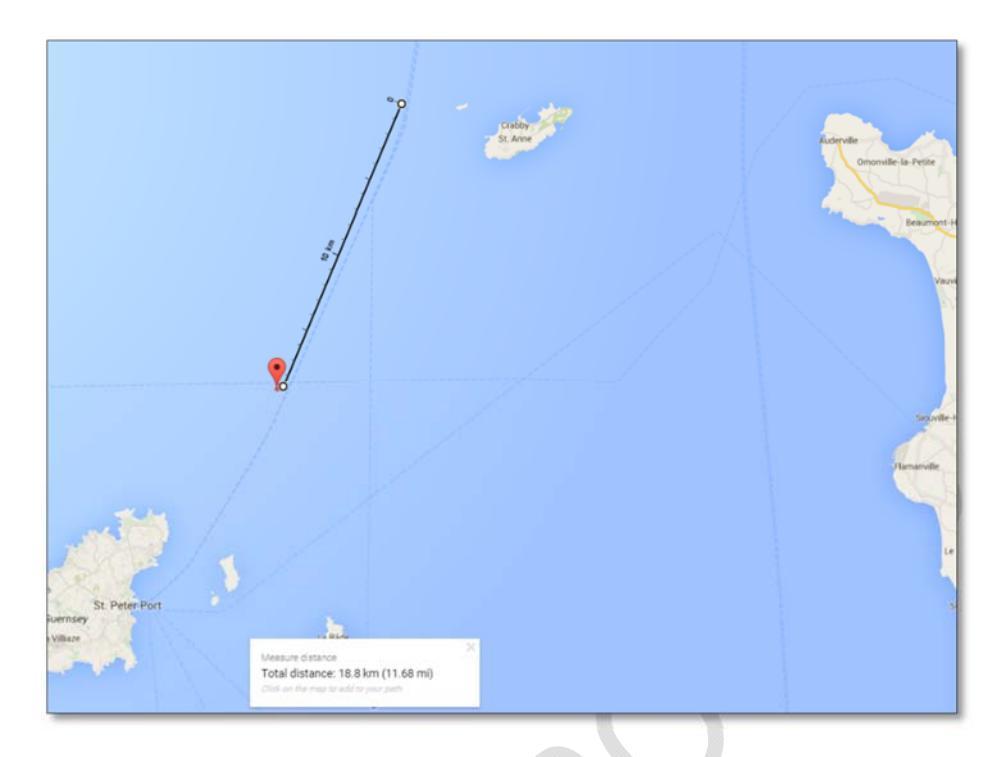
Figure 4 Track for vessel rolling on the 24 Aug 2015

- 1. The roll motions observed during the crossing on the 24th of August occurred when the vessel was operating in short steep waves generated by wind against tide conditions that were directly on the beam.

- 2. There is no discernible or common build up to the vessel rolling to a large angle (>11.5°). In this regard the event appears sudden and unexpected to the passengers on board. This causes increased disquiet amongst the passengers on board.

- 3. After the vessel has reached the maximum roll angle, she rolls back to near vertical and does not tend to overshoot or continue to roll harmonically after the initial roll. The roll is asymmetric and has only been observed to have occurred away from the direction of the weather and is an isolated event.

- 4. The vessel maintained her speed as she rolled, dropping about 2 knots. She then accelerates back to her average transit speed.
- 5. The vessel has large reserves of stability. While the motions of the vessel may appear disconcerting to passengers they do not present a risk to the stability of the Condor Liberation.

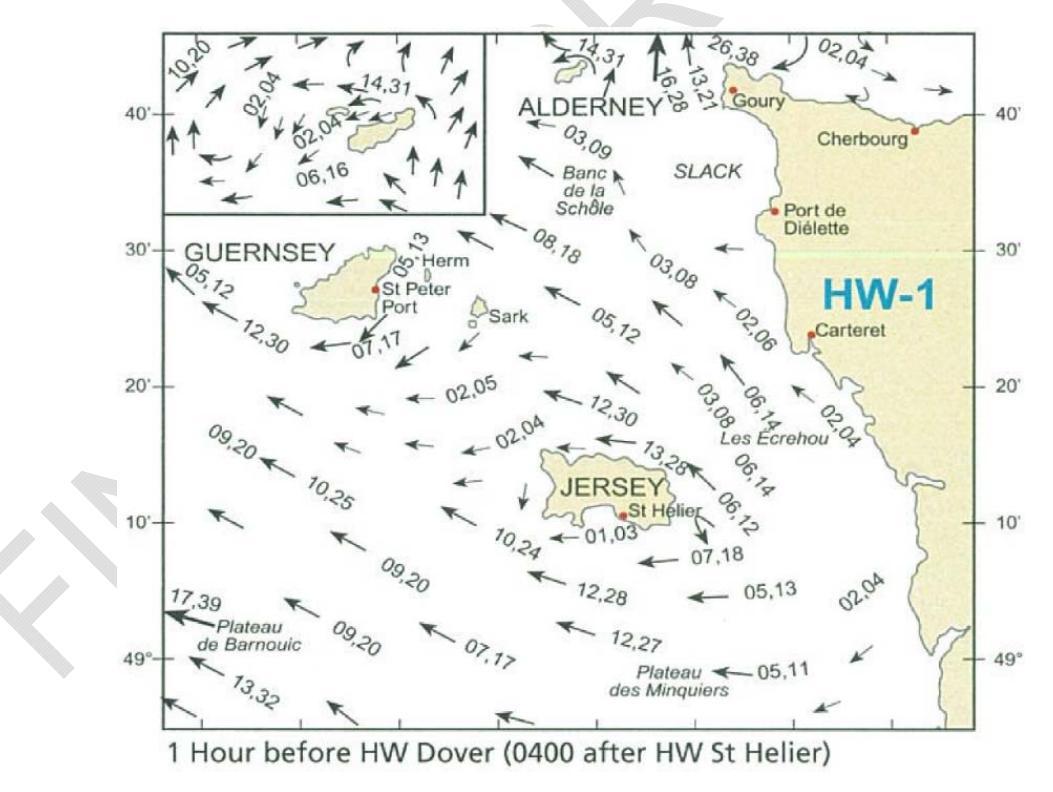
Figure 5 Tidal Chart

High water in Dover was at 1800 GMT on the 24th August 2015, with neap tides, the tidal chart for 1 hour before high water is shown in Figure 5. The wind during this period was around 30 knots from the west. These conditions caused the sea state to increase rapidly to a significant wave height of approximately 3m, with short breaking waves directly on the beam.

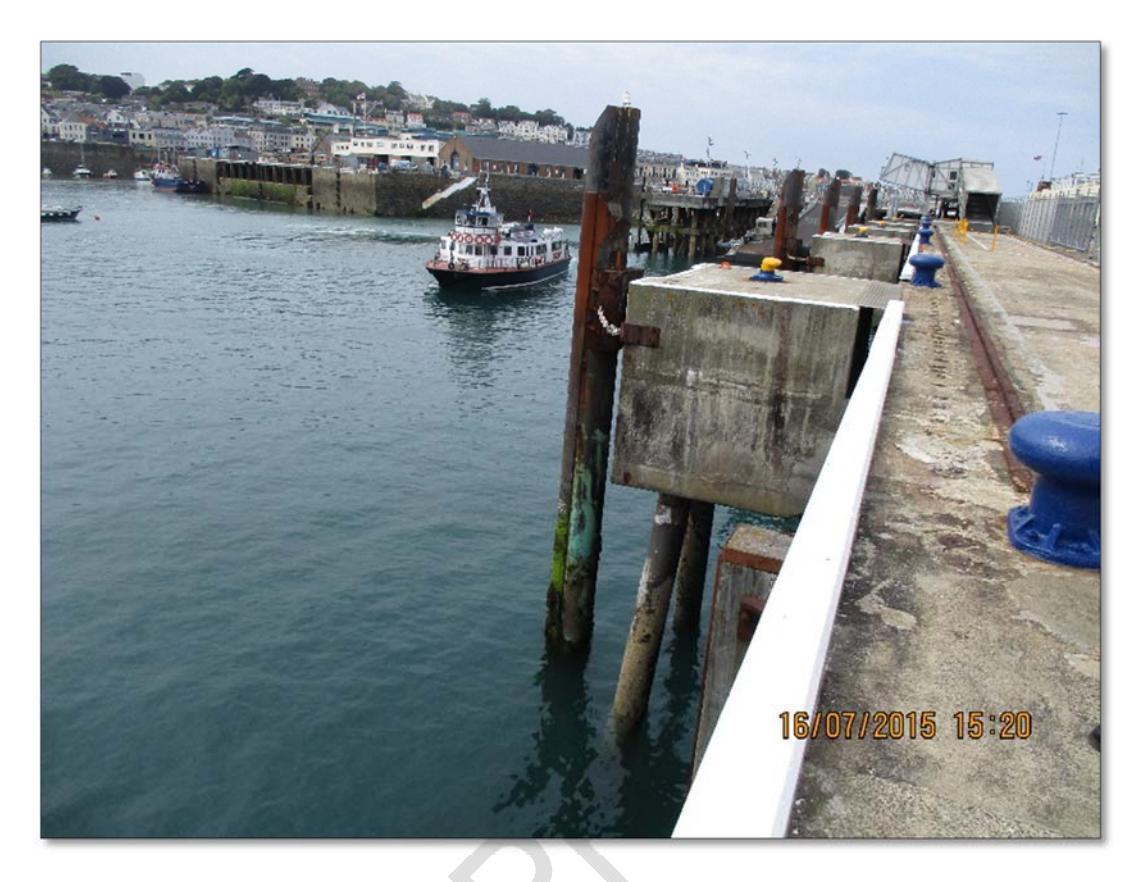
Figure 6 Typical Dolphin at St Peter's Port that the Condor Liberation landed against hard

On Saturday 28th March 2015, Condor Liberation suffered minor damage to the port amah, having landed quite heavily against a cylindrical single steel vertical cylindrical piling whilst berthing at No. 1 berth in St Peter Port, Guernsey [Ref 5] and [Ref 6].

The point load nature of the impact caused damage to the protective belting on the ship between frames 32 and 36 (which is designed to protect the hull of the ship in case of impact), but also caused deformation to some internal frames and minor hull penetration into a void space. The damage was above the water line.

The damaged area has been repaired to the satisfaction of the DNVGL surveyor.

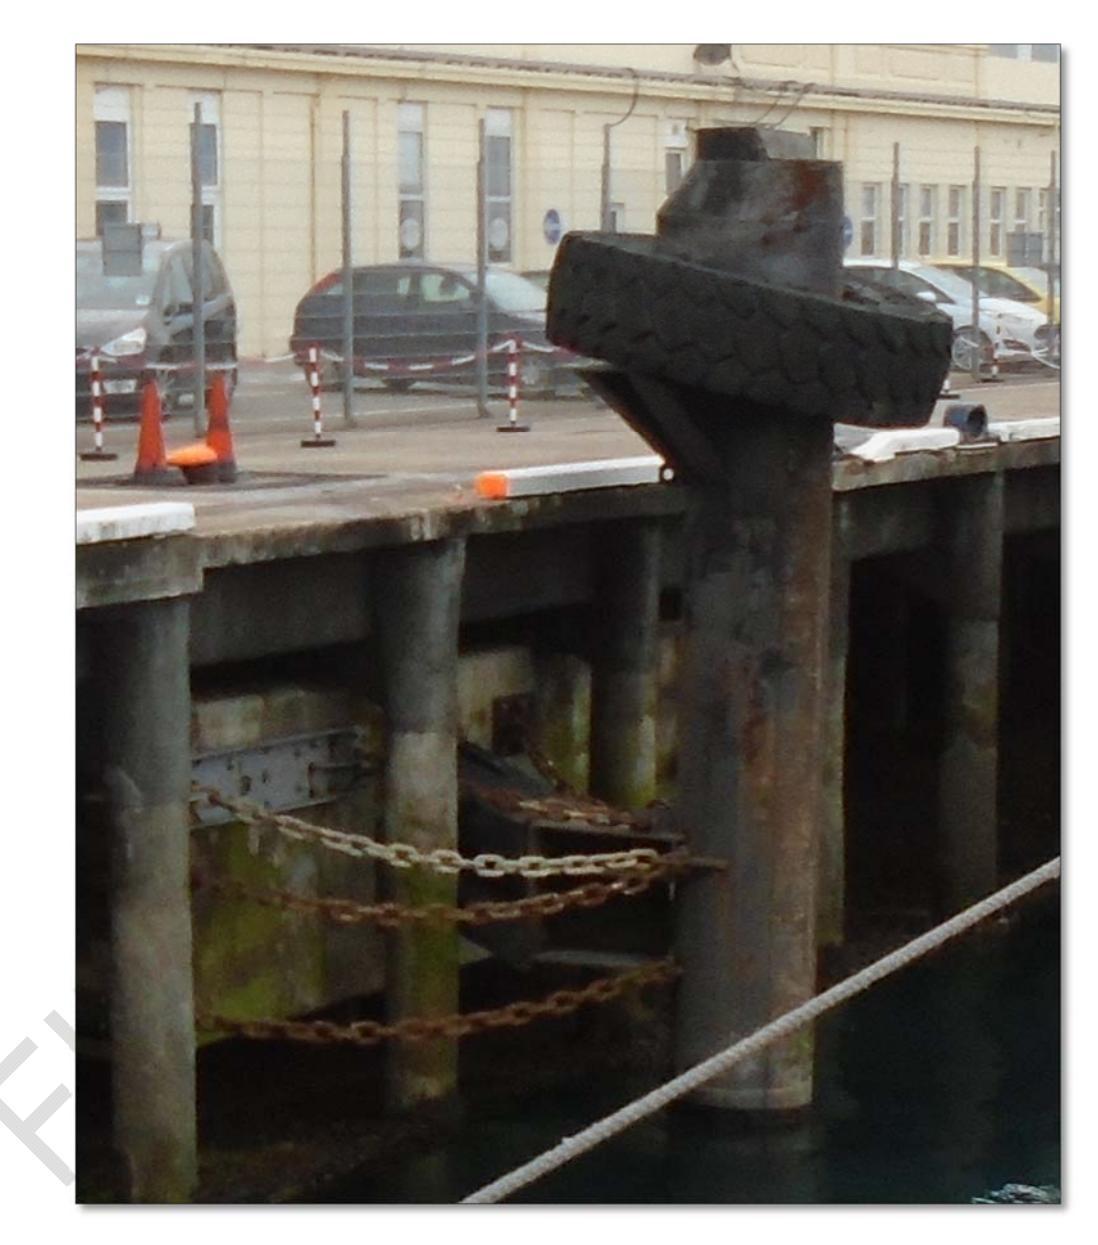
Figure 7 Mooring dockside fenders Guernsey No 2 Berth

The dockside fenders consist of steel cylindrical piles mounted on large rubber mounts. Although these resiliently mounted piles are capable of absorbing the berthing energy imposed by larger vessels than the Condor Liberation, the rubber mounts are therefore likely to be too stiff for a light high speed craft such as the Condor Liberation.

Due consideration should be given to appropriate vessel modification and also to any infrastructure changes that would increase the contact area to and reduce the relative stiffness of the shore side fendering in the interface between the vessel and the dock wall.

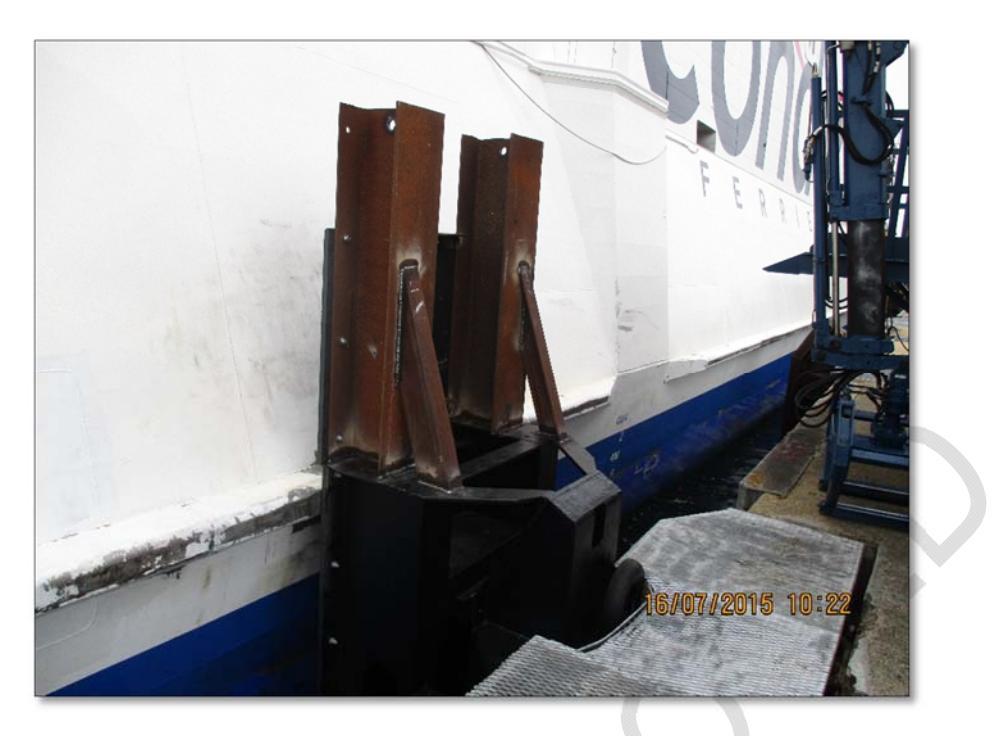
Figure 9 Typical fender in Poole

The dockside fenders in Figure 9 consist of 1200mm wide fender panels flexibly mounted on rubber mounts attached to the Quay. The fendering at this berth in Poole is tailored for high speed craft, and recent modifications are evident to extend the fendering for the Condor Liberation.

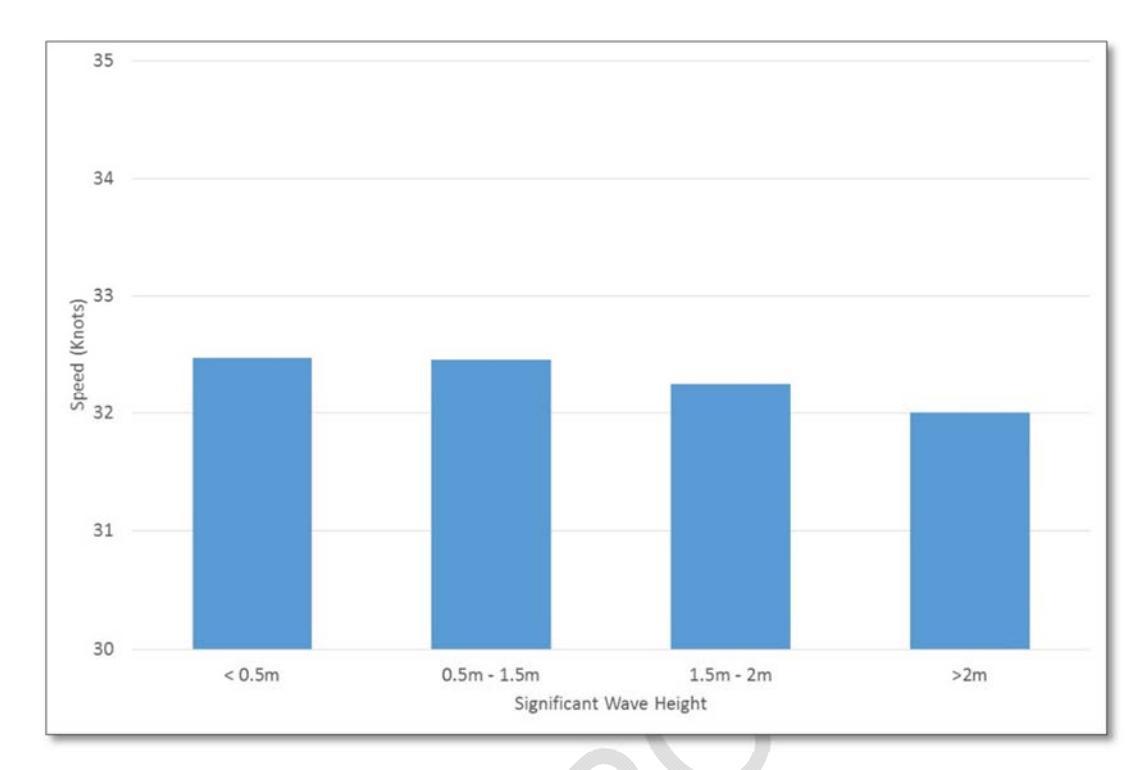
Figure 10 Variation of Transit Speed with Wave Height

Figure 10 illustrates the impact of sea state on the passage making ability of the vessel. The vessels average speed is reduced by approximately less than 1.0 knot across the range of sea states assessed. Based on discussions with the master following a rough weather crossing they felt no need to reduce speed in higher sea states. The vessel does not slam and it is noted that flow over the T foils enables the ride control system to generate a larger maximum force and this gives the potential for more effectively damping of the vessel motions.

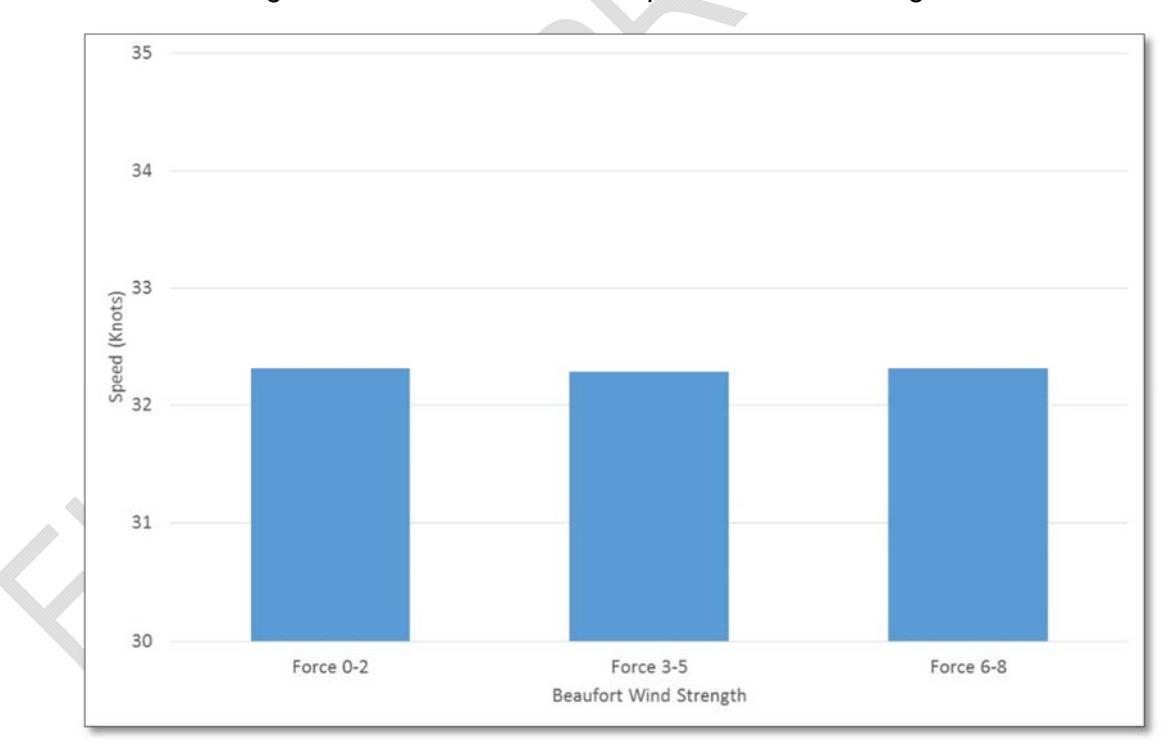
Figure 11 Variation of Transit Speed with wind strength

Figure 11 shows that there is virtually no influence of wind strength on speed.

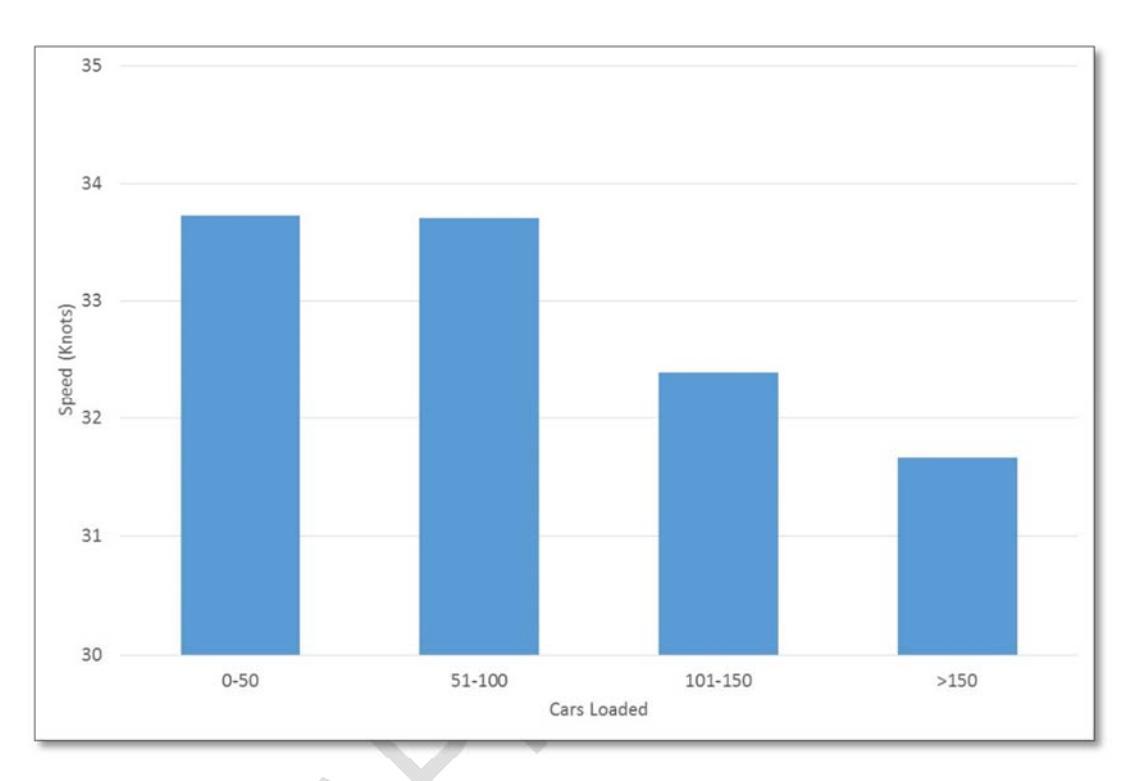
Figure 12 Variation of Transit Speed with cars loaded

Figure 12 illustrates the influence of the number of cars loaded on the transit speed. The average transit speed for the Condor Liberation is 33.7 knots with up to 100 cars loaded. This reduces to 31.7 knots when over 150 cars are loaded. Given the vessel transits for 202nm on a complete round trip, this speed reduction equates to ~23 minutes during the day.
