SAFETY BULLETIN 02 OF 2021:

Lessons from a fire at sea

This Safety Bulletin is issued following a fire aboard 'Just Mine' a 23-metre-long, Jersey registered, pleasure vessel off the coast of Greece in November 2020.

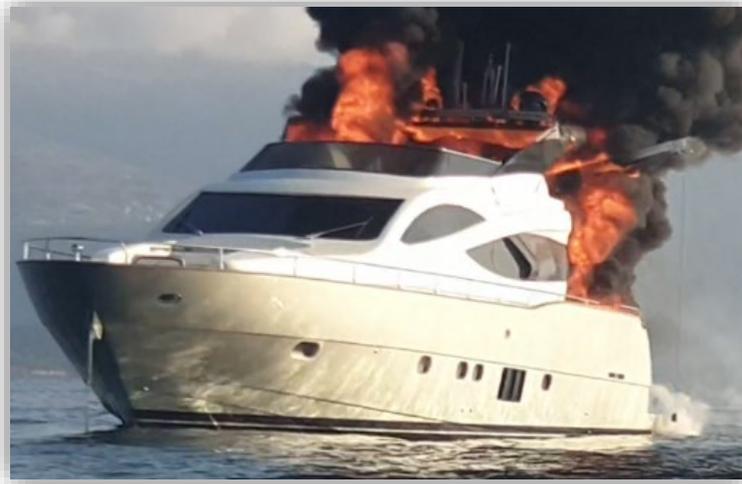
The fire, which started in the Engine Room (ER), spread so rapidly that the crew were forced to abandon the vessel within ten minutes of the fire starting.

The vessel subsequently sank during attempts by a fire-fighting vessel to extinguish the fire.
