Safety Bulletin 01 of 2025

Spontaneous combustion in the anchor Locker

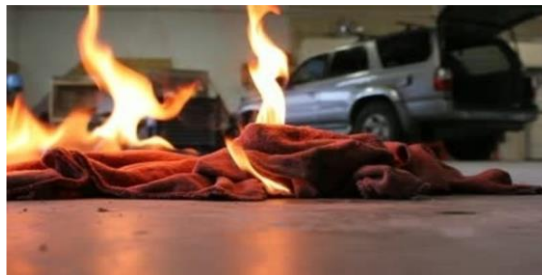
The incident resulted in smoke damage to the inside of the anchor locker and other minor repairs required.

- A fire incident occurred on a yacht due to improper storage of oily rags in a plastic box.
- The rags smouldered from heat buildup, likely due to exothermic evaporation causing the box lid to melt.
- The incident caused smoke damage and other minor repairs required, highlighting fire risks of improper rag storage.

1. **Dispose of rags safely:** Always dispose of rags in accordance with the product's safety material data sheets as soon as possible.
2. **Consider use of fire-resistant containers:** Place oily rags in a closed, fire-resistant container pending disposal.
3. **Ensure proper ventilation:** Store the container in a well-ventilated area, away from other flammable materials.
4. **Educate crew members:** Ensure all crew members are properly educated on the potential hazards and the correct procedures for handling and disposing of oily rags.

The UK P&I Club advises that oil-soaked rags, known to "self-heat" and combust spontaneously, should be kept in a steel container with a lid until they can be properly disposed of.
